Tylorstown Landslide
Environmental Impact Assessment
Volume 3 - Appendices
Series 13 Major Accidents and
Disasters
December 2021

Appendix 13.1

Slope Stability Report

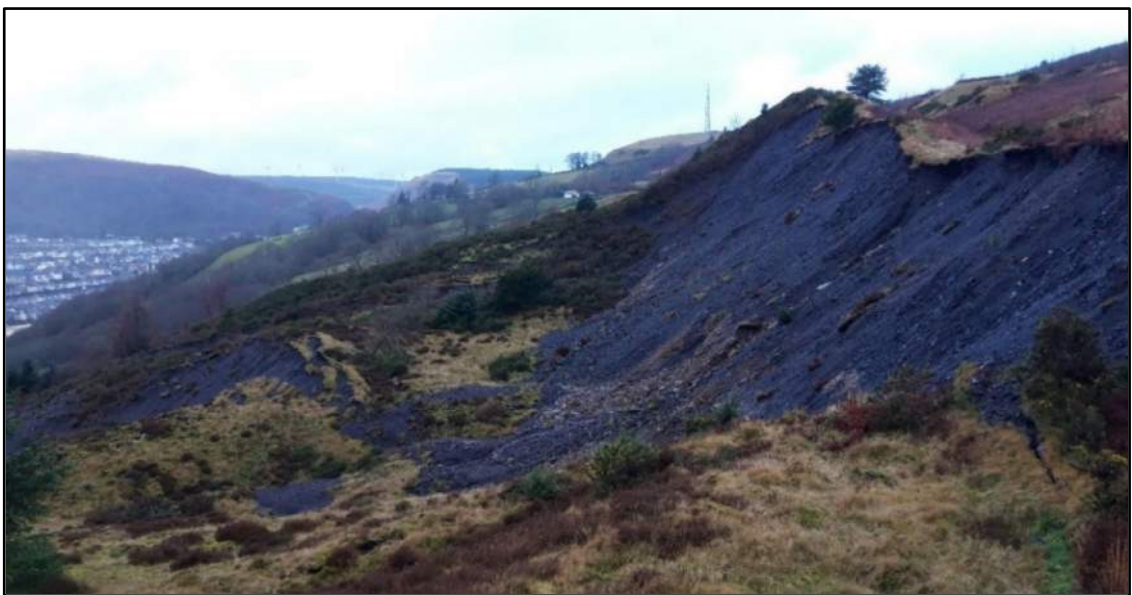
On Sunday 16th February, Storm Dennis instigated the failure of Llanwonno Upper Tip (also referred to as RH01). The largest (main) slip occurred overnight, where the upper part of the tip complex failed in a classical circular slip movement (see Photo 1 below). A further landslide/debris flow (video footage on internet on 16.02.2020, Ref. 1), appears to show a secondary slip mechanism where water had accumulated and burst through (breached) the southern end of the tips (adjacent to former ponds) and flowed down the hillside in a fully saturated state (flow slide failure).

Photo 1: Backscarp of main landslide

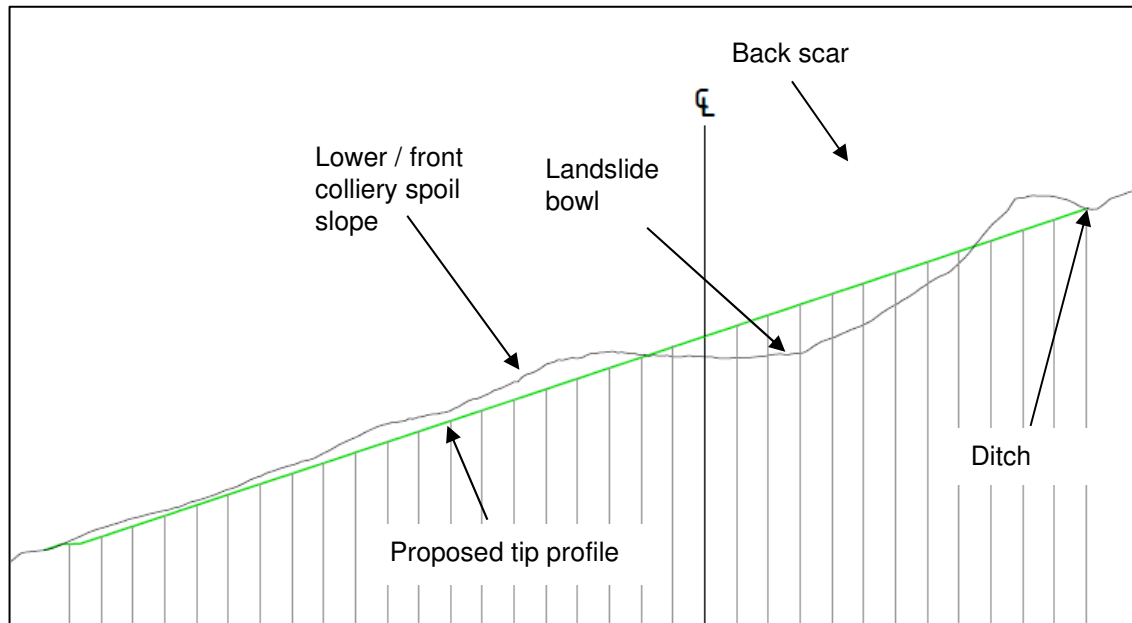
Typical cross-section through the central part of the site (Ch.280m).

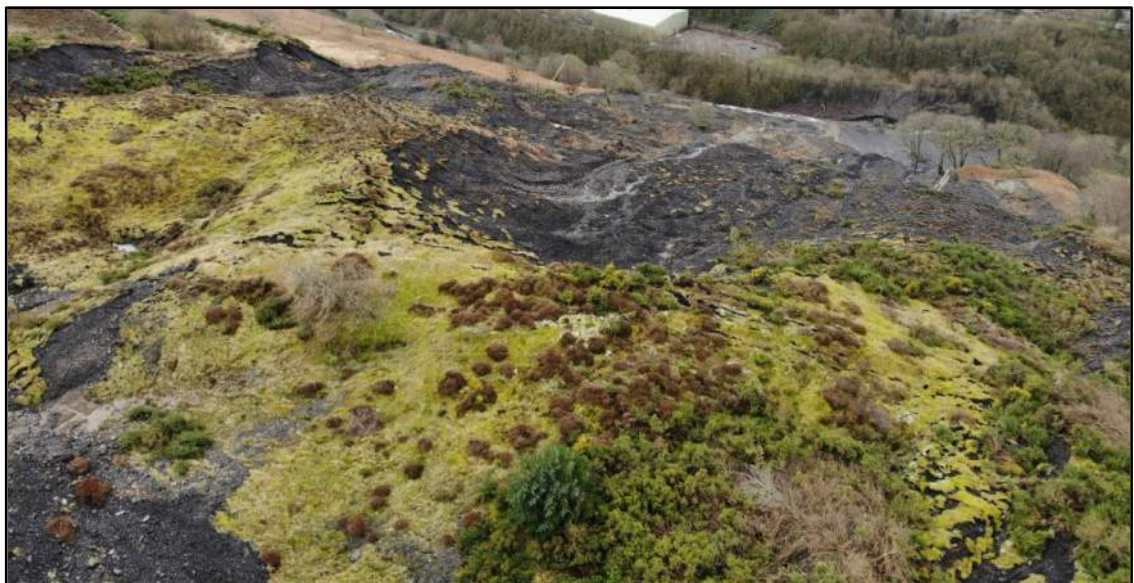
Within Llanwonno Upper Tip, where the landslide occurred, there are three distinct areas (i) rear backscarp, (ii) lower / front colliery spoil slope, separated by (iii) a back-tilted block between (i) and (ii) forming the landslide bowl.

Several issues / spring lines have been exposed within this part of the site (see Section 2.4 for further information). Within the lower / front part of the landslide, water has scoured significant channels through the remaining layer of colliery spoil to expose natural superficial soils.

Photo 2: Central part of landslip looking from the northwest

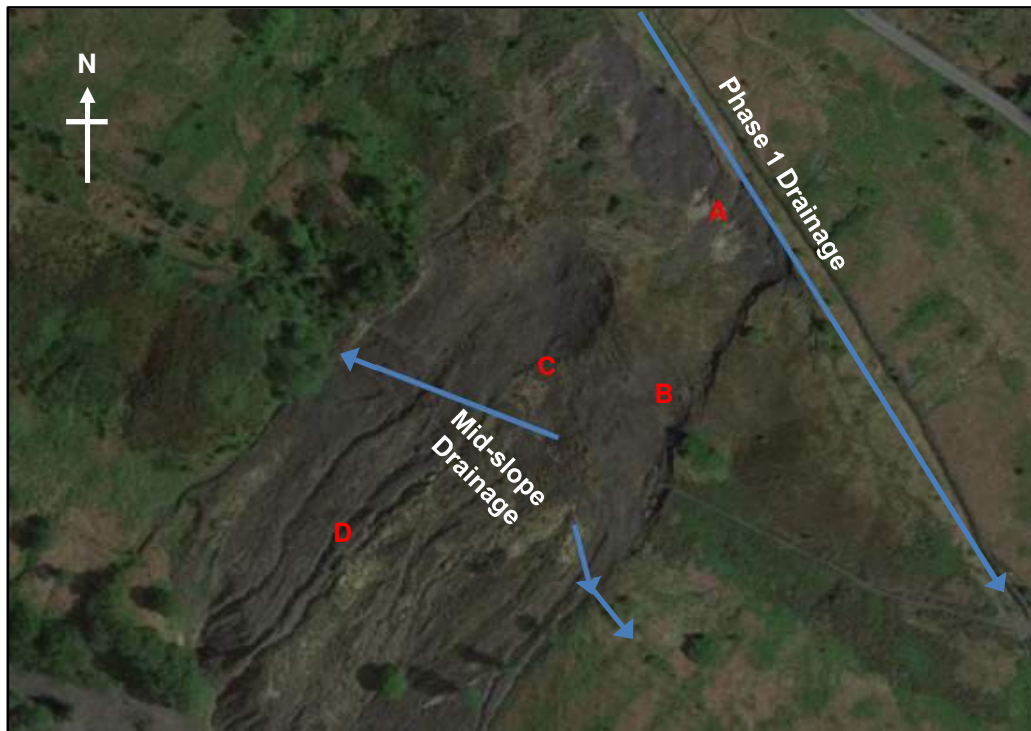
The following on-site groundwater and surface water features have been observed following the landslide. The approximate location of these features is shown on Figure B.

- A. Seepages have been observed within the exposed back scarp feature, occasionally resulting in ponding water within the landslide bowl feature.
- B. Issue / spring line within exposed colliery spoil. Highly responsive during periods of intensive rainfall.
- C. Series of issues / spring lines (and soft cohesive material present).
- D. Surface water scouring deep downslope channels through the colliery spoil.

Figure B: Approximate location of on-site observations of water features post landslip

Phase 1 emergency remediation works involved the installation of a temporary drainage system to capture several surface watercourses and issues from above the Upper Tip and divert them south-east of the site (see Figure B above).

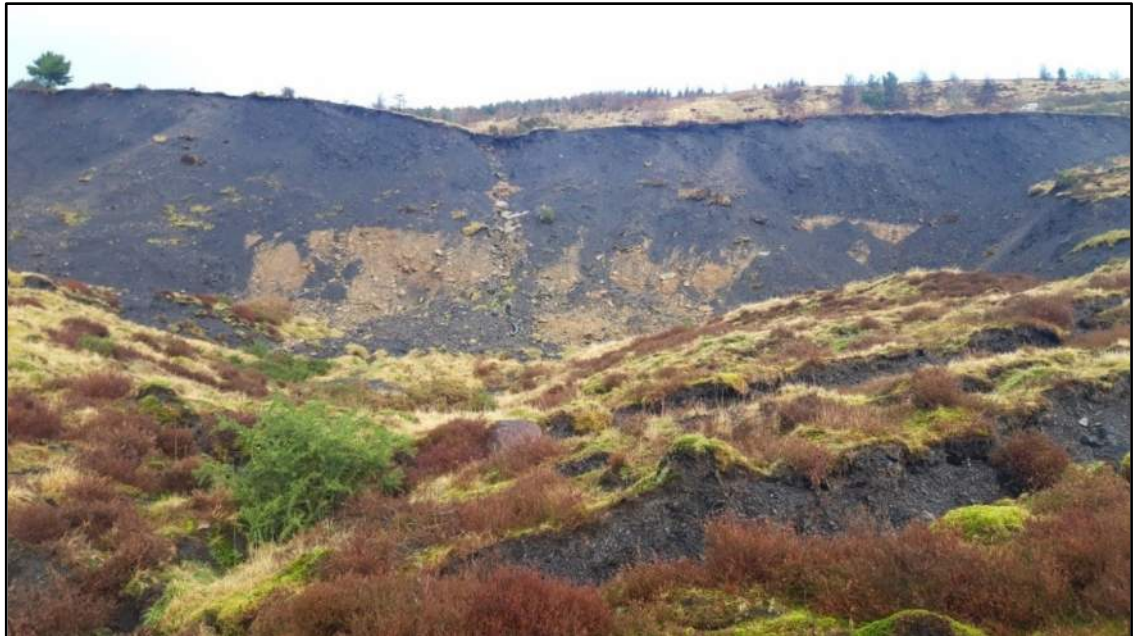
Photo 3: View of main back scarp showing exposed glacial deposits.

Back analysis of the exposed back scarp suggested that the soil parameters used for the natural glacial deposits may have been conservative, and potentially material parameters used should be equal to peak and not residual strength values as previously analysed.

The analysis concluded that, in terms of overall stability, the Factor of Safety on the materials (colliery spoil) left on the slope is close or at unity and these materials will need to be removed in the long term if other remediation measures are not implemented.
