Flood and Water Management Act 2010

Section 19 Flood Investigation Report

Unnamed Storm – 04/10/2021

Rhydyfelin

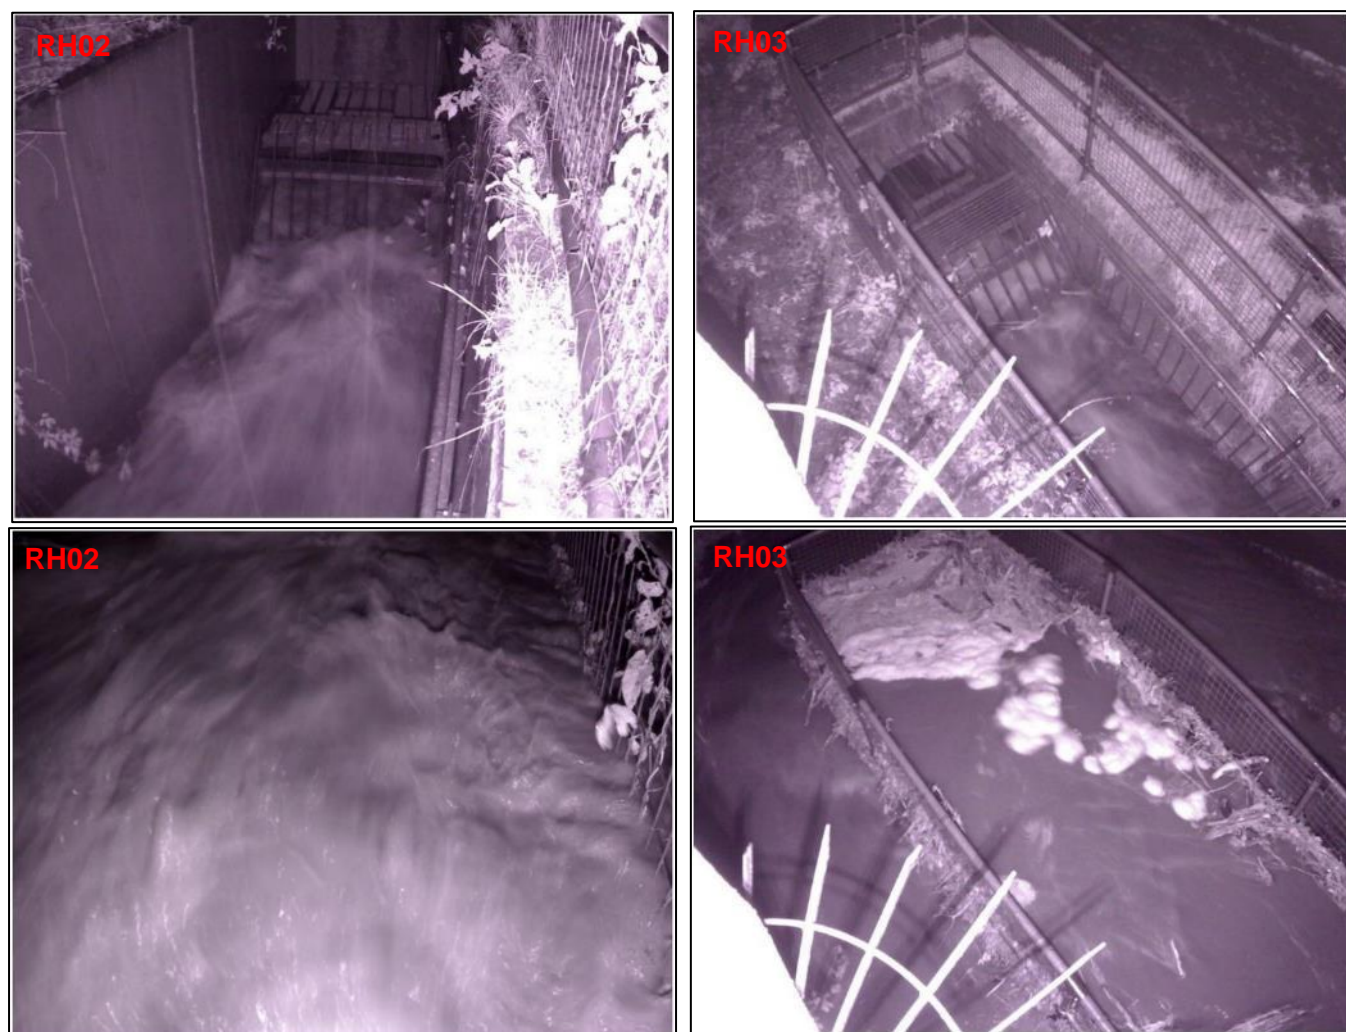
Figure 4 demonstrates the watercourses' rapid response to rainfall within Rhydyfelin, whereby, within a 1-hour period, the unnamed watercourses conveying towards Rhydyfelin rapidly rose in levels, resulting in surcharging flows beyond the culvert inlet structures and onwards to impact properties downstream.

Figure 4: Images captured at RCT's monitoring station at culvert inlets RH02 (left) and RH03 (right) in Rhydyfelin. (04/10/21 22:14 (top left), 04/10/21 23:25 (bottom left), 04/10/21 21:53 (top right), 04/10/21 23:55 (bottom right))

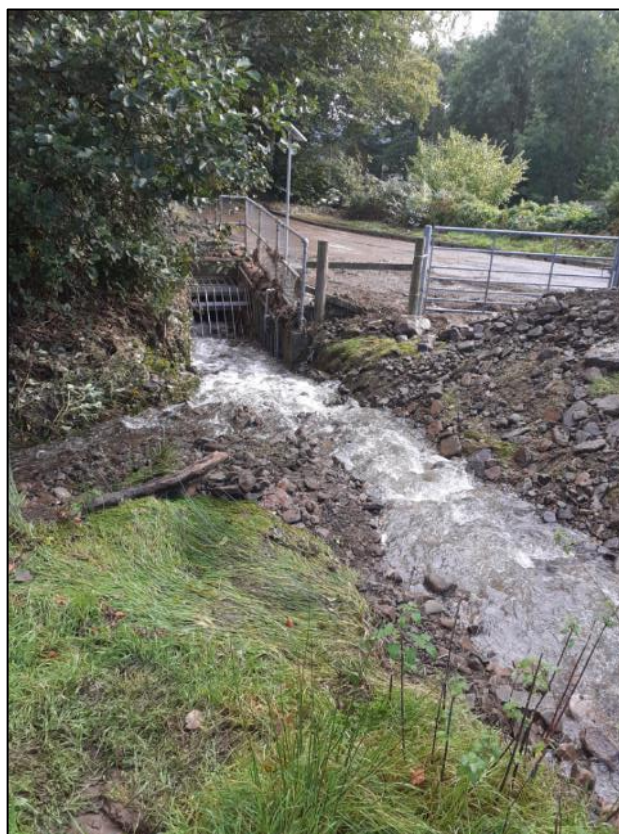
Post event inspections also noted significant debris, consisting of large stones and silt, deposited along the channel embankments and the area surrounding 'Culvert Inlet RH03' (Figure 7).

Figure 7: Image of 'Culvert Inlet RH03' showing material deposited on the channel banks during post event inspections (captured by RCT's Flood Risk Management team on 5th October 2021)

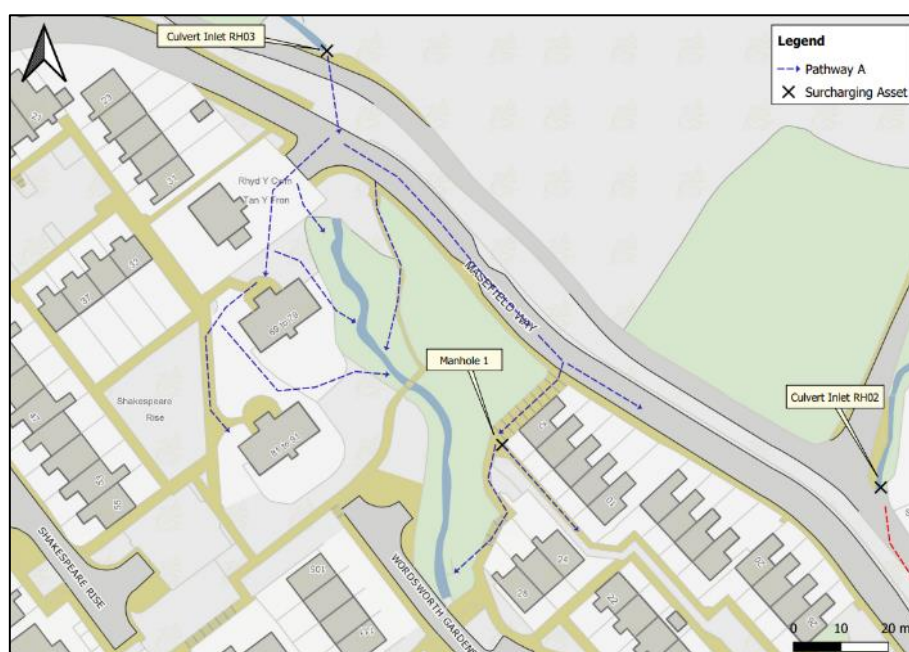
It was also reported by residents that a privately owned combined sewer manhole to the rear of Masefield Way (labelled Manhole 1, Figure 8) surcharged during the storm event. The manhole was noted as partially blocked with debris by residents and on-site inspectors. Surcharging flows from the manhole flowed east along the lane to the rear of properties at Masefield Way, contributing to the internal flooding of one property from the rear. Flow was also noted as re-entering the unnamed ordinary watercourse at this location.

Figure 8: Location of 'Manhole 1' which was identified as surcharging during the storm event

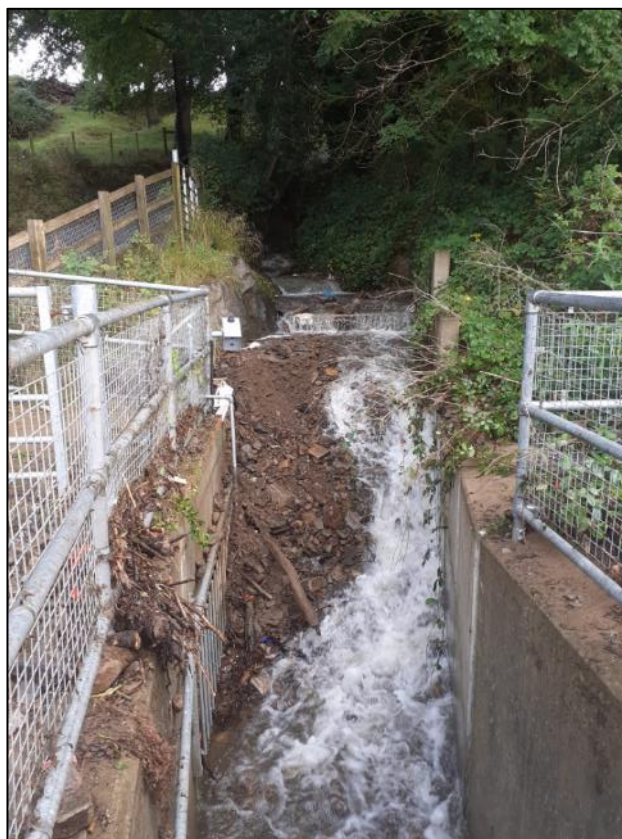
of unprecedented high flows and the presence of debris at the culvert inlet debris screen. Figure 10 shows a significant volume of deposited material, consisting of stone and silt, within the channel and area surrounding 'Culvert Inlet RH02'. At the time of inspection, a majority of the material at the inlet structure had already been cleared during emergency cleansing operations by RCT's Highway and Streetcare Depot.

Figure 10: Image of 'Culvert Inlet RH02' showing material deposited within the channel during post event inspections (captured by RCT's Flood Risk Management team on 5th October 2021)

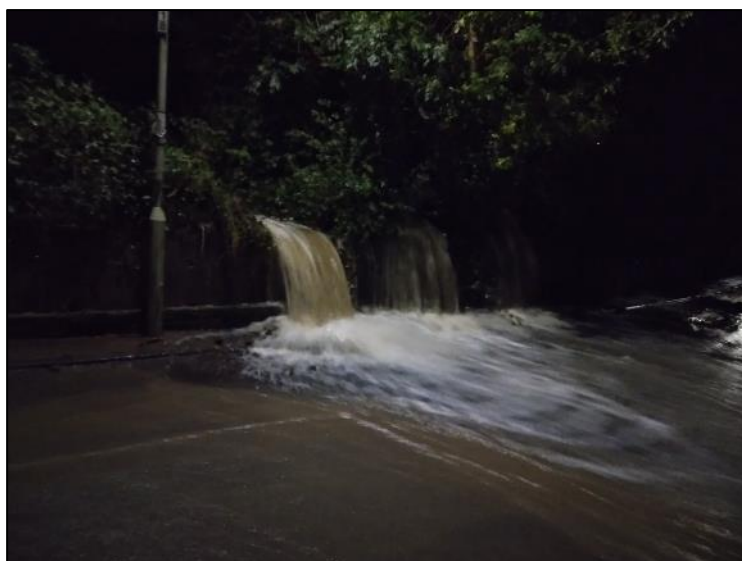
Figure 11: Surcharging flows from 'Culvert Inlet RH02' conveying over the embankment and onto Masefield Way during the storm event (image provided by resident)

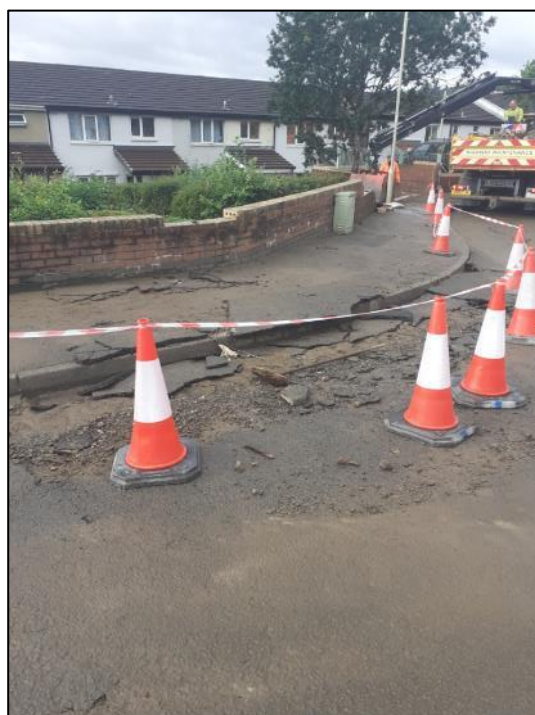
The powerful ordinary watercourse exceedance flows were also observed to have damaged sections of the highway (Figure 12) and a section of retaining wall opposite the impacted properties at Wordsworth Gardens.

Figure 12: Damage to the highway at Wordsworth Gardens (captured by RCT's Flood Risk Management team on 5th October 2021)

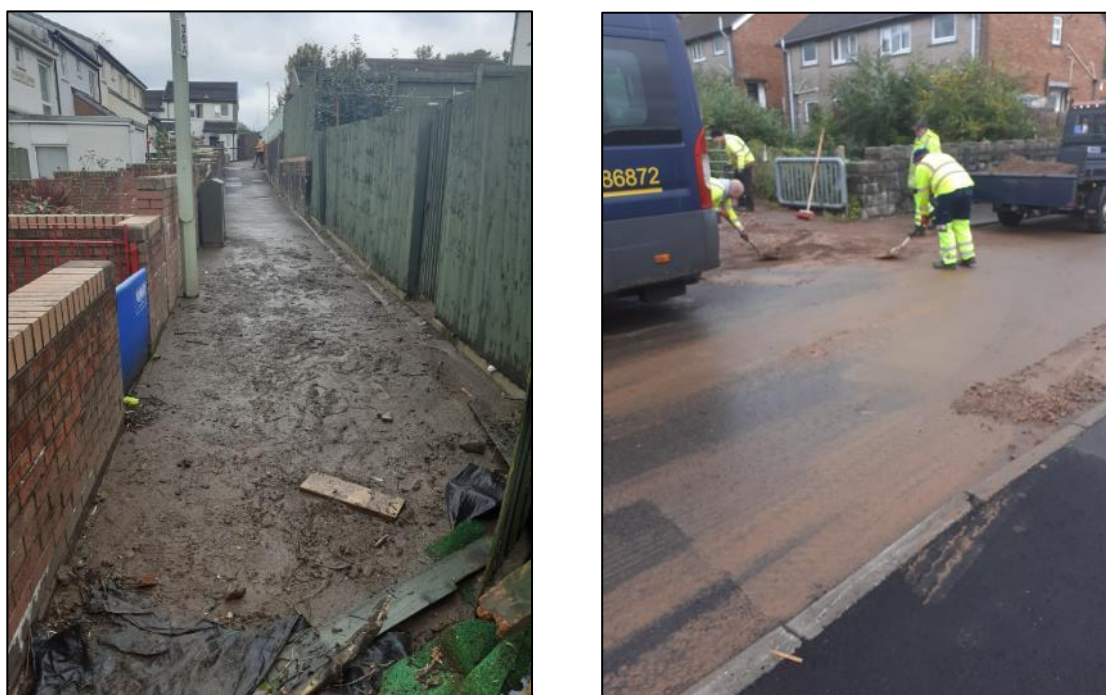
The following images depict the mud and silt deposits along the highway network, indicative of flow 'Pathway B' throughout several streets in Rhydyfelin during the storm event.

Figure 13: Mud and silt deposits within the lane at Wordsworth Gardens (left) and Oak Street (right) during post event cleansing operations (captured by RCT's Flood Risk Management team on 5th October 2021)

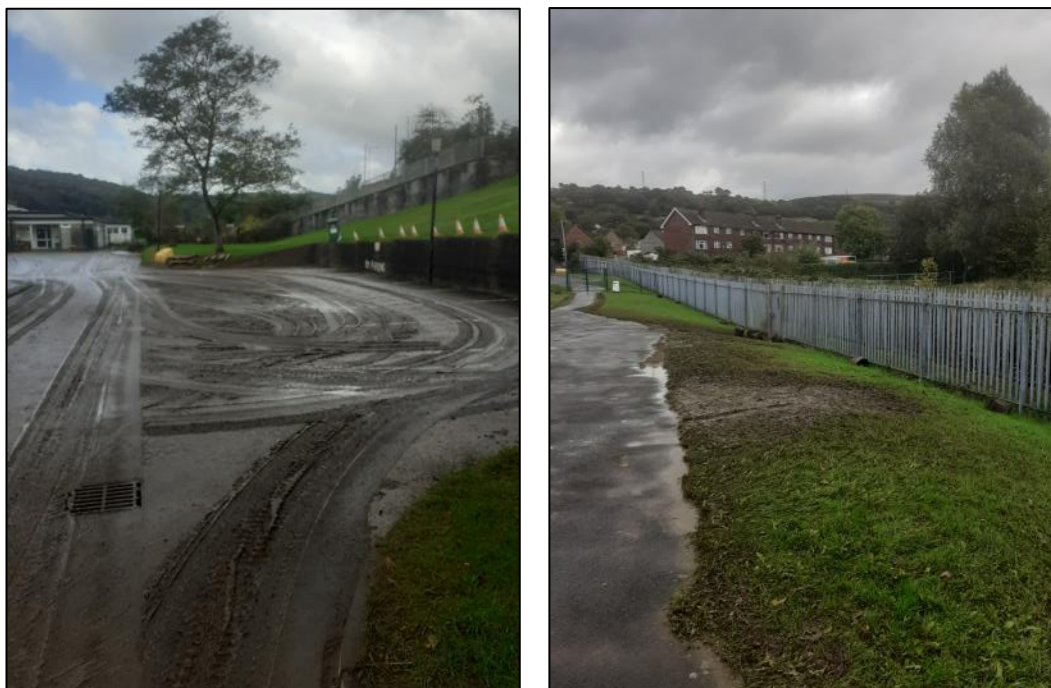
Figure 14: Mud and silt deposits (left) and evidence of saturated ground indicative of the flow path of water (right) within the grounds of Heol-y-Celyn School (captured by RCT's Flood Risk Management team on 5th October 2021)

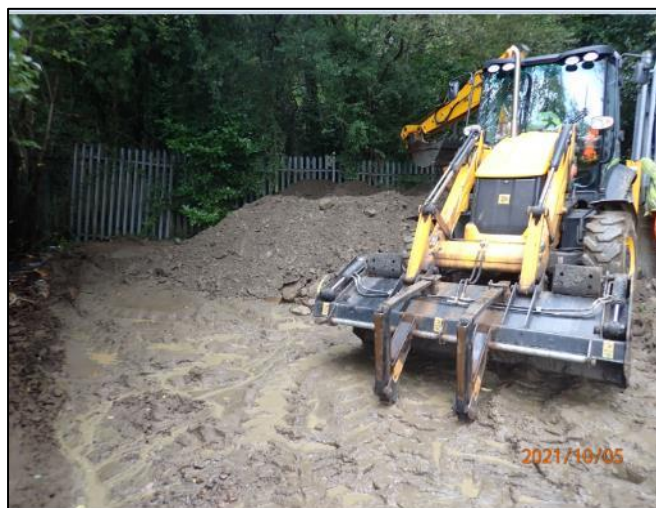
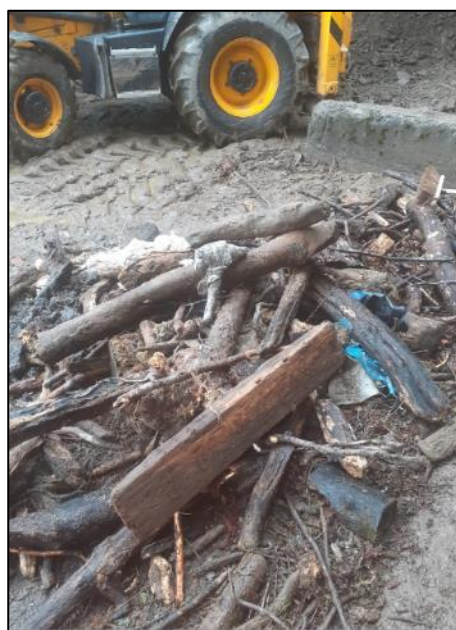
During the evening of the 4th of October 2021, residents at Dynea Road reported flooding to properties sourced by the 'Nant Corrwg Culvert Inlet' above Dynea Caravan Site. The inlet and overflow system showed evidence of overtopping caused by a build-up of debris including natural scour material and wooden debris at the inlet's debris screen. This material was identified in the area surrounding the culvert inlet following cleansing operations on the 5th October 2021 (Figure 16).

Figure 16: Mud, silt and scour material being cleared from the 'Nant Corrwg Culvert Inlet' by RCT's Highway and Streetcare Depot on 5th October 2021 (captured by RCT's Flood Risk Management team on 5th October 2021)

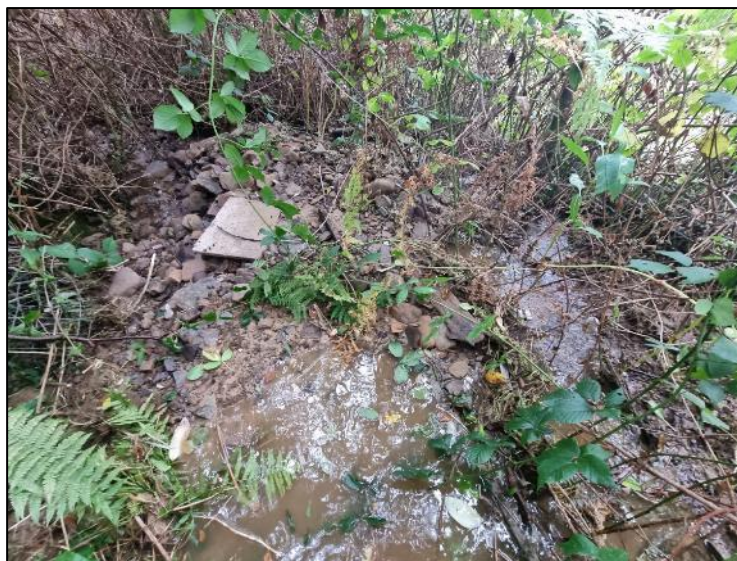
Residents reported significant overland flow travelling down the hillside to the rear of residential properties along Dynea Lane. It was identified upon a site inspection of the area on 8th October 2021, that the watercourse upstream of 'Culvert Inlet RH01' had significant debris, consisting of stonewash, within the channel (Figure 18). This material was observed to be impeding the flow of water downstream, resulting in out-of-bank flows down the hillside. An obstruction of flow was also identified within the watercourse (Figure 19) which was also observed to be contributing to the overtopping of the watercourse. The obstruction in Figure 19 consists of large concrete slabs.

Figure 18: Silt and stone causing an impediment of flow within the unnamed ordinary watercourse channel (captured by RCT's Flood Risk Management team on 8th October 2021)

The obstruction and impediment of flow caused the unnamed ordinary watercourse to overtop and flow overland towards Dynea Road. Pathway D caused external flooding to one residential property and contributed surface water runoff to Pathway C along Dynea Road.

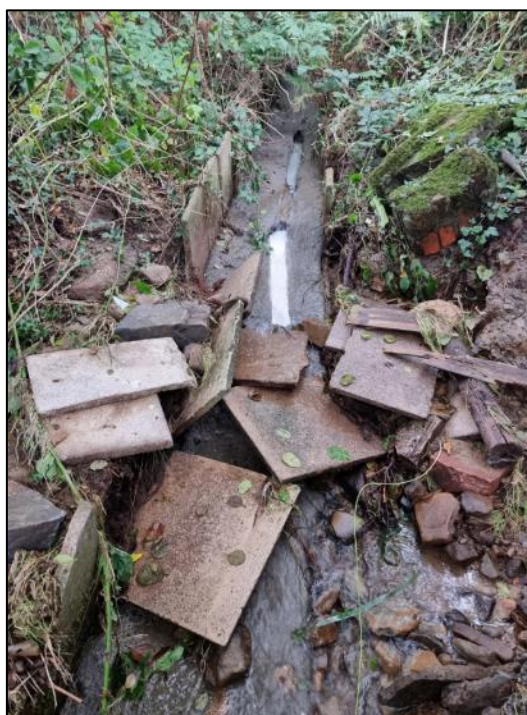
Figure 19: Obstruction of flow within the unnamed ordinary watercourse channel (captured by RCT's Flood Risk Management team on 8th October 2021)

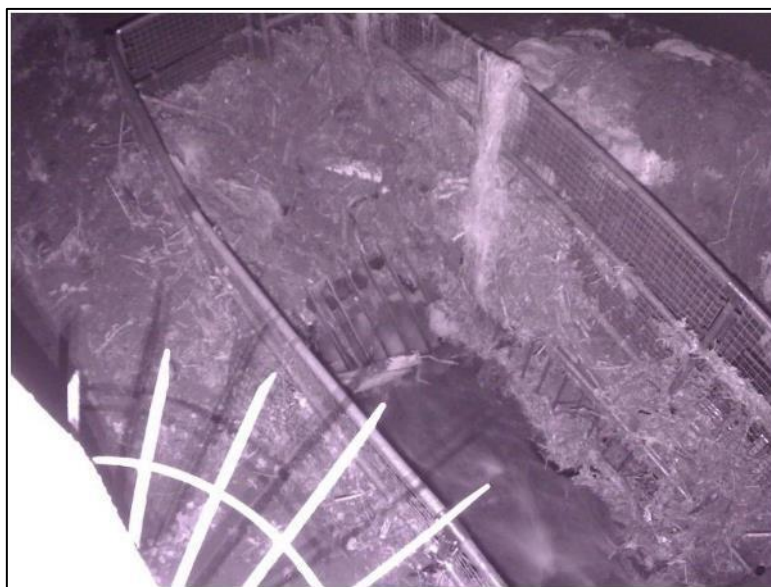
Following the surcharge and recession in water levels within the watercourse (shown in Figure 4), a significant volume of debris and material was deposited on the culvert and overflow debris screens. This is depicted within Figure 22 captured at 01:57 5th October 2021.

Figure 22: CCTV image of 'Culvert Inlet RH03' captured at 01:57 5th October 2021

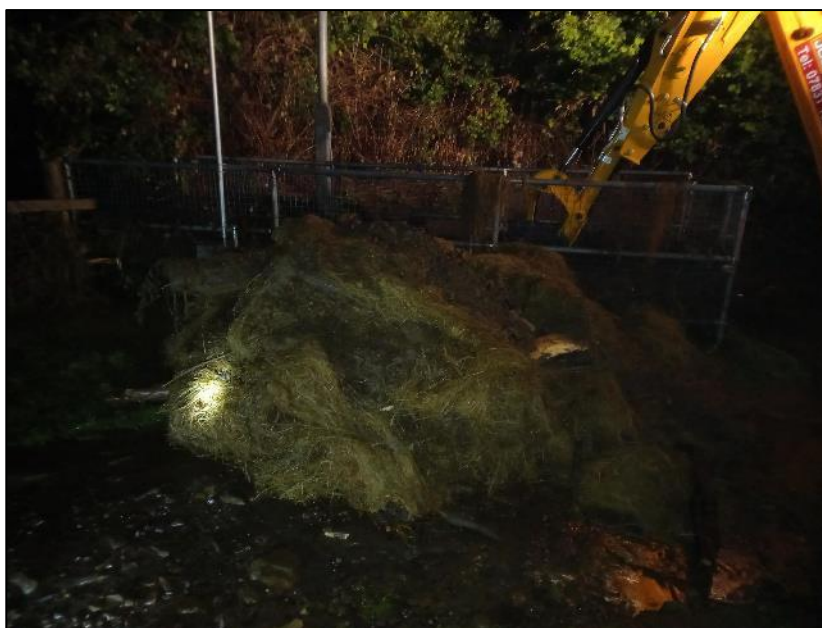
Approximately 6 tonnes of material was removed from 'Culvert Inlet RH03' during emergency clearance operations carried out by RCT's Highway and Streetcare Depot.

Figure 23: Image of the debris removed from 'Culvert Inlet RH03' during emergency clearance works carried out by RCT's Highway and Streetcare Depot on 5th October 2021

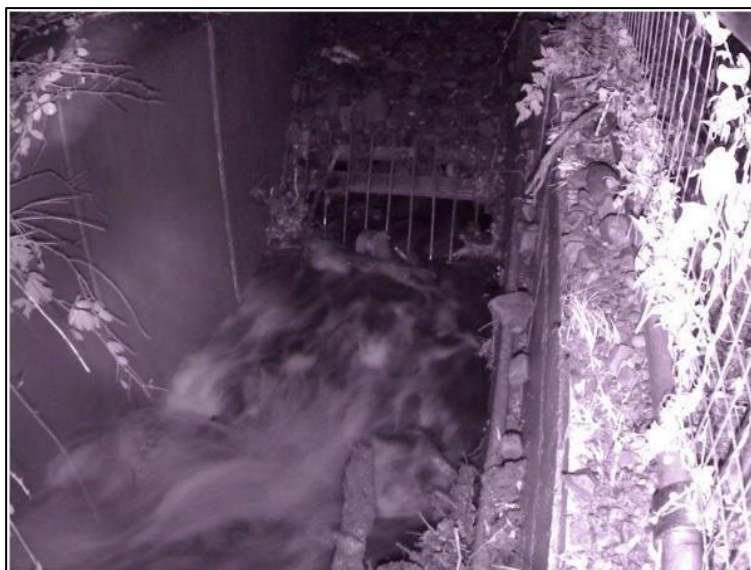
Following the surcharge and recession in water levels within the watercourse (shown in Figure 4), a significant volume of debris and material was deposited on the culvert and overflow debris screens. This is depicted within Figure 25 captured at 02:17 5th October 2021.

Figure 25: CCTV image of 'Culvert Inlet RH02' captured at 02:17 5th October 2021

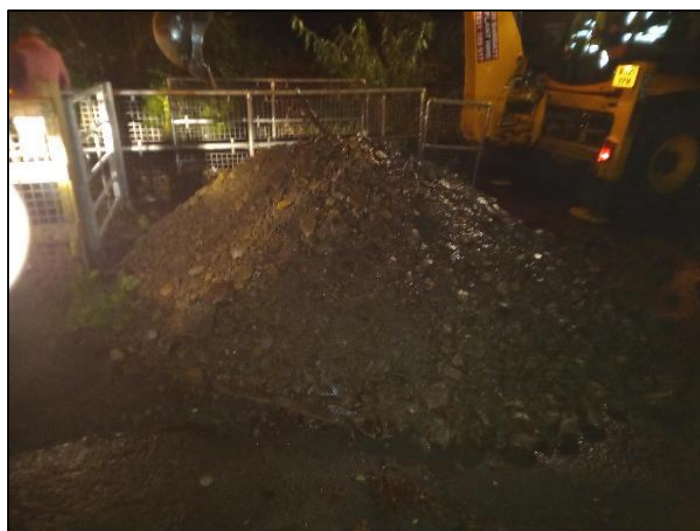
Approximately 7 tonnes of material was removed from 'Culvert Inlet RH02' during emergency clearance operations carried out by RCT's Highway and Streetcare Depot.

Figure 26: Image of the debris removed from 'Culvert Inlet RH02' during emergency clearance works carried out by RCT's Highway and Streetcare Depot on 5th October 2021

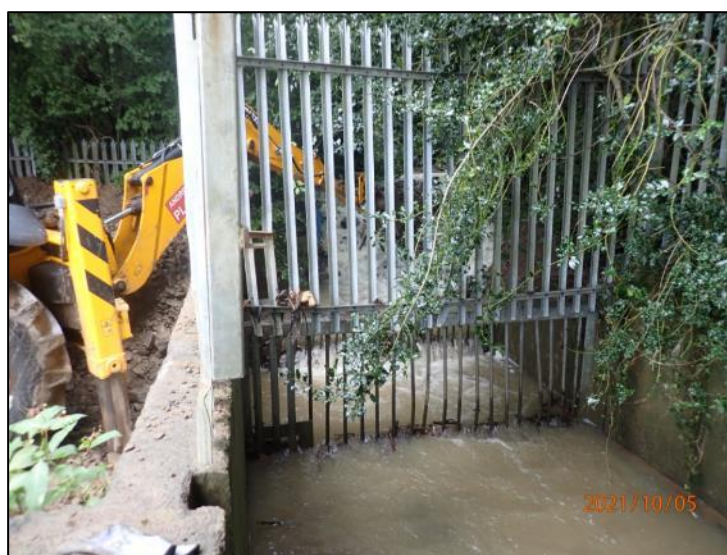
The debris screens upstream of the 'Nant Corrwg Culvert Inlet' was identified by first responders as being significantly blocked with scour material and woody debris mobilised by the fast-flowing water within the Nant Corrwg watercourse during the storm event. The blockage at the debris screens was observed as restricting the flow of water entering the culvert inlet and overflow system, resulting in the overtopping of flows over the western headwall (behind the debris screen depicted in Figure 27) and onwards towards Dynea Road.

Figure 27: Image of the 'Nant Corrwg Culvert Inlet' debris screens captured during emergency cleansing operations by RCT's Highway and Streetcare Depot on 5th October 2021

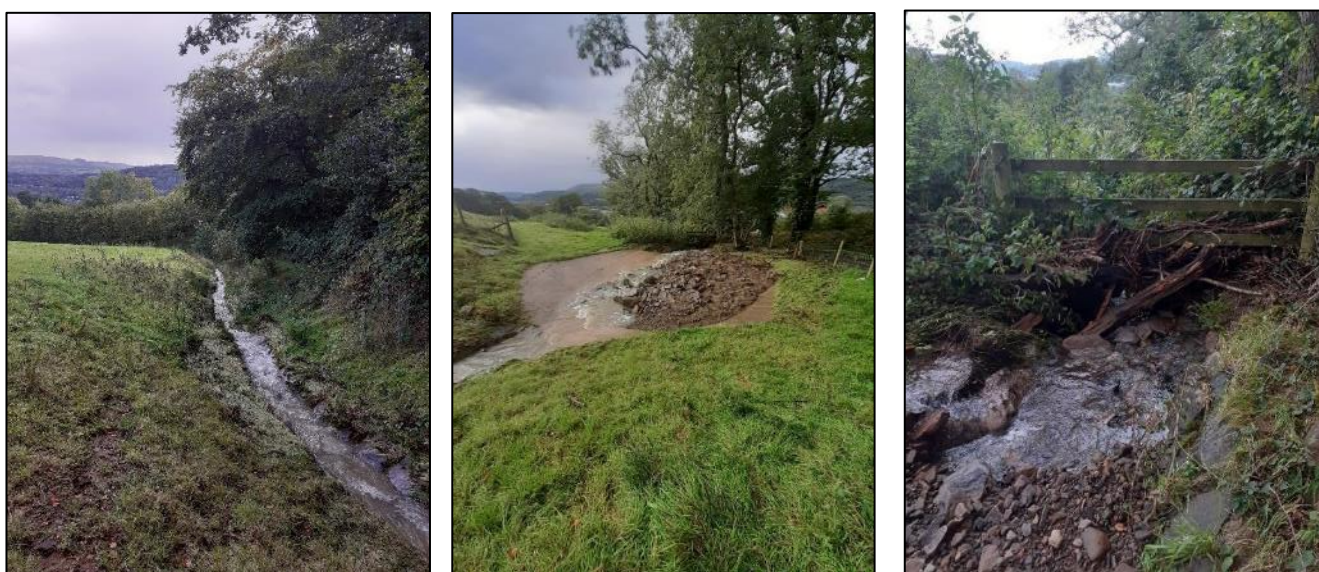
Debris was also identified downstream of the ford at the fence line (shown in Figure 30). The debris consisted of vegetation and debris, causing an impediment to the flow. During the storm event this area was observed to be overtopping onto the highway and onwards towards Masefield Way.

Figure 30: Evidence of the overtopping of 'Unnamed Ordinary Watercourse RH03' (left), debris accumulation at the ford (middle) and debris causing an impediment of flow (right) at RH03 Area 1 (images captured by RCT during post event inspections)

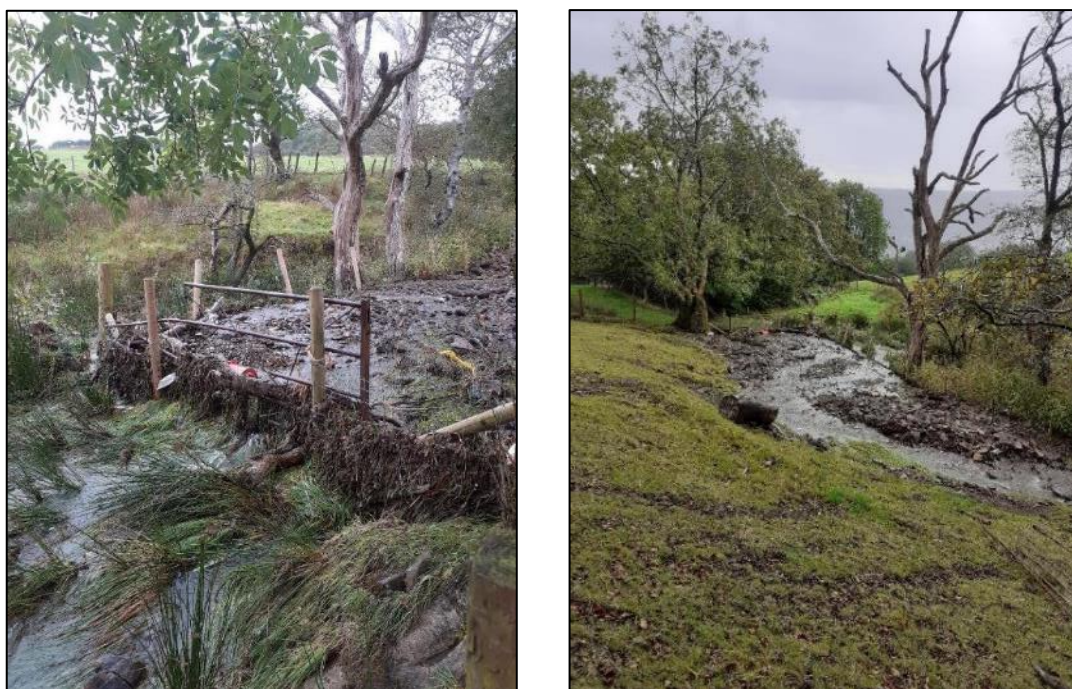
velocities flowing downstream during the storm event, in addition to the identified areas of deposition, it is likely that scouring occurred.

Figure 31: Obstruction of flow (left) and accumulated debris (right) within RH03 Area 3 of 'Unnamed Ordinary Watercourse RH03' (images captured by RCT during post event inspections)

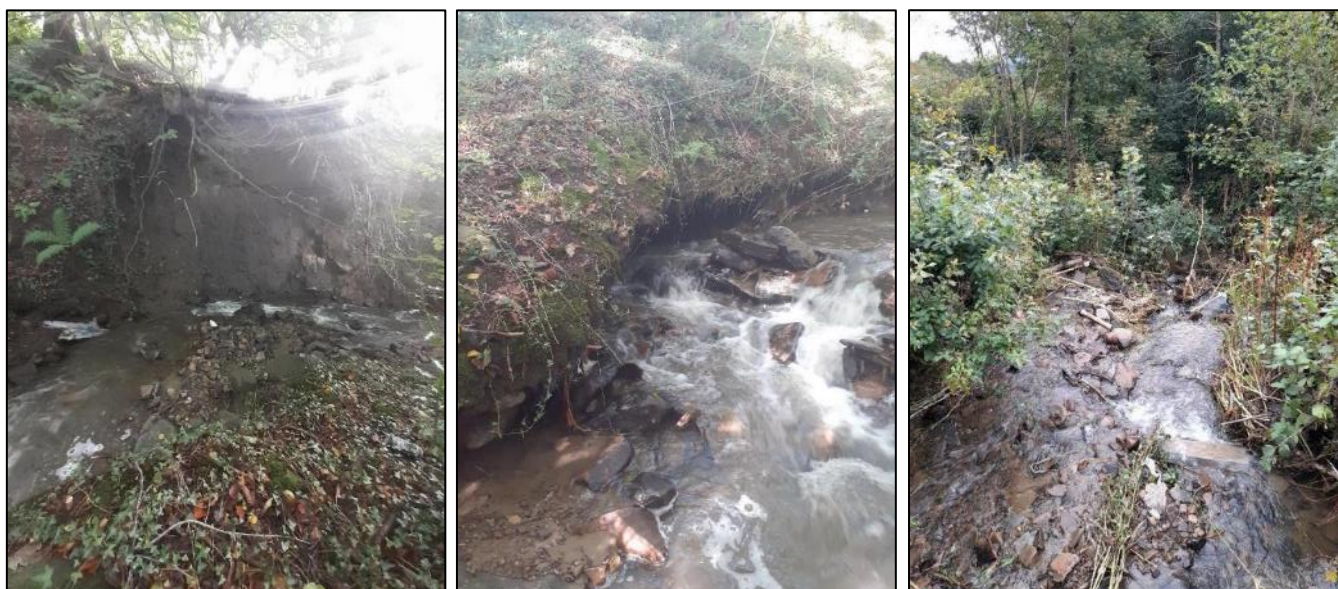
Several areas of minor scour and undercutting of the watercourse was evident upon inspection of 'RH02 Area 1', with one section of significant embankment scour identified (Figure 33, left) and considered to have occurred during the storm event. The soil of the embankments were also observed to comprise of alluvium deposits inclusive of stones and cobbles which is susceptible to scour.

Figure 33: Evidence of significant embankment scour (left), undercutting (middle) and debris deposition (right) within RH02 Area 1 of 'Unnamed Ordinary Watercourse RH02' (images captured by RCT during post event inspections)

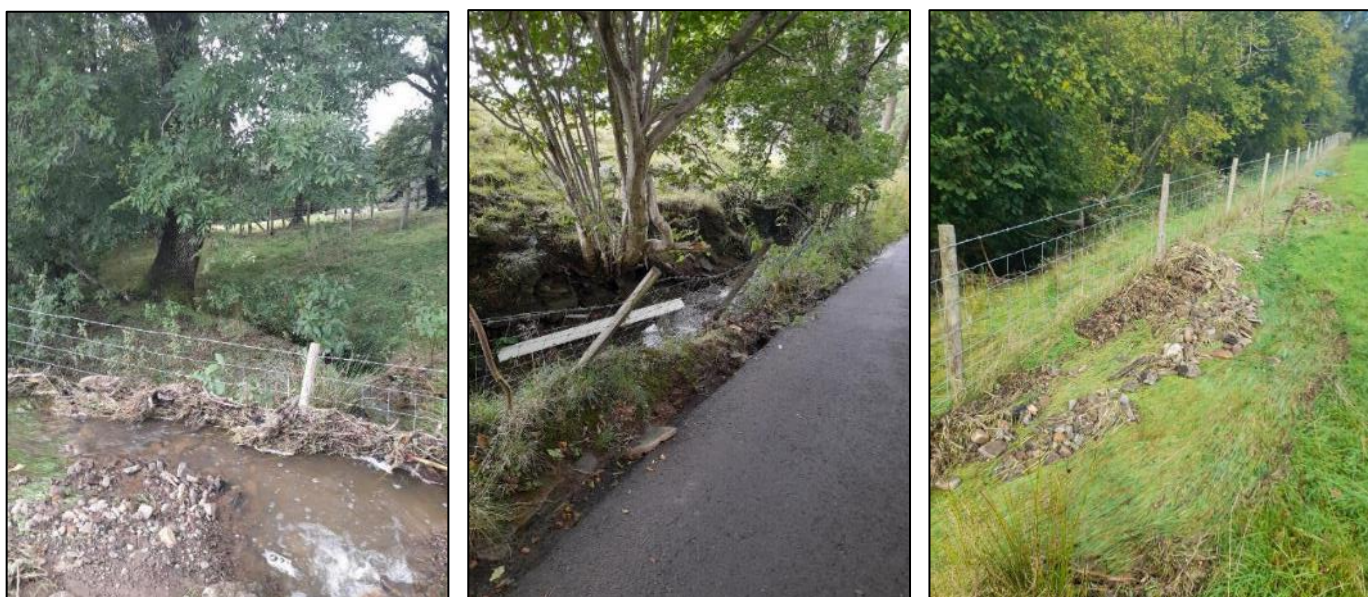
Minor scouring of the channel embankments was observed, particularly towards the lower section of 'RH02 Area 3'. Figure 34 (middle) depicts the observed embankment scour which appears to have resulted in the overtopping of the watercourse and conveyance along the tarmac road causing minor erosion.

Evidence of further overtopping was also observed as a result of obstructions identified along the watercourse length in 'RH02 Area 3'. Figure 34 depicts debris accumulation alongside the fence line causing an obstruction of flow and resulting in deposition of material on the banks of the channel.

Figure 34: Obstruction of flow (left), scouring of the channel embankment and tarmac road (middle) and deposits of material indicative of out-of-bank flows (right) within RH02 Area 3 of 'Unnamed Ordinary Watercourse RH02' (images captured by RCT during post event inspections)

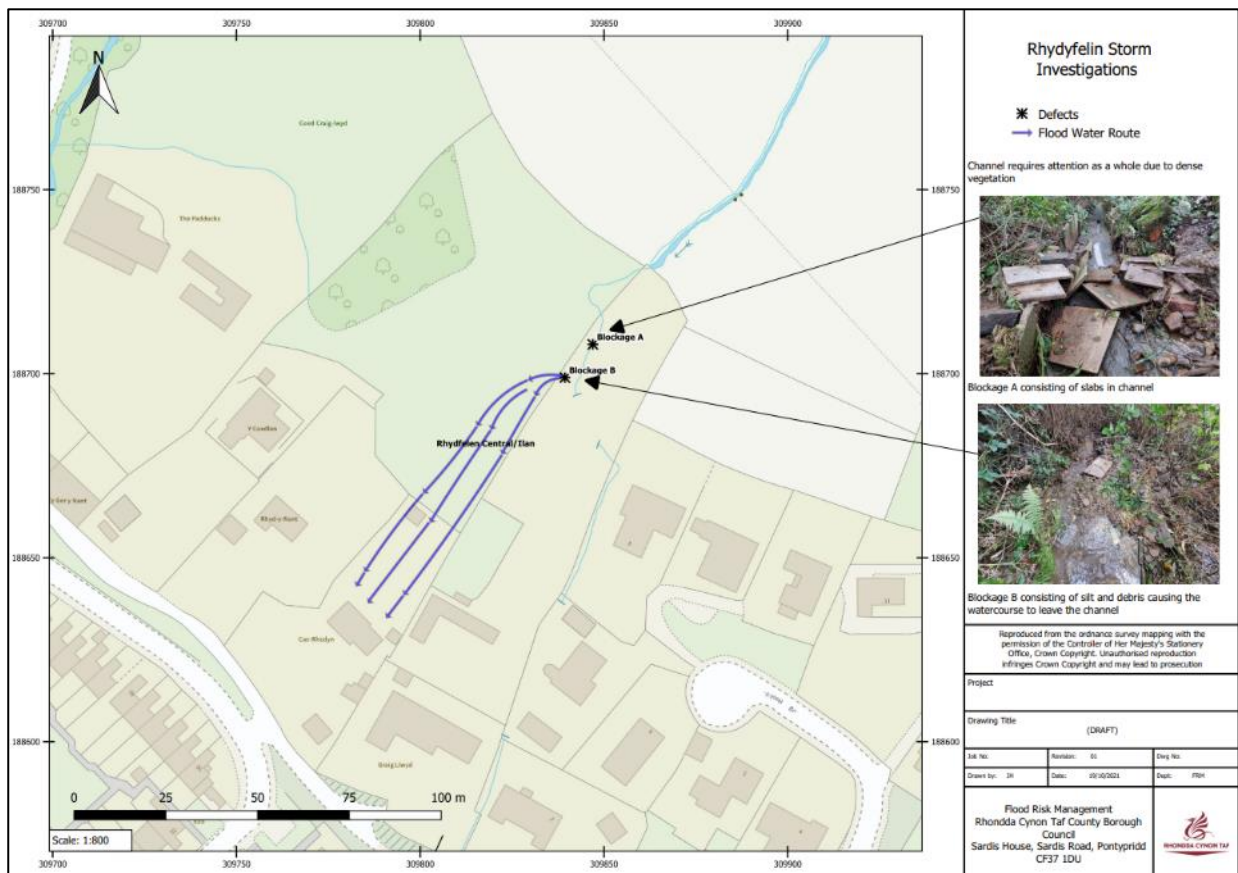
Figure 35: Site Inspection and Investigation Plan of 'Unnamed Ordinary Watercourse RH01' produced by RCT's Flood Risk Management team

Blockage B consisted of stone and silt, indicative of natural erosive processes within the channel. Blockage A comprised of concrete slabs which is considered to have been the primary cause of the overtopping of 'Unnamed Ordinary Watercourse RH01' and the resultant overland flows running down the hillside towards Dynea Road.

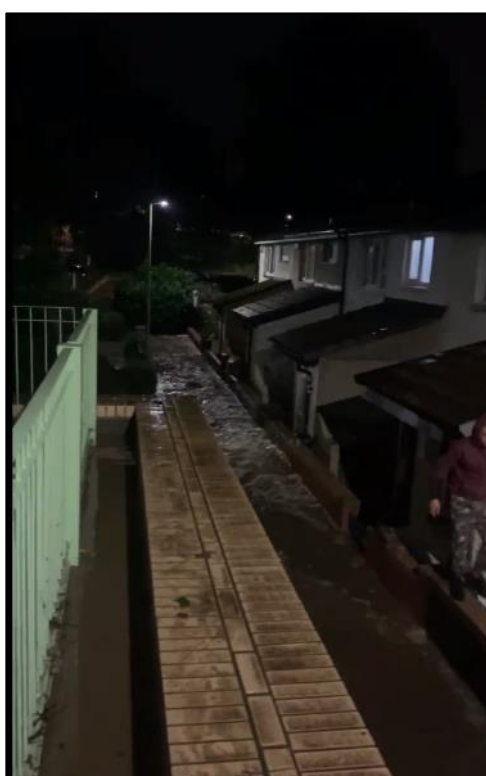
Figure 37: Surface water accumulation at the fronts of properties at Wordsworth Gardens as a result of 'Culvert Inlet RH02' surcharging during the storm event on 4th October 2021 (image provided by resident)
