Section 19 Flood Investigation Report

Storm Dennis –

Flood Investigation Area RCT15
(Rhydyfelin & Hawthorn)

July 2022

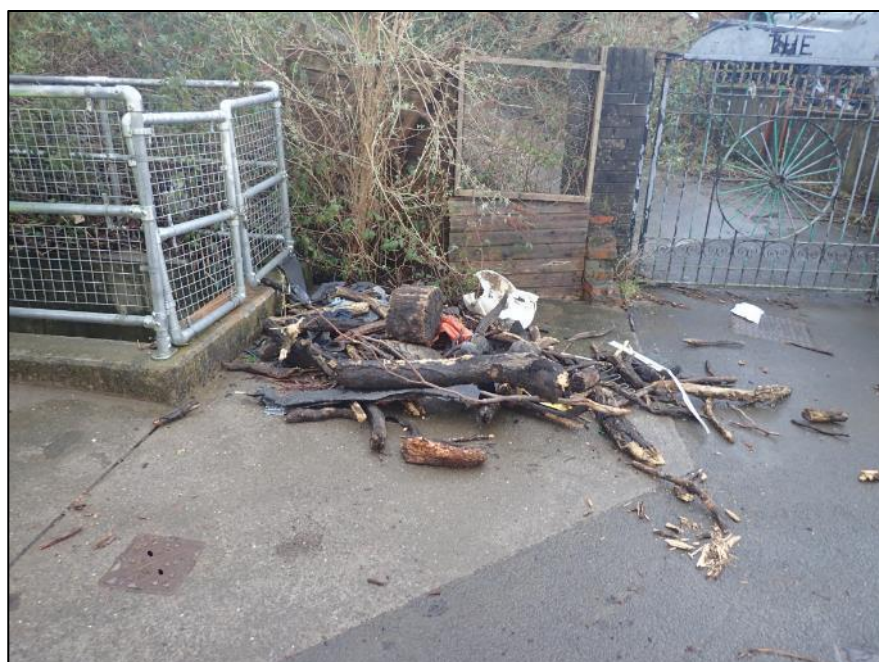
Figure 6: Image of the debris that was cleared from 'Culvert Inlet 1' during emergency cleansing operations (image captured by RCT's Flood Risk Management team on 17th February 2020)

Evidence of debris, inclusive of stones and woody debris, was identified to have been cleared from 'Culvert Inlet 1' (Figure 6) and 'Culvert Inlet 2' during post event inspections. Evidence of deposited debris within the channels, in addition to debris trapped behind the upper debris screen was also observed post event, indicative of the entrainment of material within the watercourses during the storm event. Figures 16 and 17 illustrate the condition of the channels upstream of 'Culvert Inlet 1 and 2' before and after Storm Dennis and depict the identified debris accumulation within the channels and upper debris screen.

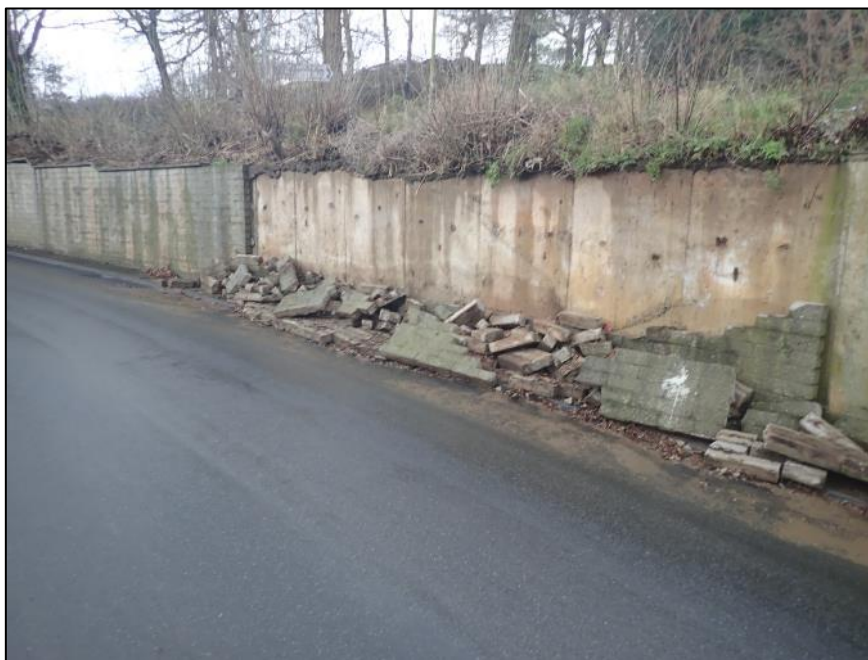
The exceedance flows were also observed to have damaged a section of highway retaining wall immediately below 'Culvert Inlet 1' (Figure 7), in addition to a retaining wall opposite the impacted properties at Wordsworth Gardens (Figure 8).

Figure 7: Damaged highway retaining wall below 'Culvert Inlet 1' (image captured by RCT's Flood Risk Management team on 17th February 2020)

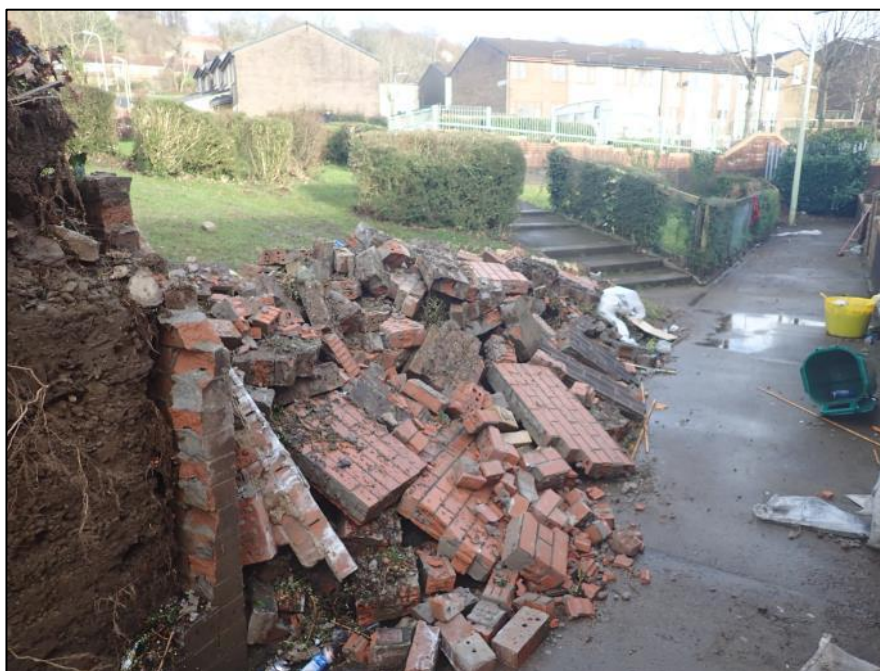
Figure 8: Damaged retaining wall at Wordsowrth Gardens caused by the surcharging of 'Culvert Inlet 1' (image captured by RCT's Flood Risk Management team on 17th February 2020)

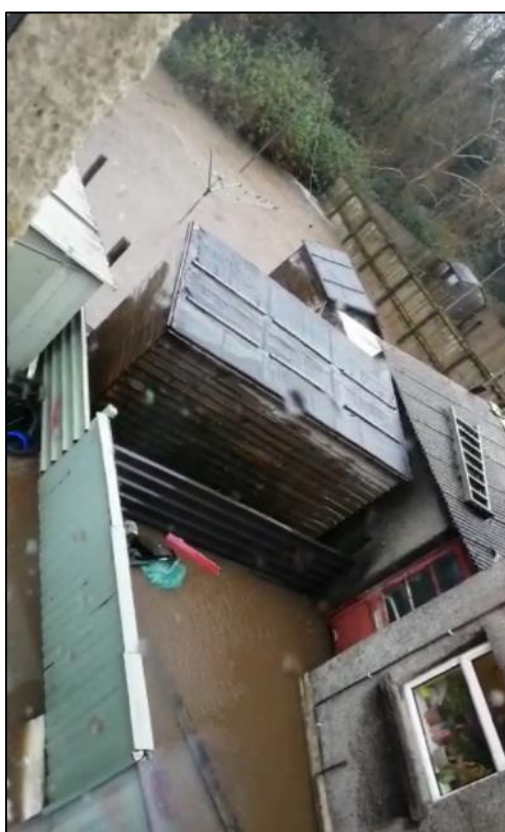
Figure 10: Flooding observed at Hawthorn Crescent from the Nant Lonydd ordinary watercourse during Storm Dennis (image provided by resident)

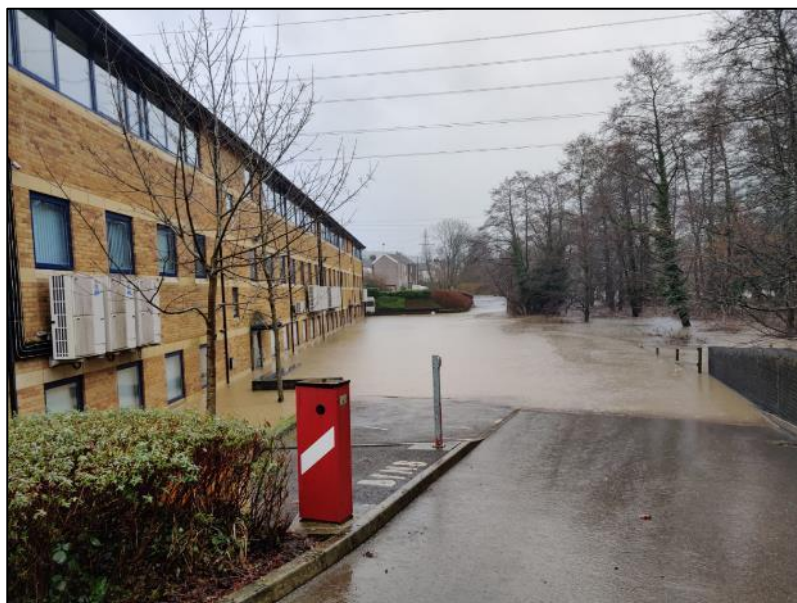
Figure 11: Flooding observed at Melin Corrwg Business Park from the Nant Lonydd ordinary watercourse during Storm Dennis (image provided by resident)

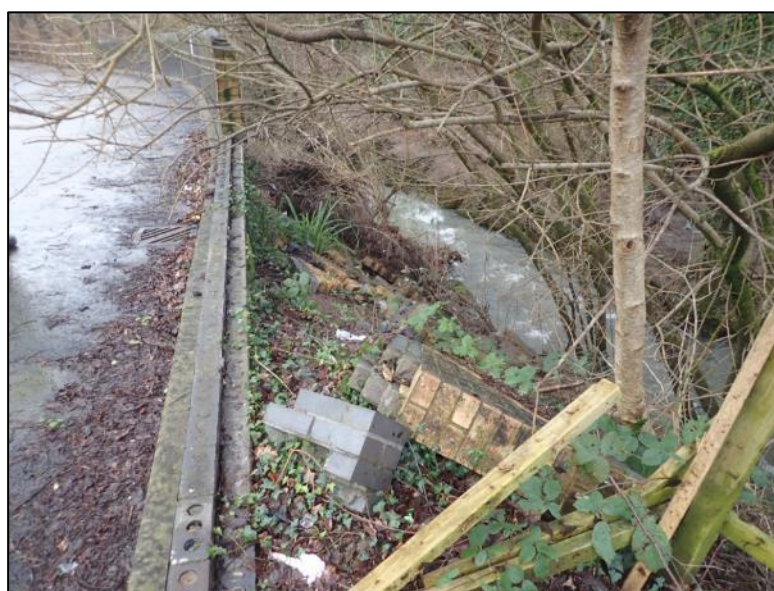
Observations made during the site inspection identified sections of damaged retaining wall at Melin Corrwg Business Park (Figure 12), indicative of the forceful flows which occurred during the storm event. The Nant Lonydd is identified to have breached the retaining wall at Melin Corrwg Business Park, resulting in significant flood depths within the affected commercial properties. Figure 13 shows water depth marks of over 2 metres in height within the flooded properties.

Figure 12: Damaged retaining wall at Melin Corrwg Business Park following the breach of the Nant Lonydd watercourse during Storm Dennis (image captured by RCT's Flood Risk Management team on 17th February 2020)

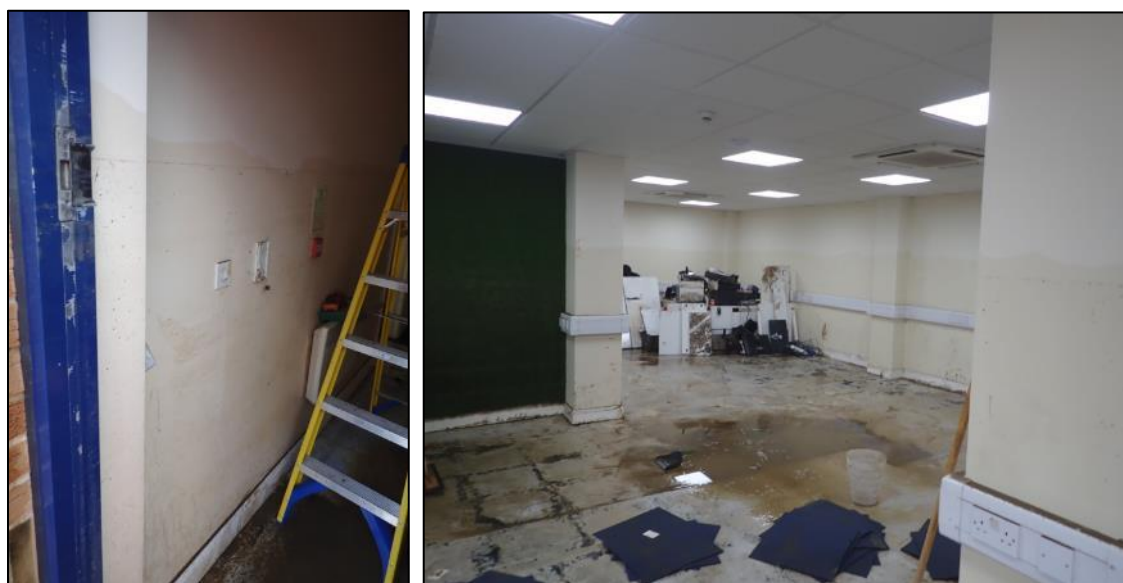
Figure 13: Water depths recorded within the impacted commercial properties at Melin Corrwg Business Park (image captured by RCT's Flood Risk Management team on 17th February 2020)

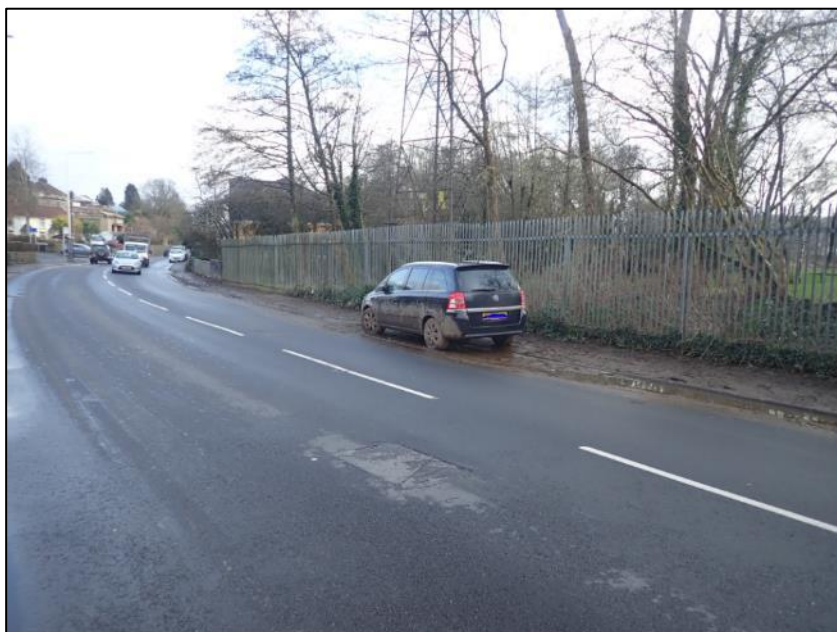
Figure 14: Evidence of mud and silt along the A4054 (Cardiff Road) identified post event as a result of the overtopping of the Nant Lonydd and an ordinary watercourse channel which runs behind the fence (image captured by RCT's Flood Risk Management team on 17th February 2020)

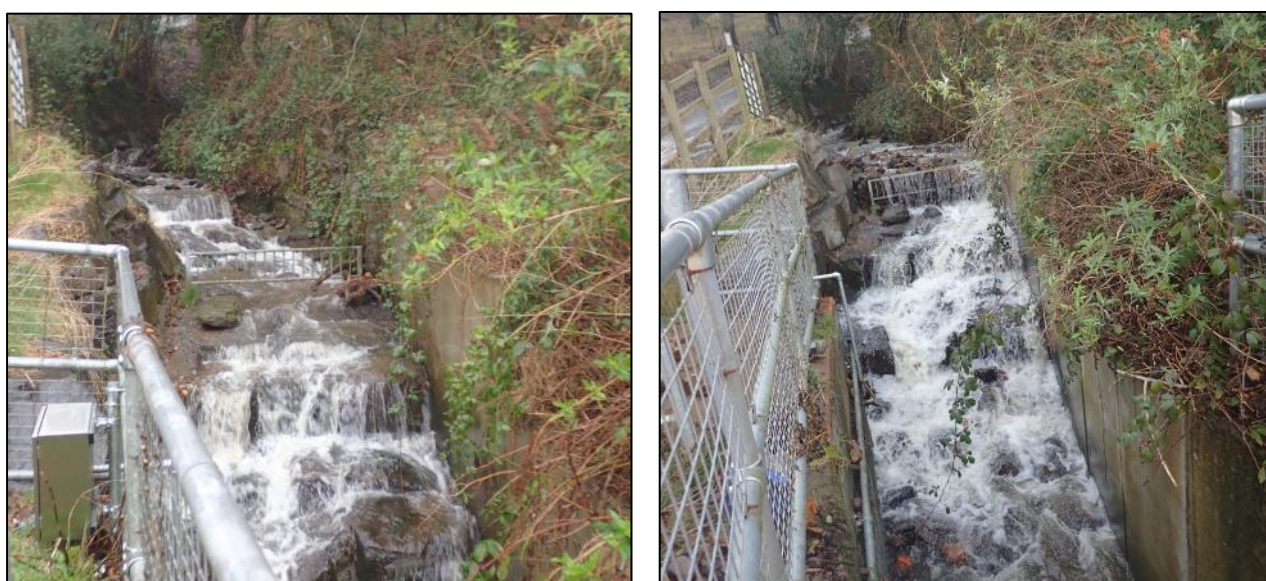
Figure 16: Upstream view of 'Culvert Inlet 1' before Storm Dennis (left) and post Storm Dennis (right) showing debris behind the upper debris screen (captured by RCT's Flood Risk Management team)

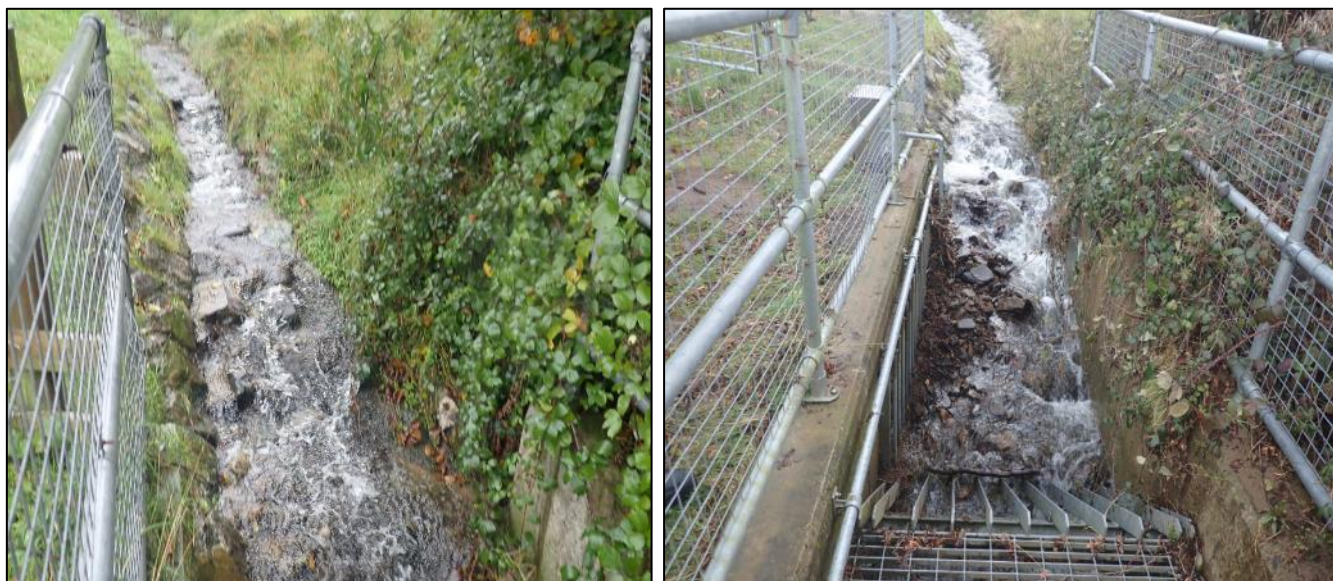
Figure 17: Upstream view of 'Culvert Inlet 2' before Storm Dennis (left) and post Storm Dennis (right) showing silt and stone deposition within the channel (captured by RCT's Flood Risk Management team)

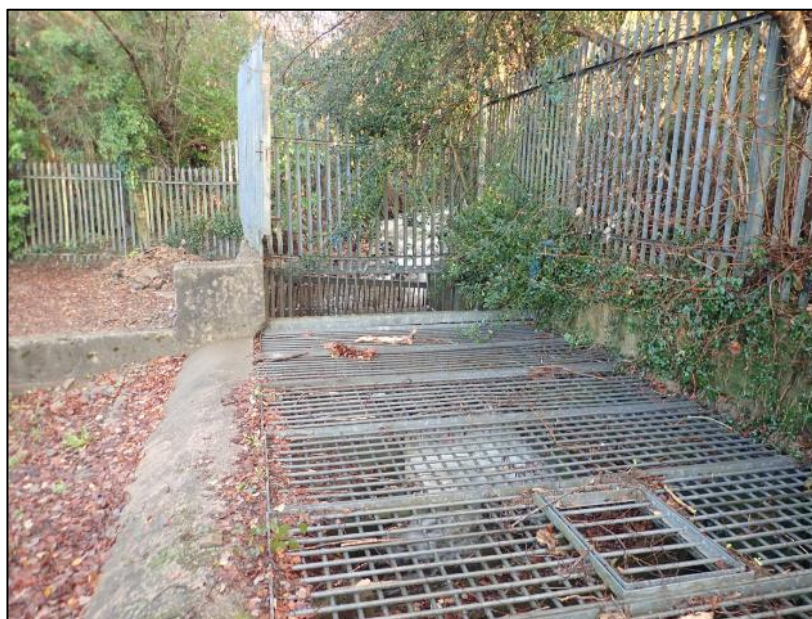
Figure 18: Image of 'Culvert Inlet 3' showing initial debris screen and safety grid (captured by RCT's Flood Risk Management team post event)

This material is considered to have restricted the flow of water entering 'Culvert Inlet 3' and has been attributed as the primary cause of surcharge.

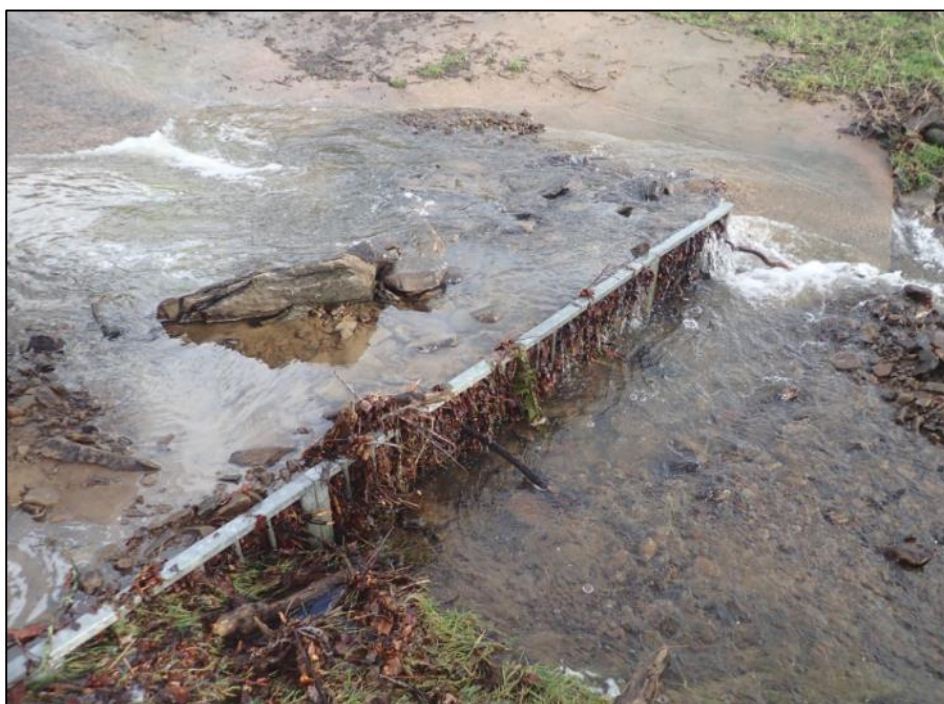
A general assessment of 'Unnamed Ordinary Watercourse 2', upstream of 'Culvert Inlet 2', also revealed evidence of loose materials within the channel. This material consisted of natural scour material including stone, silt and dead vegetation. Figure 21 illustrates the condition of the upper debris screen, located approximately 200 metres upstream of 'Culvert Inlet 2', operating with significant accumulation of natural material, considered to have been mobilised by the fast flows during the storm event.

Figure 21: Evidence of debris trapped behind the upper debris screen above 'Culvert Inlet 2' (captured by RCT's Flood Risk Management team on 17th February 2020)

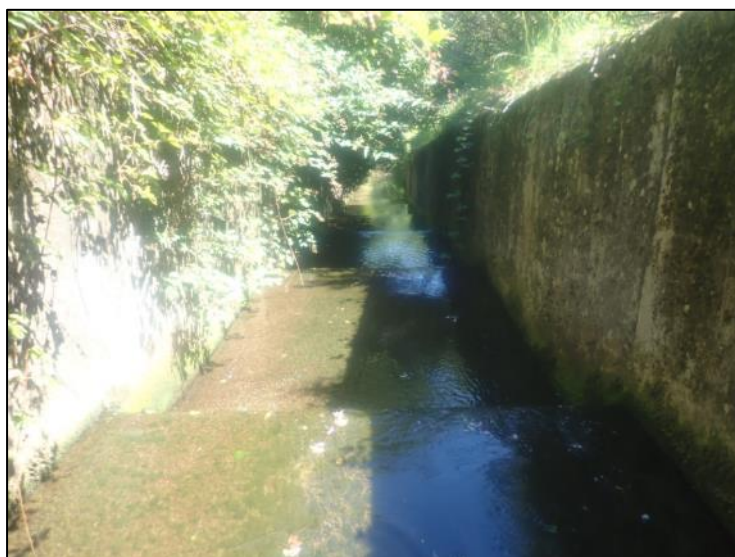
The ordinary watercourses upstream of the Nant Lonydd were identified primarily as manmade channels which were stepped in some areas, notably along sections of channel ahead of the confluence with the Nant Corrwg above the A470 (Figure 23). Heavy overgrowth of vegetation was also observed along the channel banks in some areas however, this is not considered to have contributed to the flooding observed during Storm Dennis.

Figure 23: Stepped concrete channel to the rear of Poplar Road (captured by RCT's Flood Risk Management team post event)

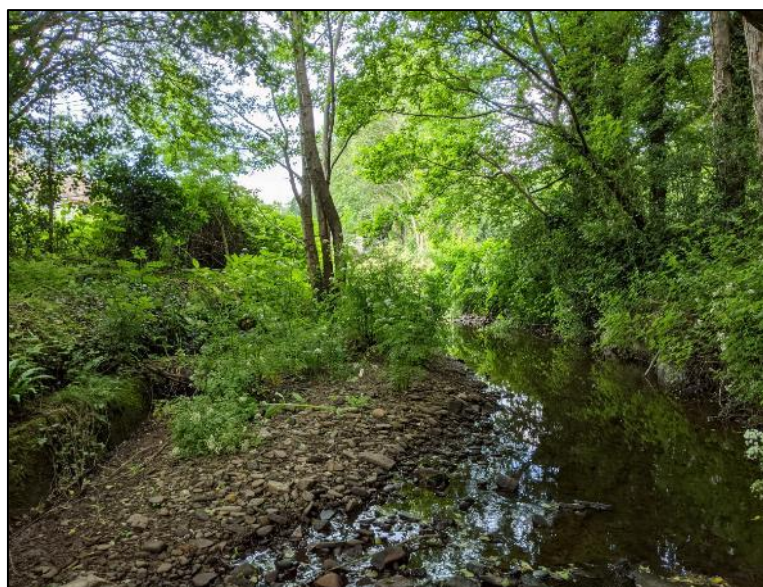
The channel to the rear of Hawthorn Crescent is relatively shallow and was also observed to be heavily silted during the assessment. These deposits are considered to have primarily originated from Rhydyfelin's upper catchment and transported downstream. Figure 25 depicts the deposition of silt and stone within the Nant Lonydd, to the rear of Hawthorn Crescent. A fallen tree was also identified within the channel however this is not considered to have significantly contributed to the overtopping of the Nant Lonydd.

Figure 25: Significant build-up of debris and silt deposits within the Nant Lonydd ordinary watercourse to the rear of Hawthorn Crescent (image provided by RCT during post event inspections)

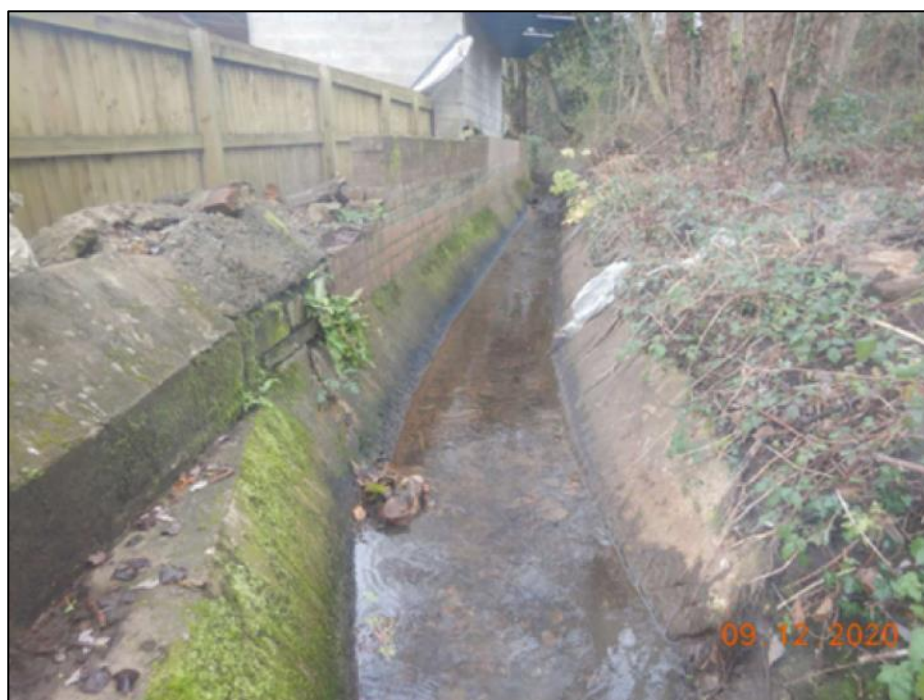
It was also identified by residents and on-site inspectors that the retaining wall to the rear of Hawthorn Crescent was badly damaged as a result of the overtopping of the Nant Lonydd. Sections of scour along the concrete and masonry structures were identified during post event inspections, indicative of the forceful and erosive flows within the Nant Lonydd watercourse during Storm Dennis. Figure 26 depicts a section of damaged retaining wall to the rear of the impacted properties. The retaining wall falls on unregistered land and is identified as a privately owned structure.

Figure 26: View of damaged channel retaining wall to the rear of Hawthorn Crescent looking upstream (captured by Edwards Diving Services post storm event)

The poor condition of the retaining wall is considered to have contributed to the flooding of 9 properties at Hawthorn Crescent during Storm Dennis however, it is considered that the Nant Lonydd watercourse exceeded its usual capacity as a result of intense rainfall and associated ordinary watercourse flows from the upper catchment during the storm event. The overtopping resulted in more severe flooding

- Undertaken repair works to the river retaining wall which falls on unregistered land to the rear of Hawthorn Crescent and was identified as damaged during the storm event;

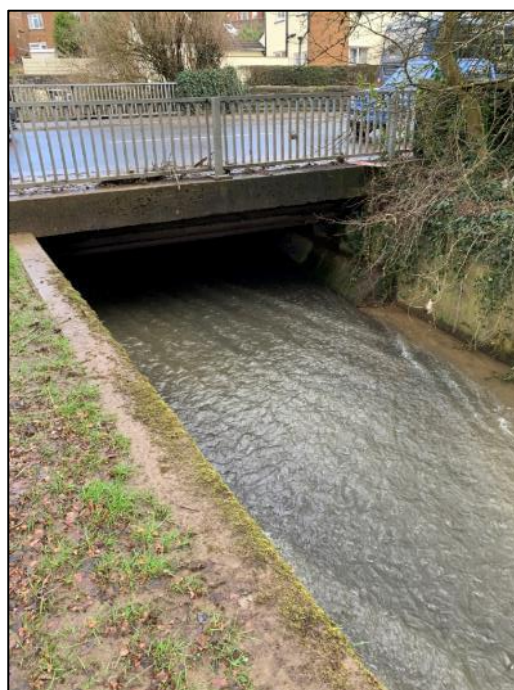
Figure 27: Nant Lonydd culvert outfall below the A4054 (Cardiff Road) which was identified as surcharging during Storm Dennis (image captured by RCT officers post event)

According to the inspecting officer during Storm Dennis, the Nant Lonydd overtopped at this location primarily due to the main River Taf backing up flow upstream of the confluence of the Nant Lonydd and River Taf. Significant flood depths were recorded within the Business Park in addition to thick mud and silt deposits along the channel embankments and the highway network as a result of the overtopping (Figure 28).

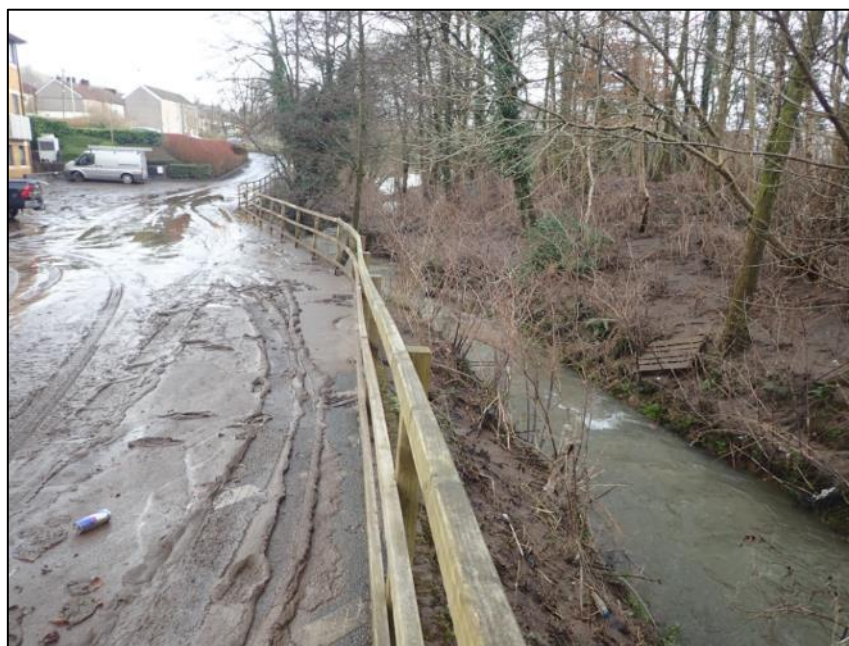
Figure 28: Mud and silt deposited adjacent to Melin Corrwg Business Park as a result of the Nant Lonydd ordinary watercourse overtopping (captured by RCT's Flood Risk Management team on 17th February 2020)
