# Flood and Water Management Act 2010

## Section 19 Flood Investigation Report

Storm Dennis –  
Flood Investigation Area RCT01  
(Hirwaun)

January 2022

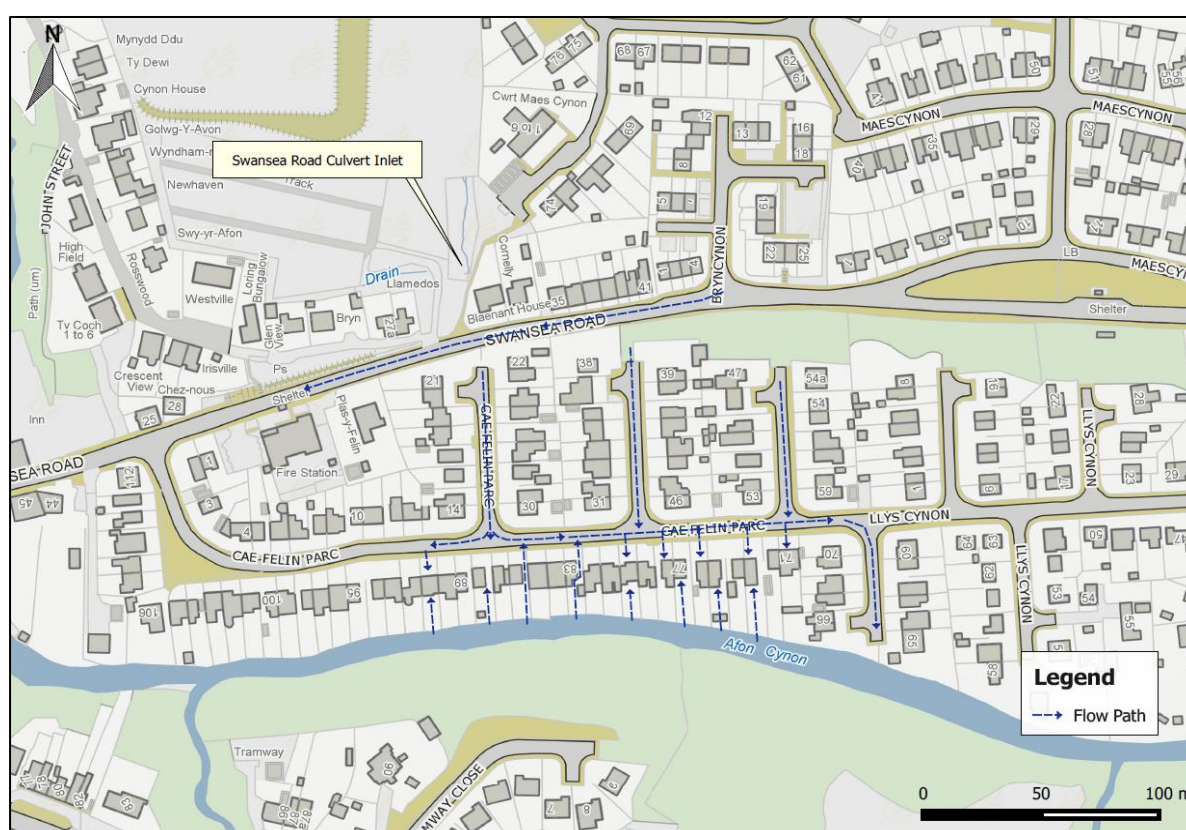
The associated flow paths observed during Storm Dennis at Cae Felin Parc and Swansea Road are illustrated in Figure 3.

**Figure 3:** Observed flow paths at Cae Felin Parc and Swansea Road in Hirwaun during Storm Dennis

Reports of a suspected surcharged culvert inlet located at Swansea Road (labelled 'Swansea Road Culvert Inlet' in Figure 3) were also received by some residents, however following further engagement with RCT's Highways and Streetcare Depot and the Hirwaun Fire Station, it was confirmed that the inlet did not surcharge during Storm Dennis.

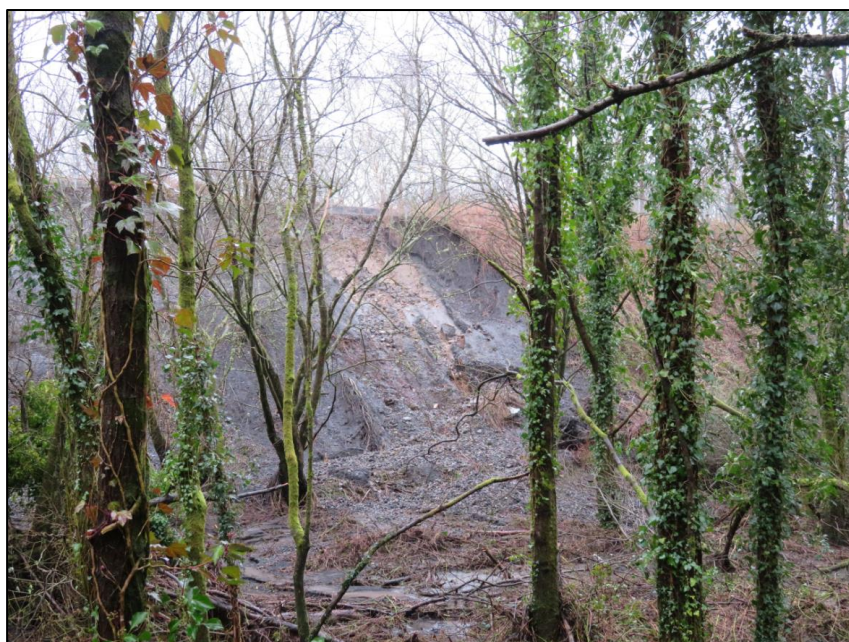
Additionally, there was a landslide reported upstream of the investigation area, to the rear of the railway track, with no properties reported as being affected by flooding. Further downstream, to the east of Devonshire Drive, eroded material sourced by the landslide was identified at the River Cynon culvert inlet, causing flooding onto the Village Green however no properties were affected at this location. Evidence of the landslide is provided in Figure 4.

**Figure 4:** Landslip of the hillside above the railway line, Hirwaun on the 16<sup>th</sup> February 2020 (image captured by resident)

Residents reported significant deposition of large stones and debris mobilised by extreme flows within the River Cynon during the storm event. It is likely that the landslide that occurred above the railway track (Figure 4) supplied additional eroded material into the watercourse, however this is not considered to have contributed to the flooding at Cae Felin Parc.

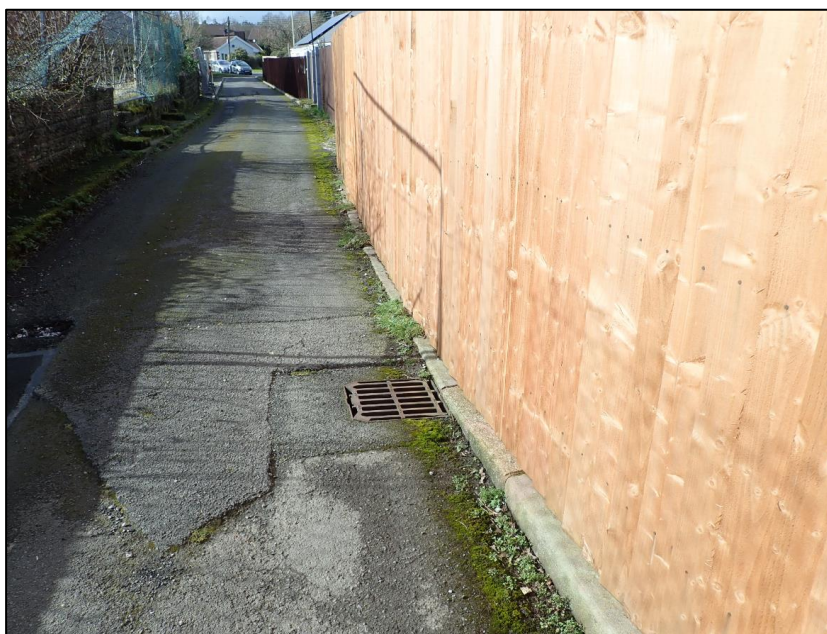
A highway gully fronting one of the properties was reportedly overwhelmed by the volume of surface water, resulting in water ingress from the front. Ponding surface water on Meadow Lane is believed to have overtopped the dropped kerbs behind Beacons View and enter properties from the rear. Figure 5 shows the lowered section of pavement at Meadow Lane which allowed surface water to overtop and enter the impacted properties from the rear.

**Figure 5:** Dropped kerb and highway gully at Meadow Lane, to the rear of the impacted properties at Beacons View (image captured by RCT's Flood Risk Management officers on 26/02/2020)

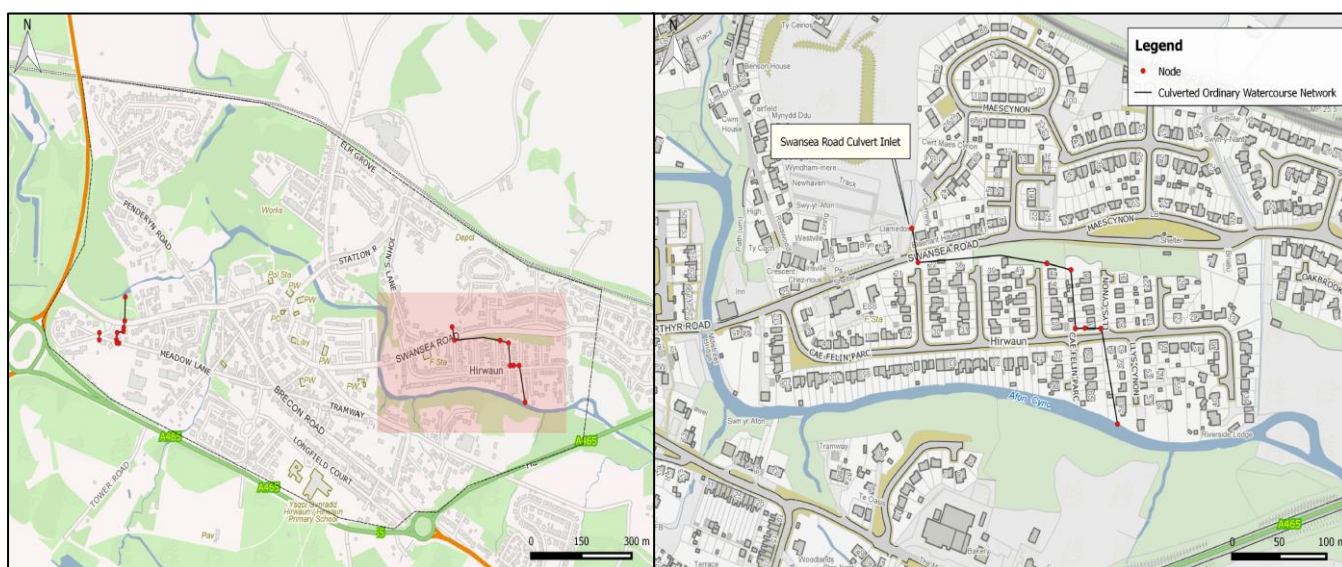
**Figure 6:** Swansea Road culverted watercourse network in investigation area RCT01

The condition of the Swansea Road culvert network was surveyed to be in poor condition, with multiple sections graded as 4-5 due to settled debris, fractures and

cracks reducing the culvert's cross-sectional area. Approximately 6 meters downstream of the culvert inlet the CCTV survey was abandoned due to a large obstruction identified in the network (Figure 7).

In response to the settled debris identified within the culvert networks, several jetting and cleansing operations were undertaken by a Council appointed contractor to clear the debris from within the culvert networks. An estimated 205 tonnes of material was removed from the Swansea Road and Meadow Lane culvert networks during cleansing exercises.

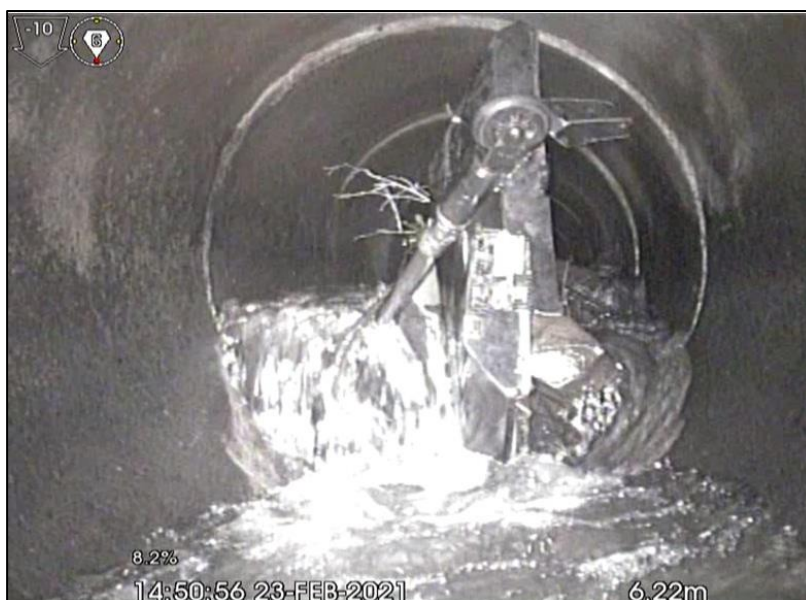
**Figure 7:** Obstruction identified approximately 6 meters downstream of the Swansea Road culvert inlet

Although the network was identified in poor condition, flooding was not observed from the inlet or anywhere along the network.

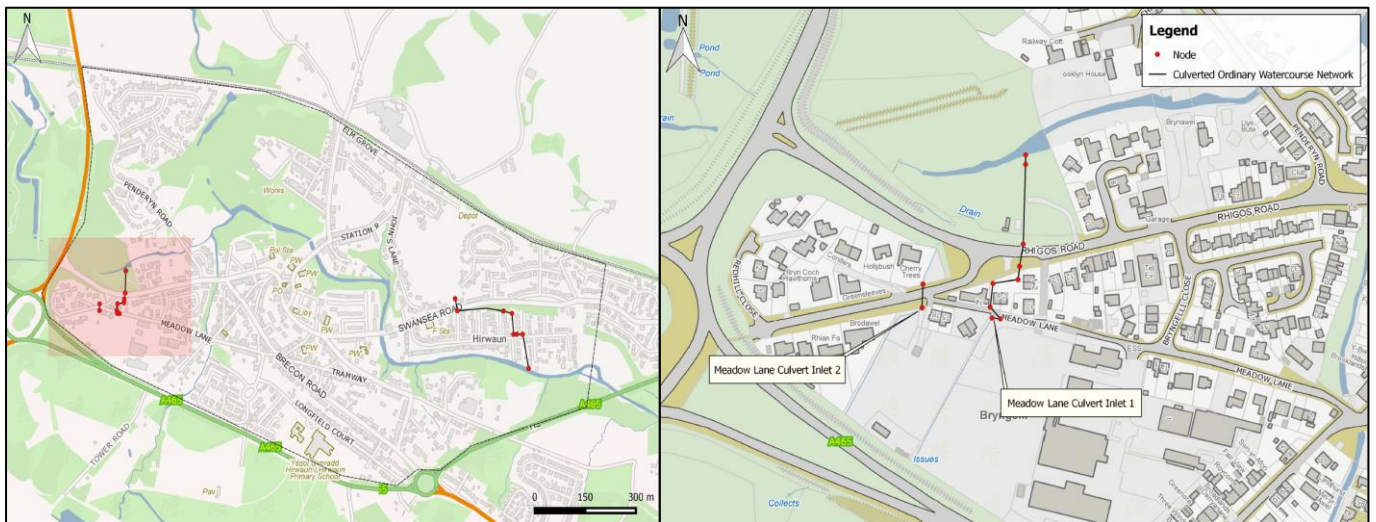
The Meadow Lane culvert networks and inlets under review are illustrated in Figure 8. Both culvert networks were surveyed to be in poor condition, with silt accumulation and obstacles reducing the networks' cross-sectional area. Despite its poor condition, 'Meadow Lane culvert inlet 1 and 2' was not identified as a source of flooding during Storm Dennis. Residents affected by flooding in this area confirmed that no flooding was observed from either inlet.

Flooding is therefore considered to have been as a result of overland runoff flowing from the area of hillside behind the affected properties at Rhigos Road. The area of hillside is discussed in Sections 3.2 and 3.6.

**Figure 8:** Meadow Lane culverted watercourse network in investigation area RCT01

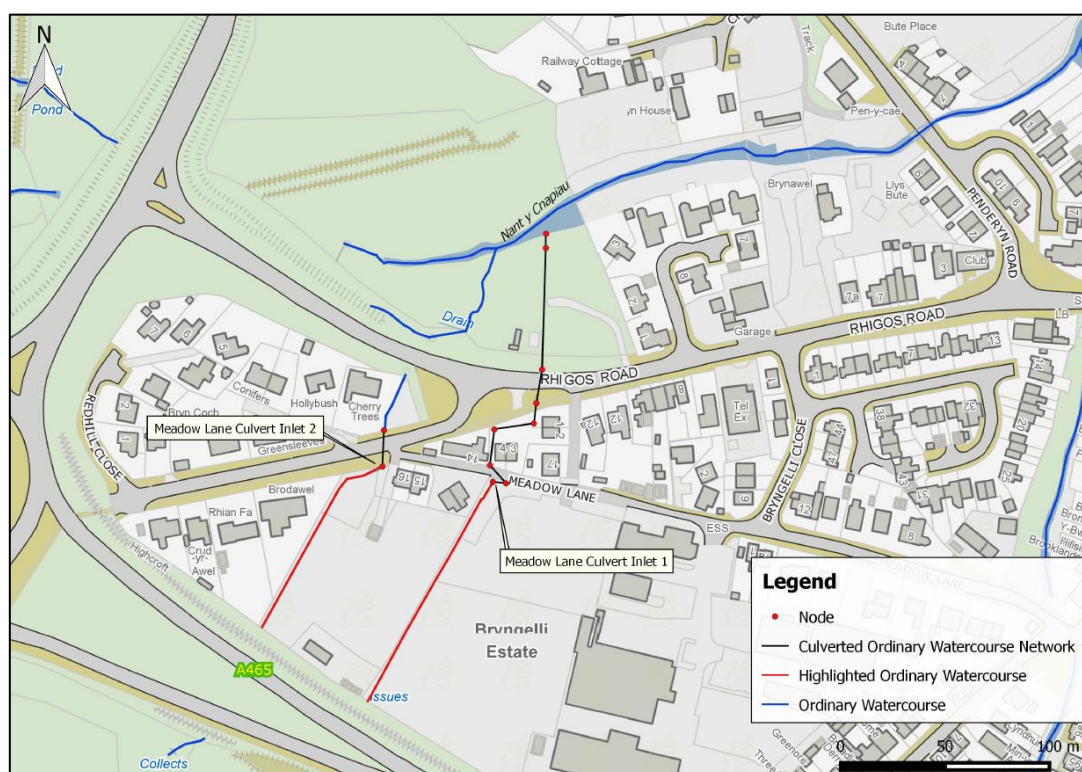
The unnamed watercourses flowing down the hillside below the A465 (highlighted red in Figure 10), before discharging into the Nant y Cnapiau, were investigated by RCT Flood Risk Management officers as potential sources of flooding to properties at Rhigos Road and Beacons View following reports that water originated from the hillside.

**Figure 10:** Ordinary watercourses and culverted networks identified at Meadow Lane in the southwest of investigation area RCT01. The ordinary watercourses identified as possible causes of flooding during Storm Dennis are shown in red.

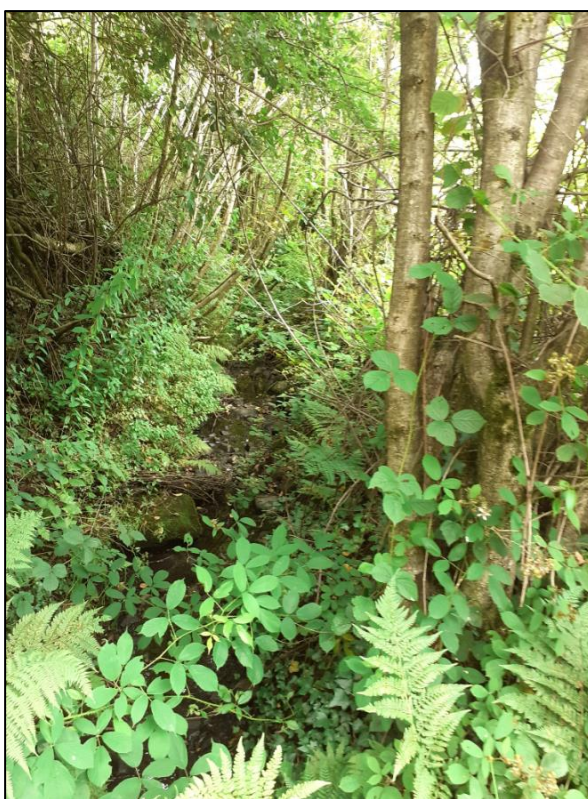
The hillside and associated watercourses were inspected to assess their condition for any evidence of scour or land movement of the hillside which would indicate potential overland flows had occurred. The assessment found no significant erosion of the channels, however both watercourses were mostly undefined and overgrown with dense vegetation which impacted the on-site assessment (Figure 11).

LIDAR data reveals that the watercourse and hillside which drains into 'Meadow Lane Culvert Inlet 2' is relatively flat in the upper section, directly below the A465, which would allow water to pond in this area before flowing overland. There is also a hedge line adjacent to the watercourse which is considered to have aided in the diversion of surface water directly towards the impacted properties. The area of hillside is identified under private landownership.

**Figure 11:** Undefined and overgrown ordinary watercourse channel above Meadow Lane Culvert Inlet 2 (image captured by RCT's Flood Risk Management team following Storm Dennis)

The intensity of rain falling on the already saturated catchment of Hirwaun during Storm Dennis is considered to have overwhelmed the unnamed watercourse below the A465 causing water to spill out of bank and flow overland towards the properties below.

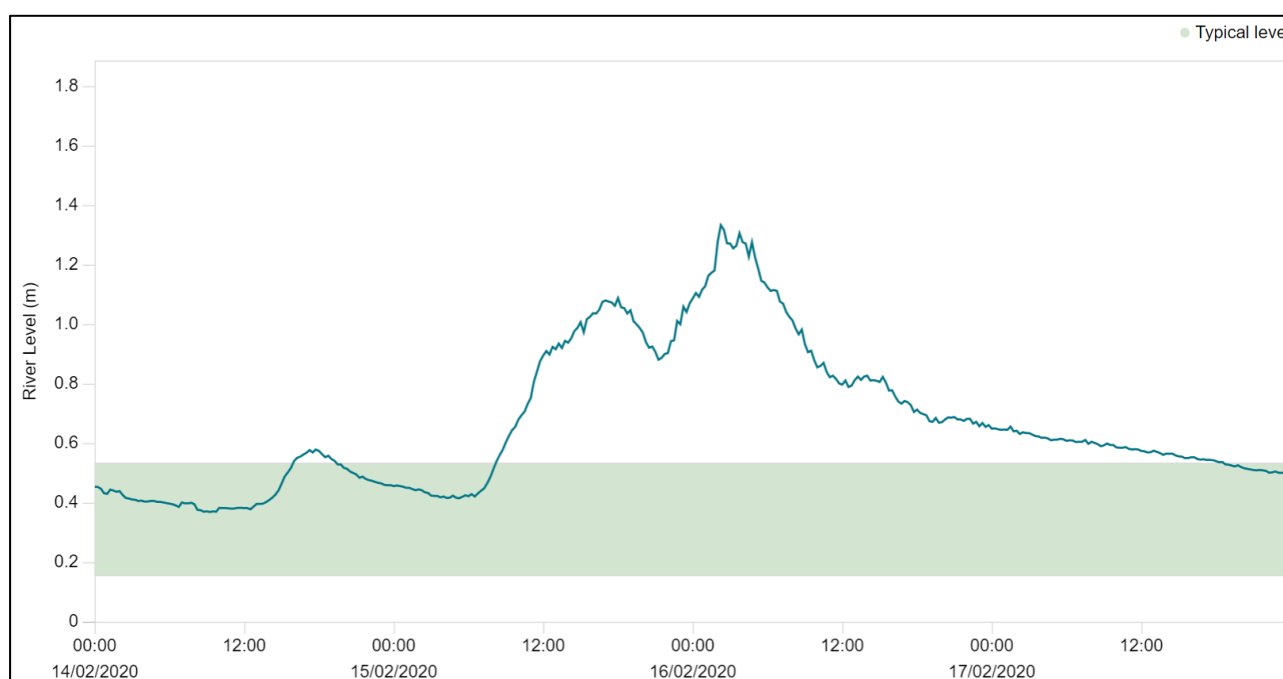
The hydrograph in Figure 12 illustrates the rapid rise in levels of the River Cynon in response to rainfall between the 14 – 17<sup>th</sup> February 2020, captured at NRW's Hirwaun monitoring station which is situated near Cae Felin Parc.

NRW issued a 'Flood Alert' (indicating possible flooding) for the entirety of the River Cynon at 12:51 on the 15<sup>th</sup> February, during that time the River Cynon at Hirwaun had reached almost a metre in depth. The River Cynon continued to rise during the early hours of Sunday 16<sup>th</sup> February morning before reaching a peak level of 1.333 metres at 02:15 on 16<sup>th</sup> February 2020; the highest level recorded for the Cynon at Hirwaun.

**Figure 12:** The River Cynon levels at Hirwaun station between the 14<sup>th</sup> and 17<sup>th</sup> February 2020 (Natural Resources Wales)

The green bar displayed on the hydrograph shows the typical level of the River Cynon at Hirwaun station, ranging between 0.15 and 0.55 metres. At its peak, the River Cynon at Hirwaun was almost a meter higher than its average level, stressing the

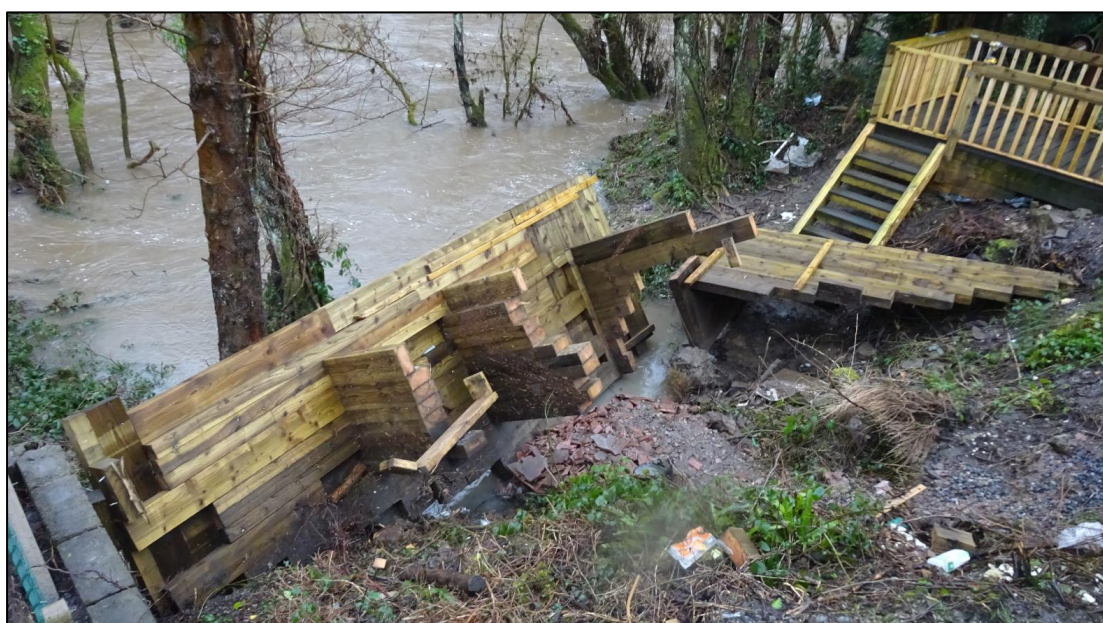
Elsewhere within the investigation area, and in addition to the flood damage at Cae Felin Parc, the River Cynon also impacted the rear of properties further upstream at Richmond Drive, to the north of investigation area RCT01, causing significant erosion of the banks in some locations. Figure 14 depicts an image of property damage caused by significant erosion of the riverbanks.

**Figure 14:** Damage to property caused by the River Cynon to the rear of Richmond Drive, Hirwaun on the 16<sup>th</sup> February 2020 (image captured by resident)

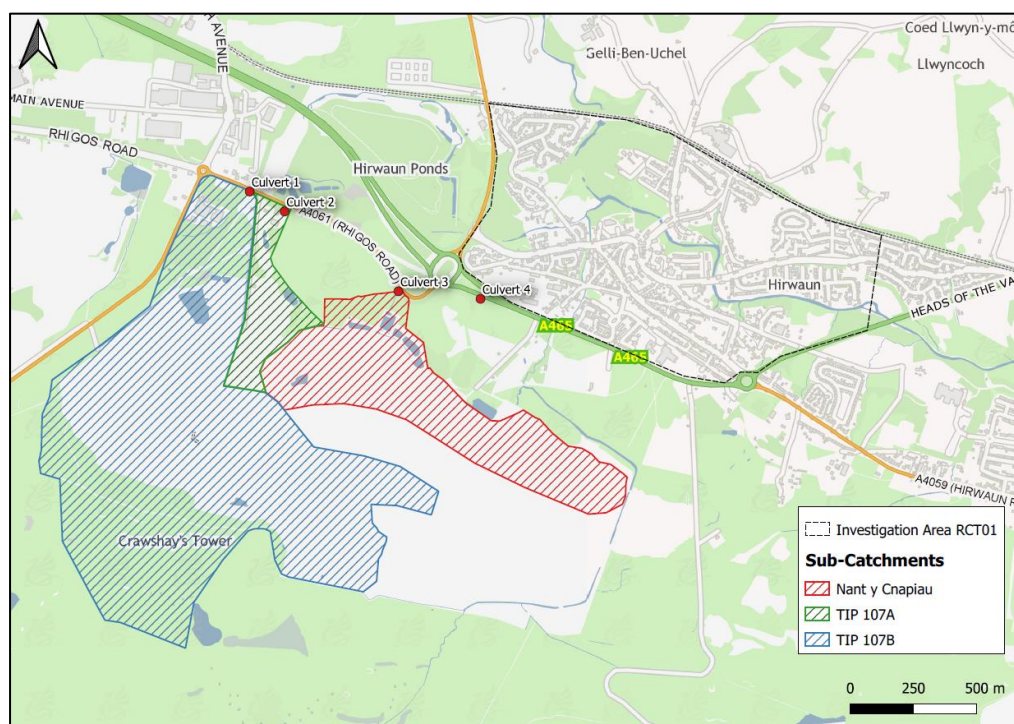
Figure 16: Tower Colliery sub-catchments and associated culvert inlets

At the time of the storm event however, the catchment areas were known to have not been arranged and re-profiled as post mining conditions stipulate. This means that the surface water and ordinary watercourse flows conveying down the sub-catchments towards 'Culverts 1, 2 & 3' (illustrated in Figure 16) were being exacerbated due to the arrangements of the catchment on site.

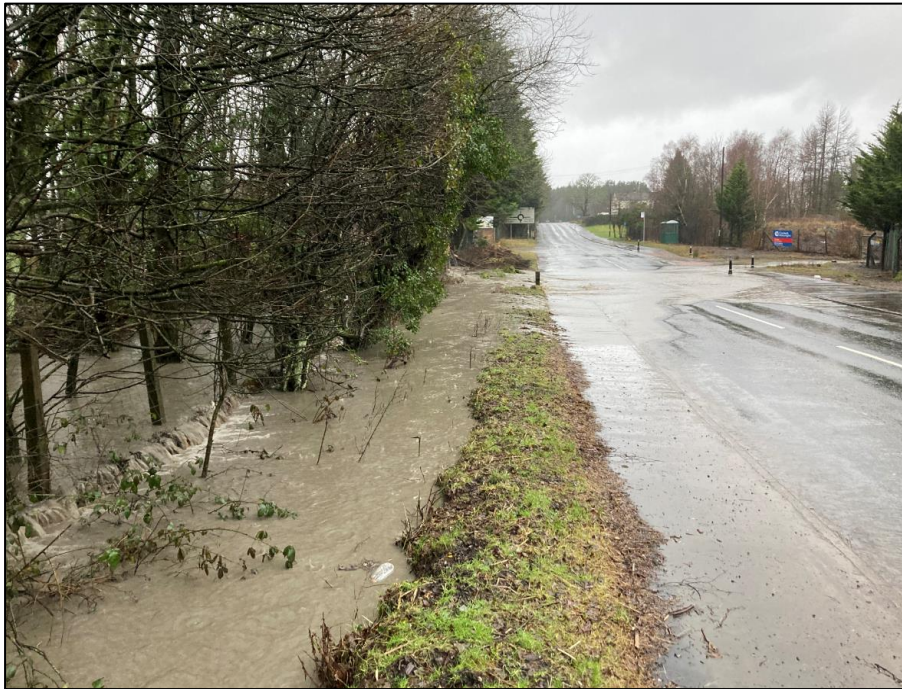
As a result of which flooding was reported along Rhigos Road by residents. A site inspection undertaken by RCT officers several hours after the peak of the storm event identified 'Culvert 1 & 2', to be flooding the highway (Figure 17). The cause of which was attributed to the volume of water identified at the culvert inlets rather than any debris accumulation. Based on available evidence, it is assumed that 'Culvert 3' was also surcharging due to excess flows travelling down the Nant y Cnapiau sub-catchment during the storm event.

**Figure 17:** Surface water flooding to the A4061 Rhigos Road caused by surcharging culvert inlets associated to sub-catchment TIP 107A and TIP 107B (captured by RCT's Highways and Streetcare Depot on 16<sup>th</sup> February 2020)

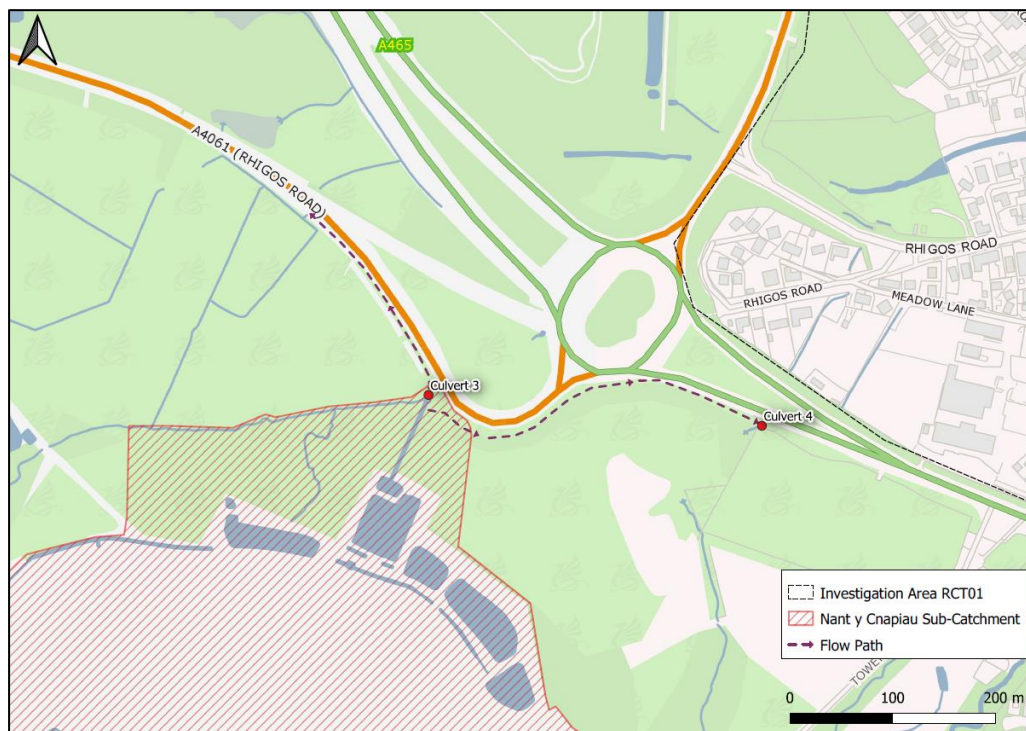
The area immediately downstream of the Nant y Cnapiau inlet (Culvert 3) is served by an existing land drainage channel which acts as a dedicated overflow channel to 'Culvert 3', i.e., the land drainage channel conveys flows both east and west at the A4061 Rhigos Road. The routing of excess water to the west of 'Culvert 3' conveys towards 'Culvert 4' where the routing to the east enters into a highway culvert that crosses Rhigos Road and outfalls into the unnamed ordinary watercourse channel. The indicative exceedance flow paths to the west and east of 'Culvert 3' are illustrated in Figure 18. The routing of water east towards 'Culvert 4' however, is considered to have exacerbated the flow of water at this location, contributing to the overland flows towards properties at Rhigos Road.

**Figure 18:** Exceedance flow paths to the east and west of Culvert 3
