Llwynycelyn Industrial Estate Flood Alleviation Scheme

Flood Alleviation Scheme delivered to reduce the risk of ordinary watercourse and surface water flooding to 9 properties and the highway in the Porth area.

Scheme Summary	
Strategic Flood Risk Area	Lower Rhondda Fach
Location	Llwynycelyn Industrial Estate, Porth
Properties benefiting	9 businesses
Type of scheme	Culvert Inlet Improvement
Cost	£150,000
Contractor	Peter Simmons Construction
Status	Completed
Scheme Completion Date	February 2024
Funding Source	Welsh Government Resilient Road Fund

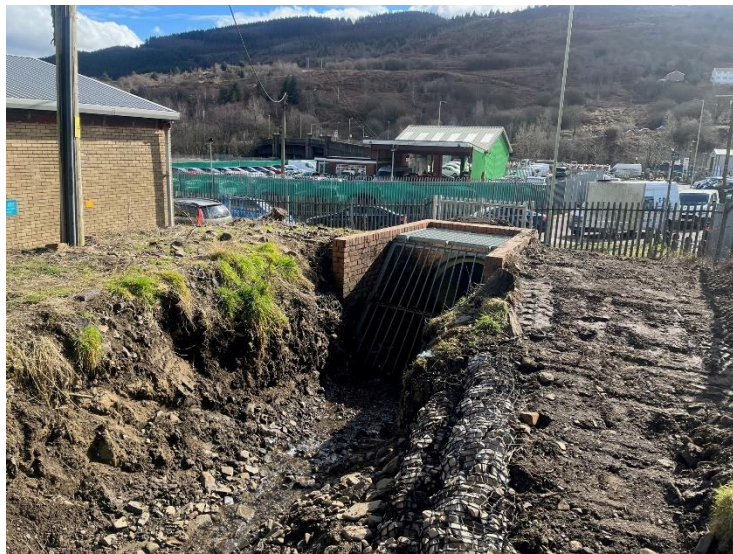
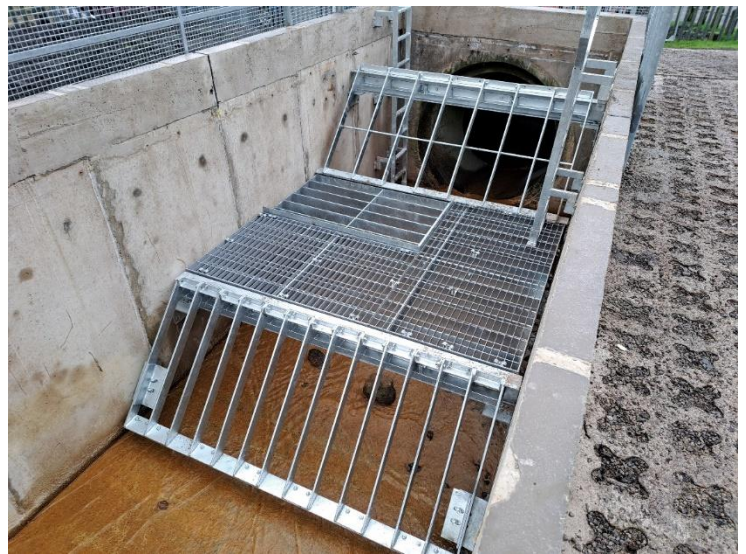
Before (left) and After (right) images of Llwynycelyn Industrial Estate Inlet improvement after scheme completion.

During Storm Dennis in February 2020, a culvert inlet associated to the Nant Llwynceilyn ordinary watercourse contributed to the internal flooding of 4 commercial properties within Llwynceilyn Industrial Estate and led to flooding along the B4278 (Llwynceilyn Road). Further incidences of property flooding associated to the culvert inlet during heavy rainfall highlighted the susceptibility of the culvert inlet to become overwhelmed both hydraulically and due to debris accumulation.

To address the repeat flooding issues to the culvert inlet at Llwynceilyn Industrial Estate, the Council carried out **culvert inlet improvements** to **increase the capacity** of the culverted ordinary watercourse network whilst also improving the ease of maintenance to **reduce the risk of debris blockages**.

The scheme involved the installation of a **new inlet headwall** and **debris control measures** within the watercourse to **improve hydraulic capacity** and **reduce the likelihood of debris** entering the culvert system and causing blockages. The scheme also re-established the upstream watercourse channel to **reduce potential scouring** of the banks and to improve capacity.
