Tylorstown Landslide

Environmental Impact Assessment

Series 12 Noise

Noise Survey

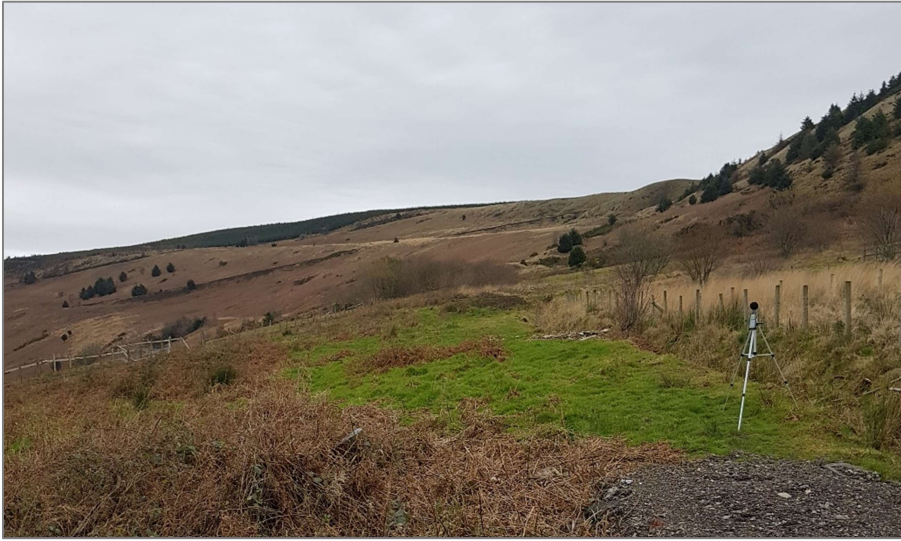
Figure 1: Sound level meter at Position 2 (Welshpoultry) looking towards the area of the Scheme's haul route

At each measurement position the microphone was mounted on a tripod at least 1.5 metres above local ground level and at least 1 metre from any other reflective surface, therefore the sound pressure levels measured are considered to be free-field levels.

Figure 1 shows the location of the sound level metre at Position 2. Figure 2 shows some Phase 1 activity seen from Position 2 (Welshpoultry).

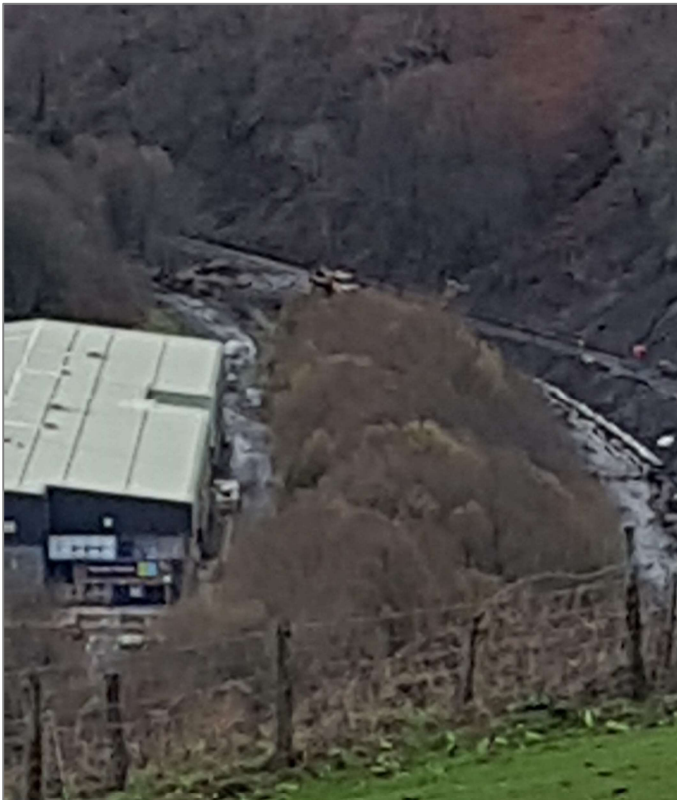
Figure 2: Some Phase 1 activity as seen from Position 2

Table 3 shows the hourly results for the measurements at Position 2 (Welshpoultry). For most of the survey, activity on Phase 1 and 2 works could be seen at the distance although it did not dominate the acoustic environment except for occasionally metal clanging. Dirt bikes could be heard far in a northern direction. Road traffic noise from the A423 was also audible. Some chainsaw noise cutting trees could be heard near trucks behind the leisure centre. However, the background noise could be defined as uneventful.
