Section 19 Flood Investigation Report

**Storm Dennis –
Flood Investigation Area RCT16
(Upper Boat & Nantgarw)**

March 2024

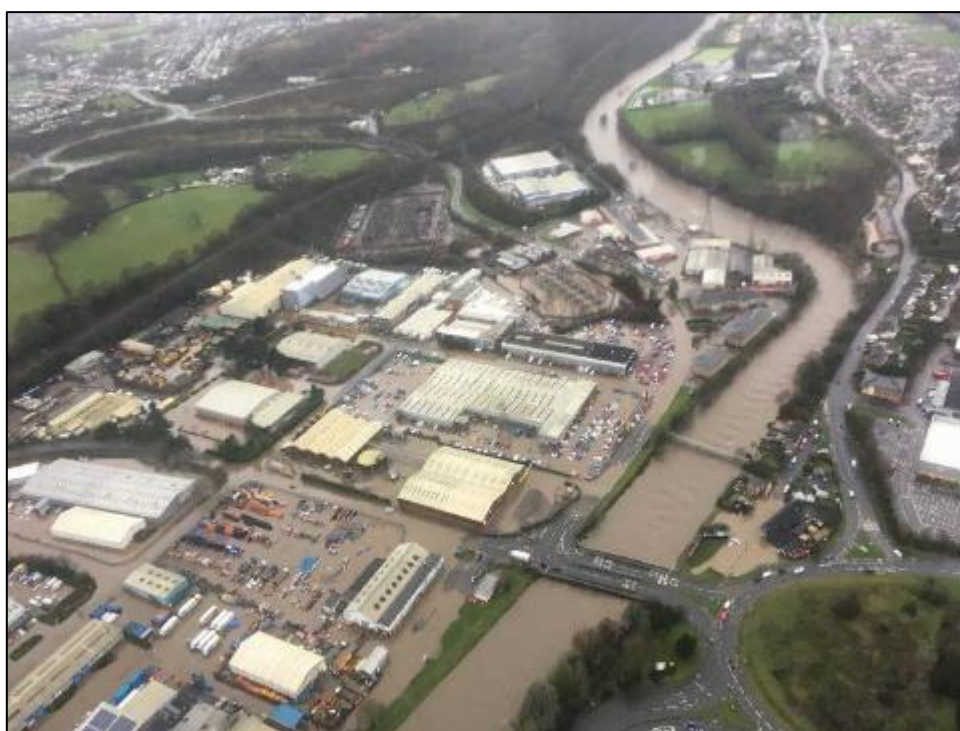
The flooding that occurred at Treforest Industrial Estate did not remain confined to areas adjacent to the main river channel, with commercial properties up to 450 metres inland from the River Taf reporting internal flooding. The main river overtopped both its eastern and western banks, resulting in internal flooding to the majority of commercial premises throughout the industrial estate. Figure 3 depicts an aerial view of the flooding at Treforest Industrial Estate and Upper Boat, to the north of RCT16.

Figure 3: Aerial view of Treforest Industrial Estate and Upper Boat following Storm Dennis (Image: National Police Air Service)

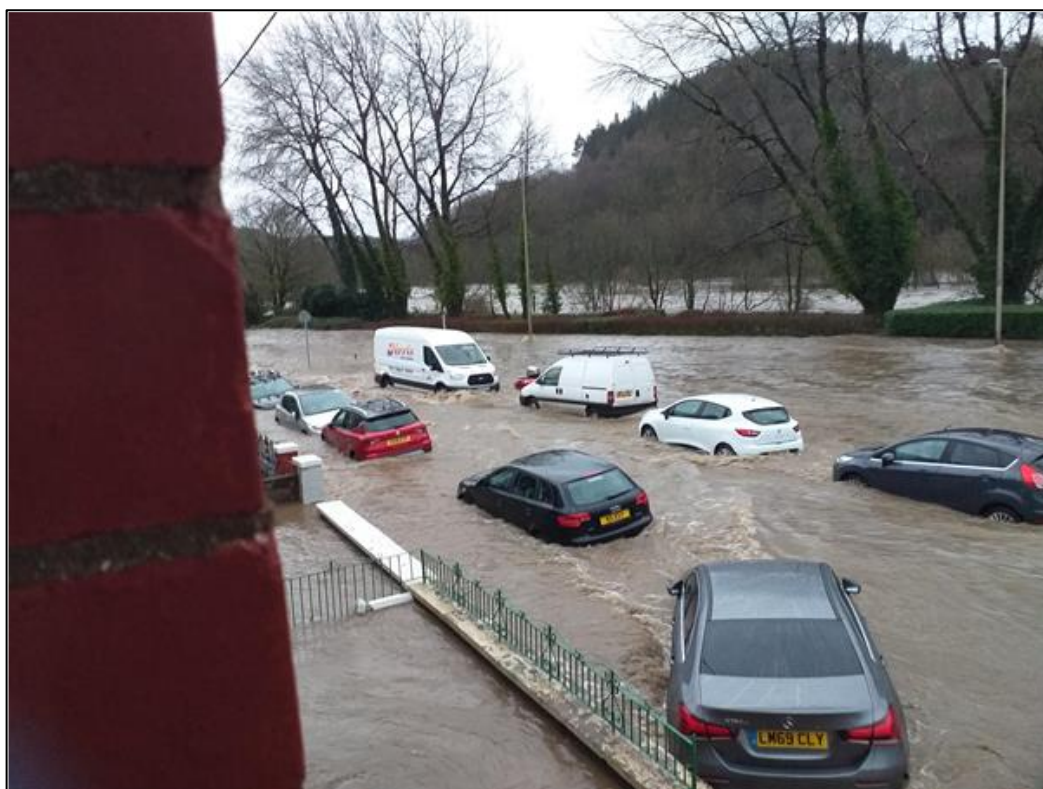
Accounts from residents at Oxford Street and Rhyd-Yr-Helyg note a significant amount of water conveyed along the highway network towards their properties during the storm event. This flow path is considered to have originated further upstream following the overtopping of the River Taf at Treforest Industrial Estate and Upper Boat, which then conveyed behind formal flood defences towards Oxford Street and Rhyd-yr-Helyg during the storm event. Photographic evidence provided by residents at Oxford Street show water flowing south along the highway, behind the eastern embankment, during the morning of Sunday 16th February 2020 (Figure 4).

Figure 4: Photo showing main river flooding along the A4054 Oxford Road during Storm Dennis (image provided by resident)

A total of 103 residential properties at Oxford Street and Rhyd-yr-Helyg were internally impacted by the River Taf, with residents reporting flood depths of over 1.8 meters.

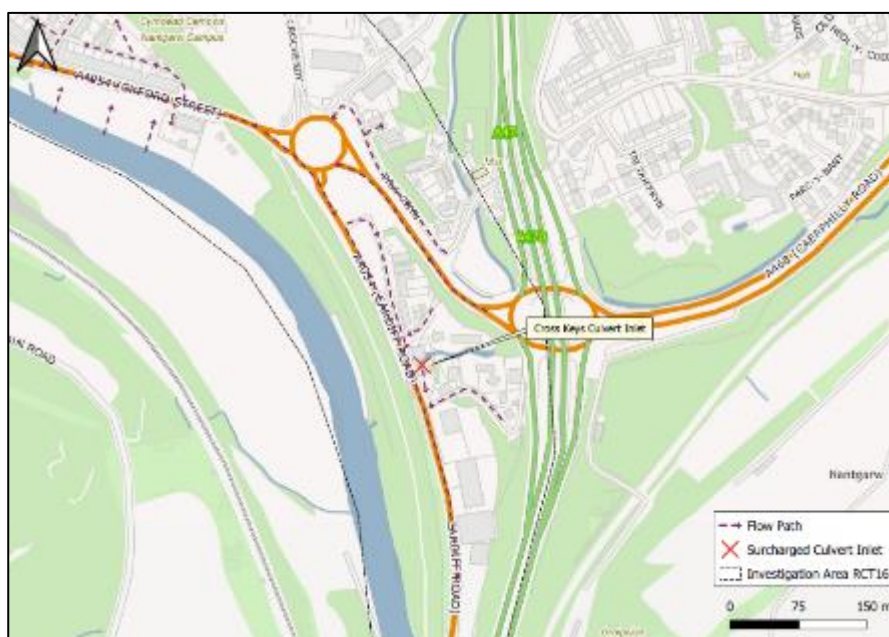
An isolated incident of surface water flooding occurred at Quarry Street, where two residential properties experienced internal flooding during Storm Dennis as a result of localised pluvial flows from the adjacent street, Tyla Gwyn. The observed flow pathways resulting in internal flooding at Cardiff Road are illustrated in Figure 7.

Figure 7: Indicative flow paths observed during Storm Dennis to the south of RCT16

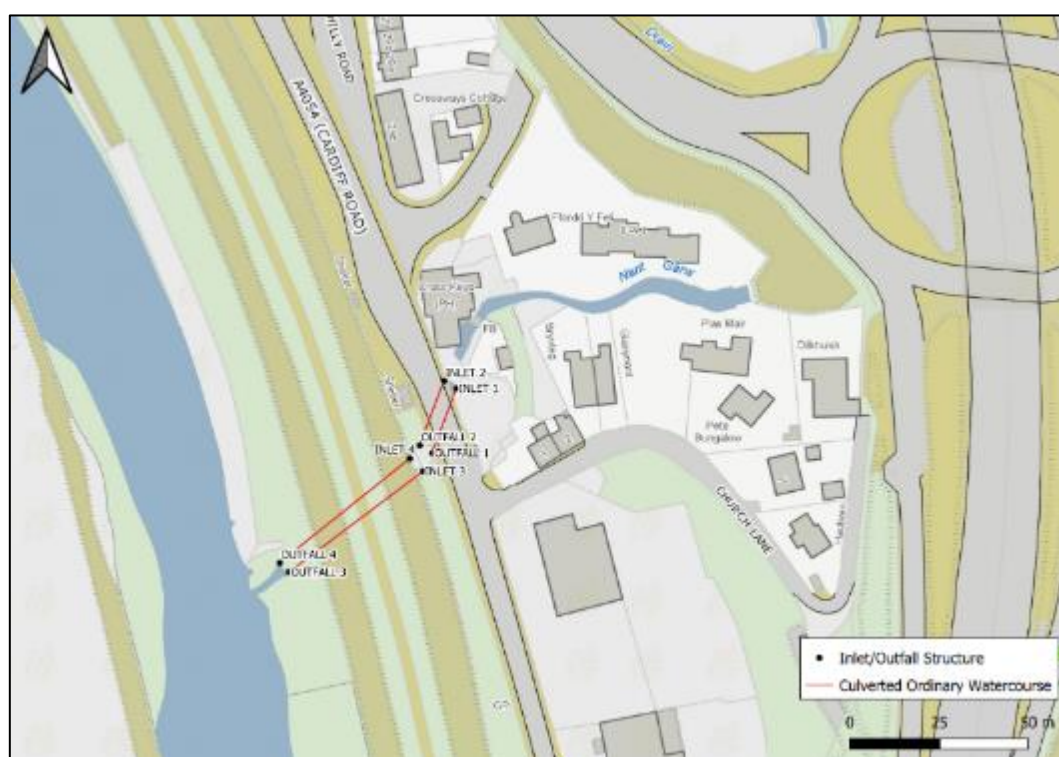
The majority of the Nant Garw ordinary watercourse is open channel, however the watercourse is culverted beneath sections of the A468 (Caerphilly Road), the A470 dual carriageway and the A4054 (Cardiff Road) before it discharges into the River Taf downstream. Following Storm Dennis, a CCTV survey inspection of the culverted ordinary watercourse beneath the A4054 Cardiff Road (Figure 8), known as 'Cross Keys' culvert, was undertaken to ascertain both the operational condition of the network and its structural integrity.

Figure 8: The Nant Garw culverted ordinary watercourse which runs beneath the A4054 Cardiff Road

Comprising of four culvert sections in a double-barrel configuration, the survey revealed that the culvert was in good structural condition, with only one of the four

sections having structural defects present. However, the serviceable condition of the culvert network identified accumulated debris within three of the four culvert sections and both outfall sections were unable to be fully inspected due to the level of the outfall within the main river at the time of the survey, which suggests the culverts are subject to debris settlement and outfall control.

Upon review of the CCTV inspection data discussed in Section 3.1, as well as the culvert capacity assessments stipulated above, it is considered that the primary cause of surcharge to the 'Cross Keys' culvert inlet during Storm Dennis was due to hydraulic overload, which contributed to the internal flooding of 6 residential and 18 non-residential properties along Cardiff Road.

R3B	<p>The LLFA and LDA to investigate the standard of protection and the condition of the culvert structure and network as a whole.</p>
					R3C	<p>The LLFA to jet and cleanse the ordinary watercourse culvert network.</p>
