Tylorstown Landslide
Environmental Impact Assessment
Volume 3 - Appendices
Series 13 Major Accidents and
Disasters
December 2021

Appendix 13.1

Slope Stability Report

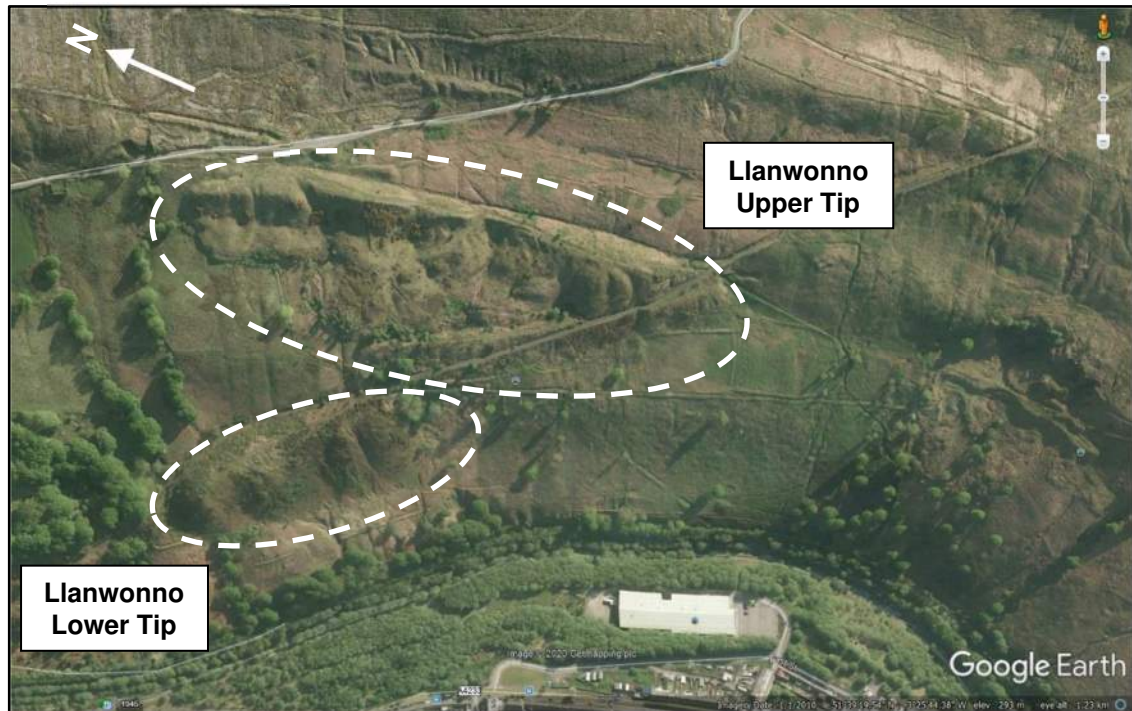
Figure A: Ariel view of Llanwonno Upper and Lower Tips (prior to landslide)

The Lower Tip lies below the Upper Tip, and slightly to the west. Remedial works to the Lower Tip are not included in the Phase 4 remediation plan.

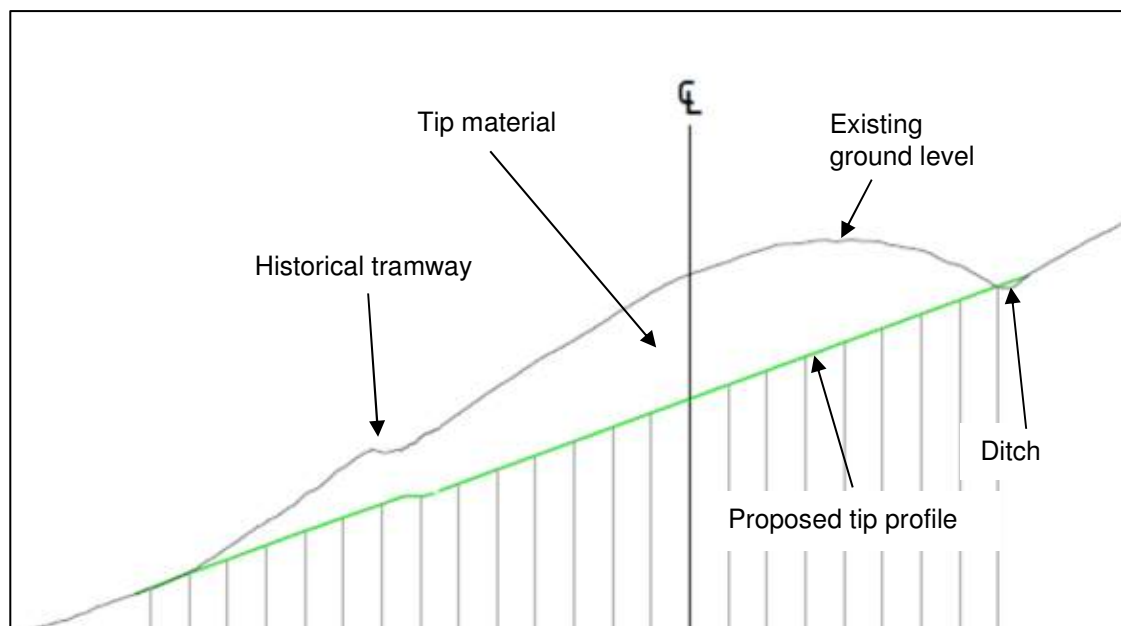
Typical cross-section through the south-eastern part of the site (Ch.120m).

Historical ground investigations suggest a former quarry, which exploited the Rhondda Sandstone, is present beneath this part of the Tip (see Section 2.3).

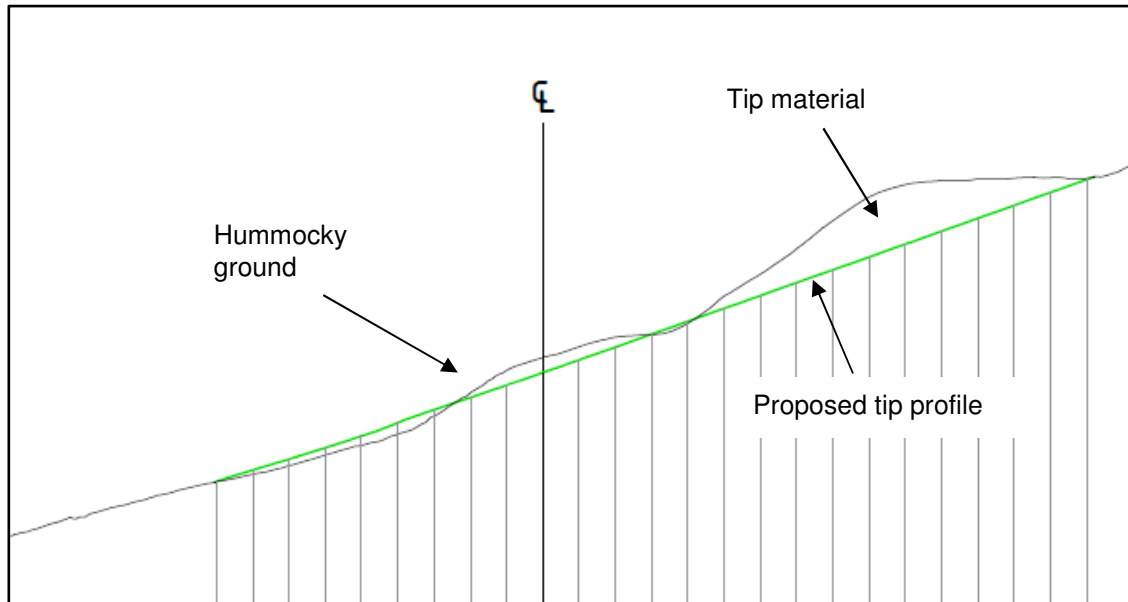
Typical cross-section through the north-western part of the site (Ch.420m).

states that 'available inspection and monitoring data indicate that some ground movements have taken place in the recent past'.

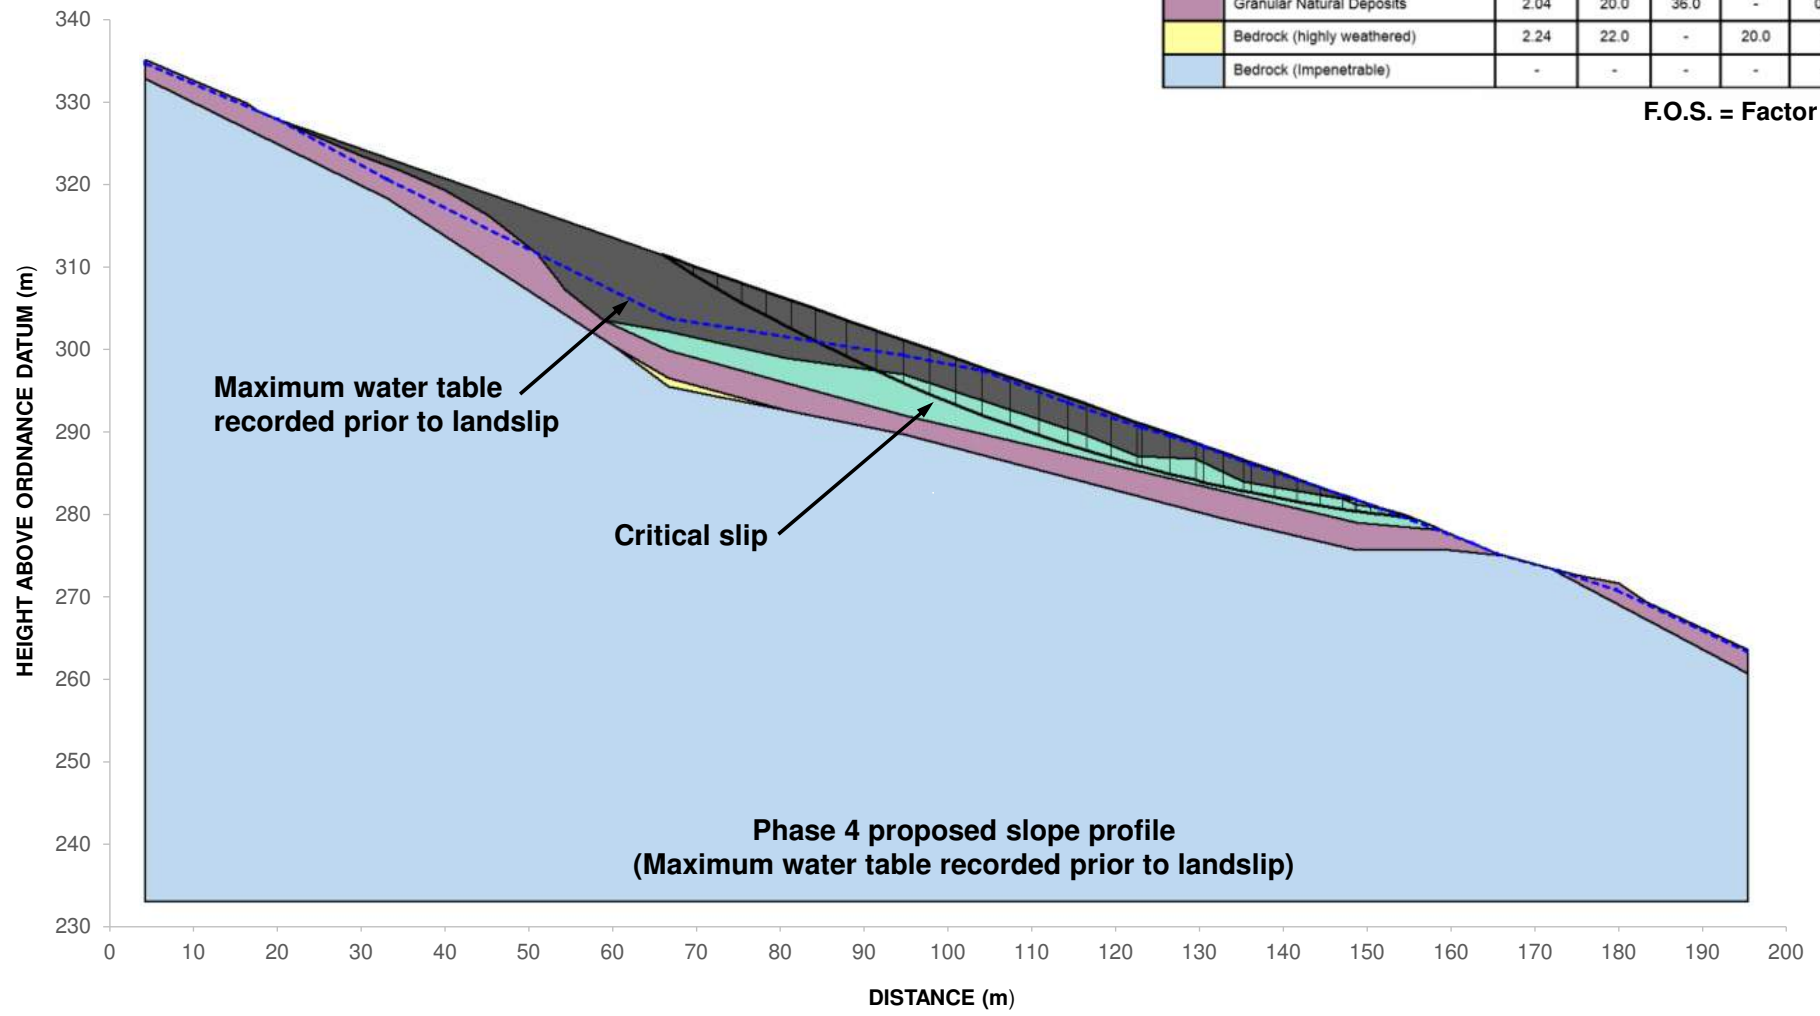
Fig. No. 8

Stability analysis has been undertaken on the proposed slope profile for the Phase 4 remediation works (colliery spoil assigned peak strength values). The original model (Figure 8) utilised the maximum groundwater table recorded at the site, recording a FoS of 0.92. This groundwater scenario is not considered to be a realistic estimate of the potential maximum groundwater level following the landslide. The rationale for this is that the Phase 4 works will include a comprehensive drainage system to collect surface water and groundwater (where possible) and divert it away from the area, and the lower 'lobe' which formed the ponds is no longer present, allowing surface water and groundwater to flow downslope and not 'build up'.

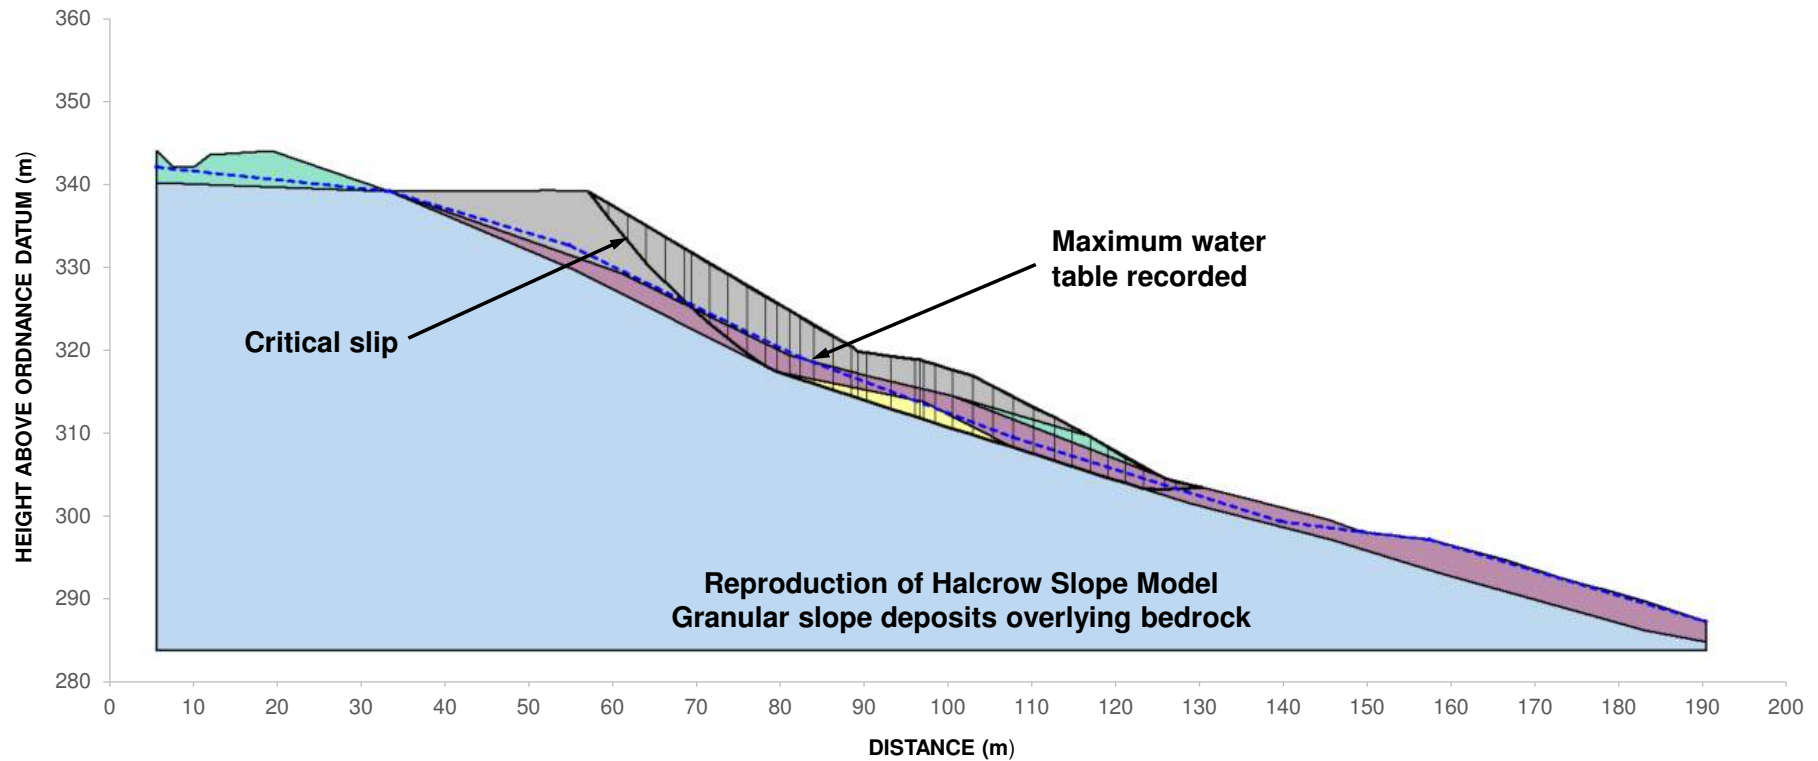
Stability analysis of the revised ground model of the existing slope (Figure 17), gave a FoS slightly below unity (0.95) under extreme groundwater (maximum recorded) conditions.

F.O.S = 0.95

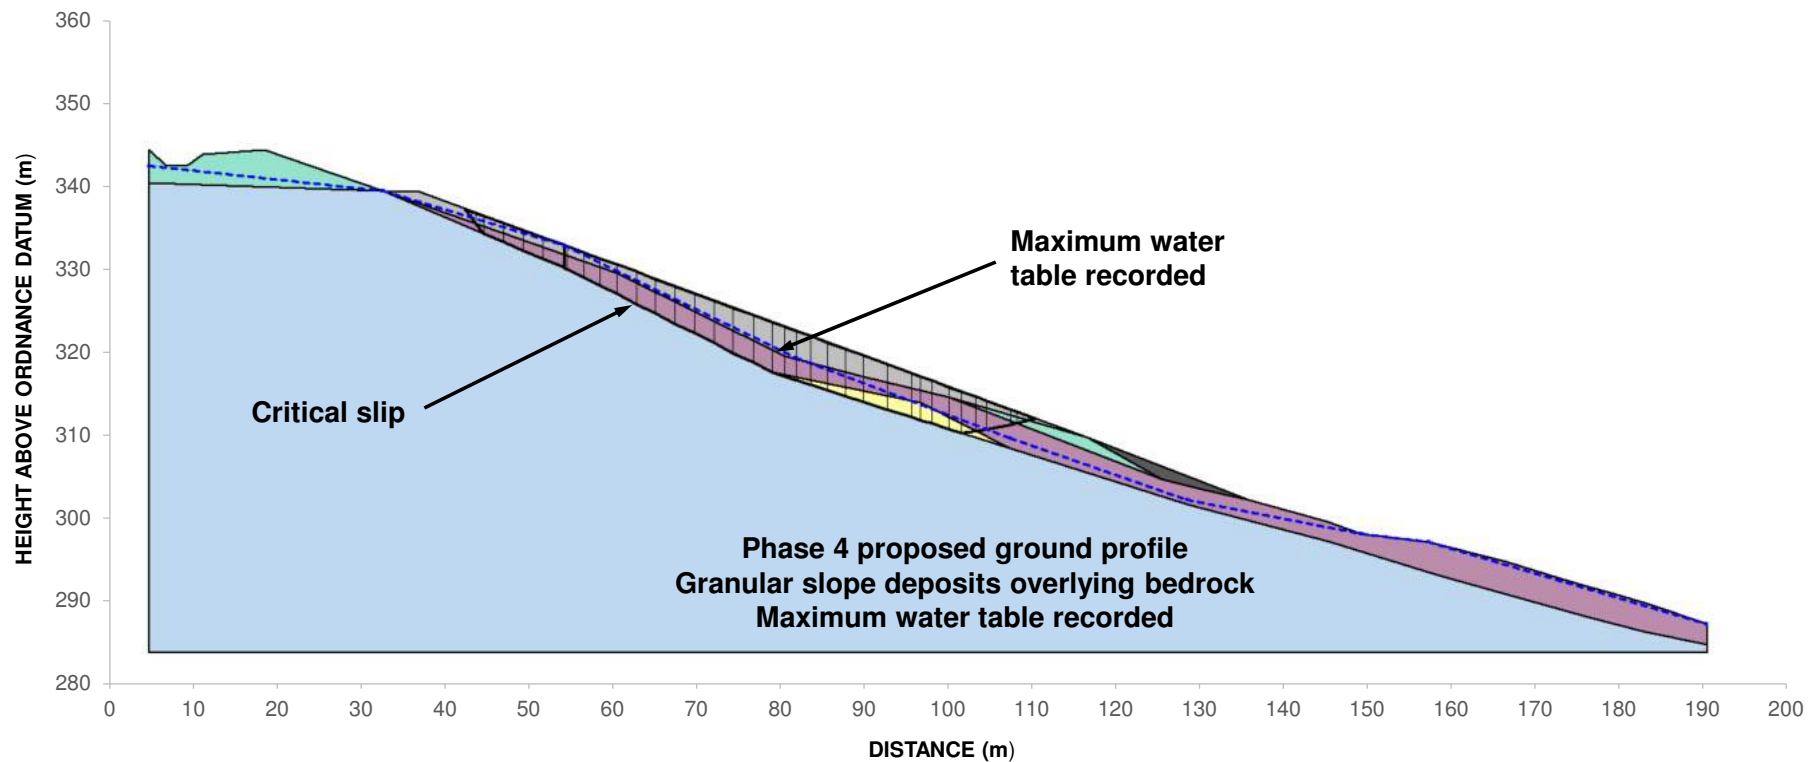
This part of the Upper Tip is currently close to unity ($FoS = 1.03$) under revised maximum water levels. The proposed slope reprofiling in combination with the water table currently observed on-site (design water table) increases the stability of the tip, achieving a minimum FoS of 1.32, and is therefore acceptable. The overall stability at this part of the site is sensitive to change in groundwater levels, with an increase of 1.0m giving a FoS of 1.17, which is slightly below the target FoS of 1.20.

F.O.S = 1.03

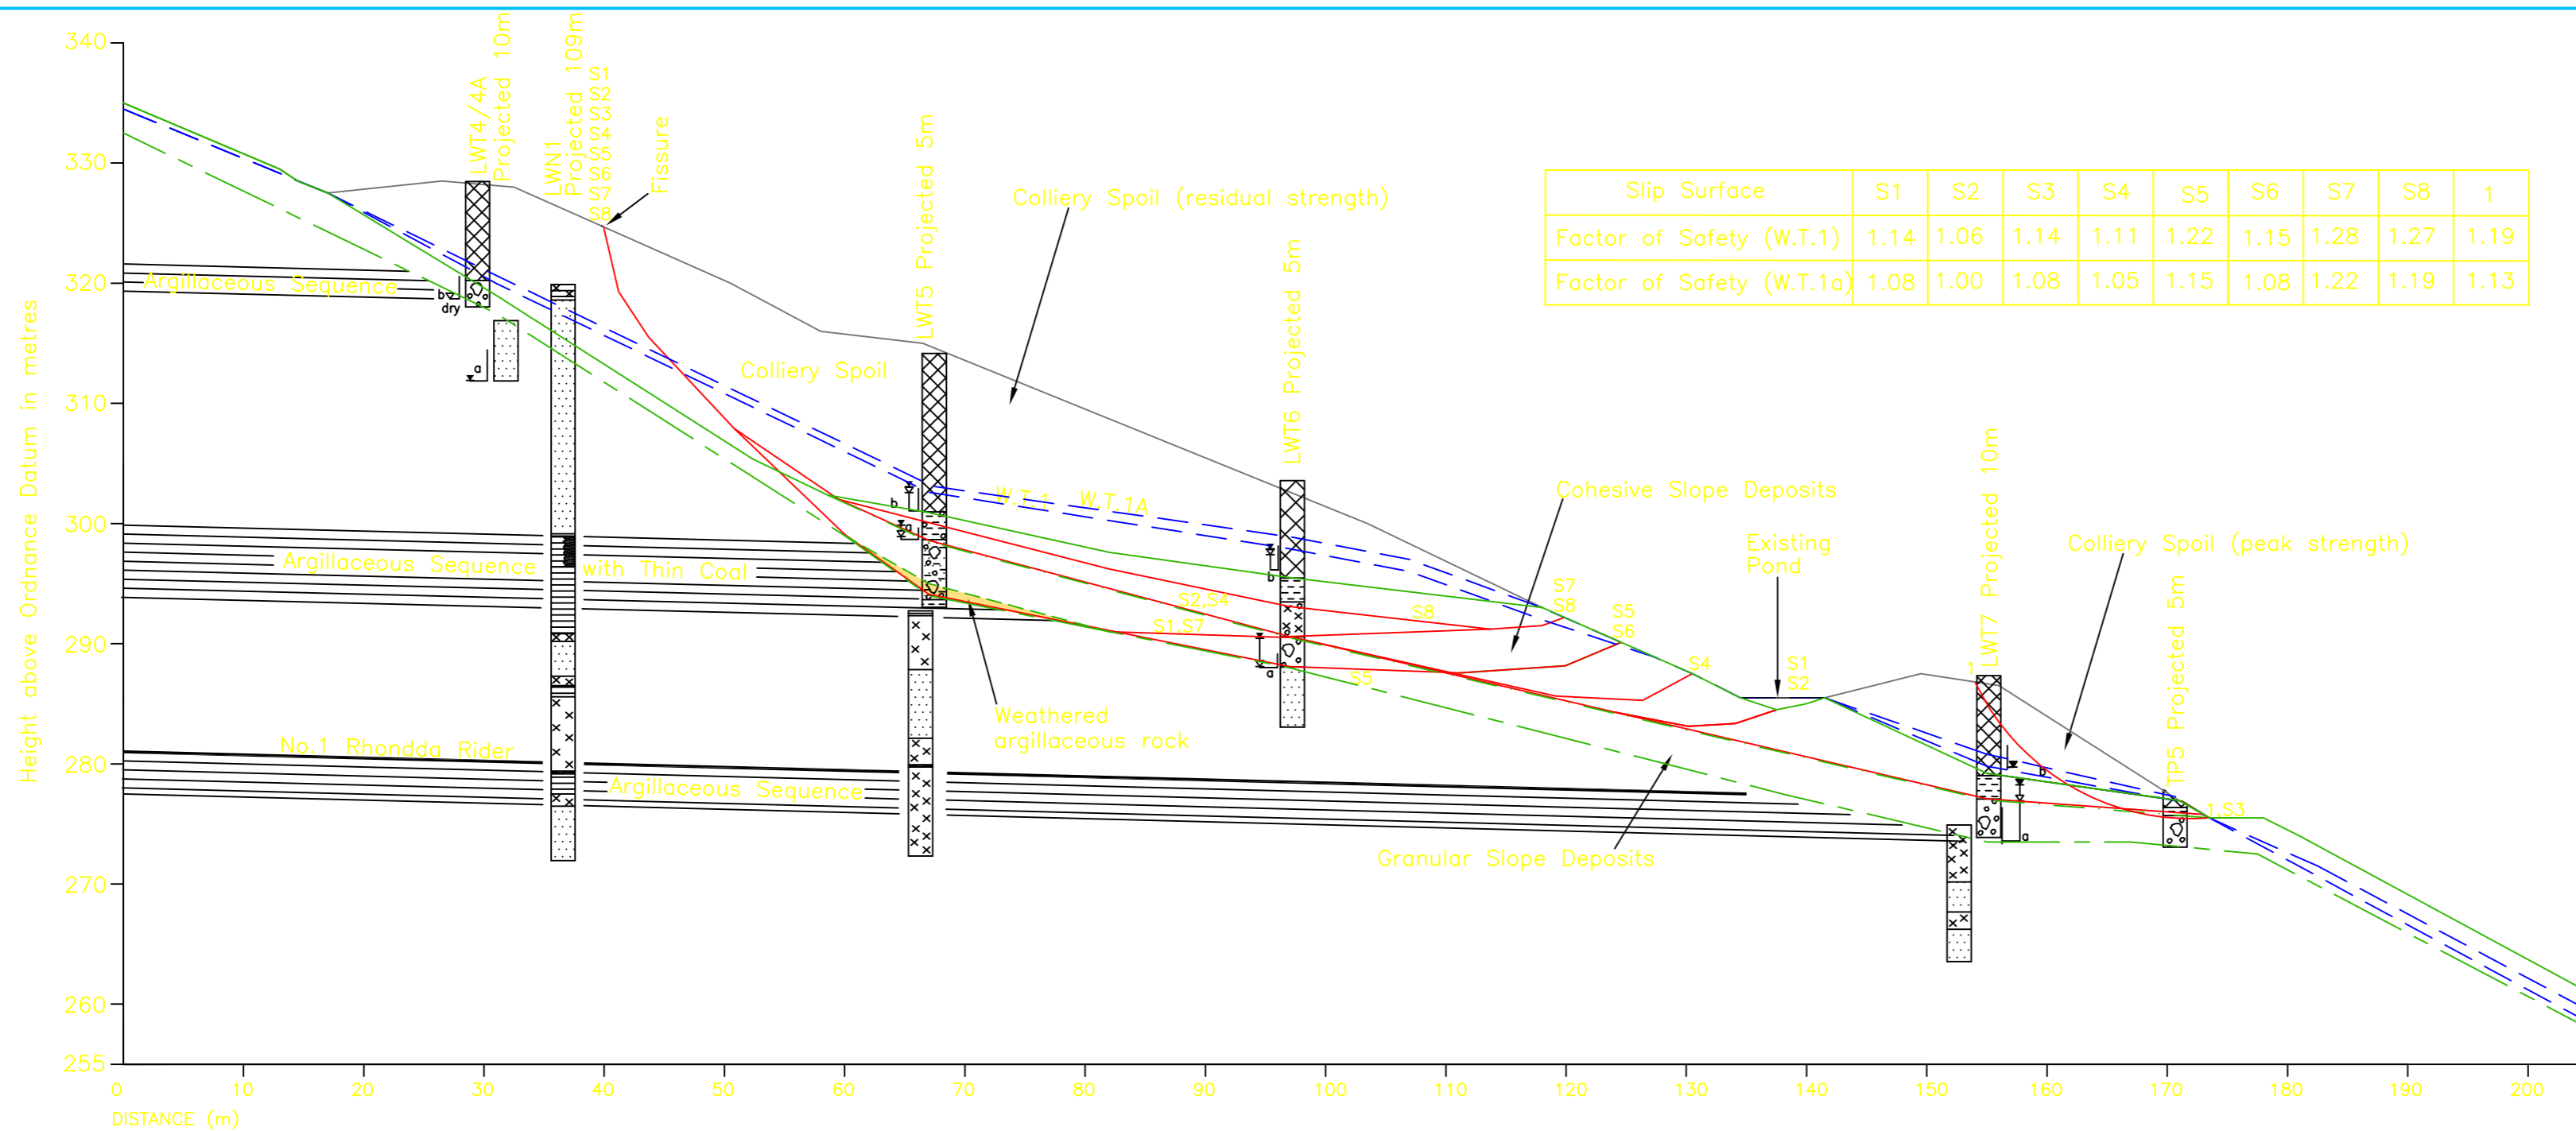
SECTION B-B (EXISTING PROFILE)

Slip Surface	S1	S2	S3	S4	S5	S6	S7	S8	1
Factor of Safety (W.T.1)	1.14	1.06	1.14	1.11	1.22	1.15	1.28	1.27	1.19
Factor of Safety (W.T.1a)	1.08	1.00	1.08	1.05	1.15	1.08	1.22	1.19	1.13

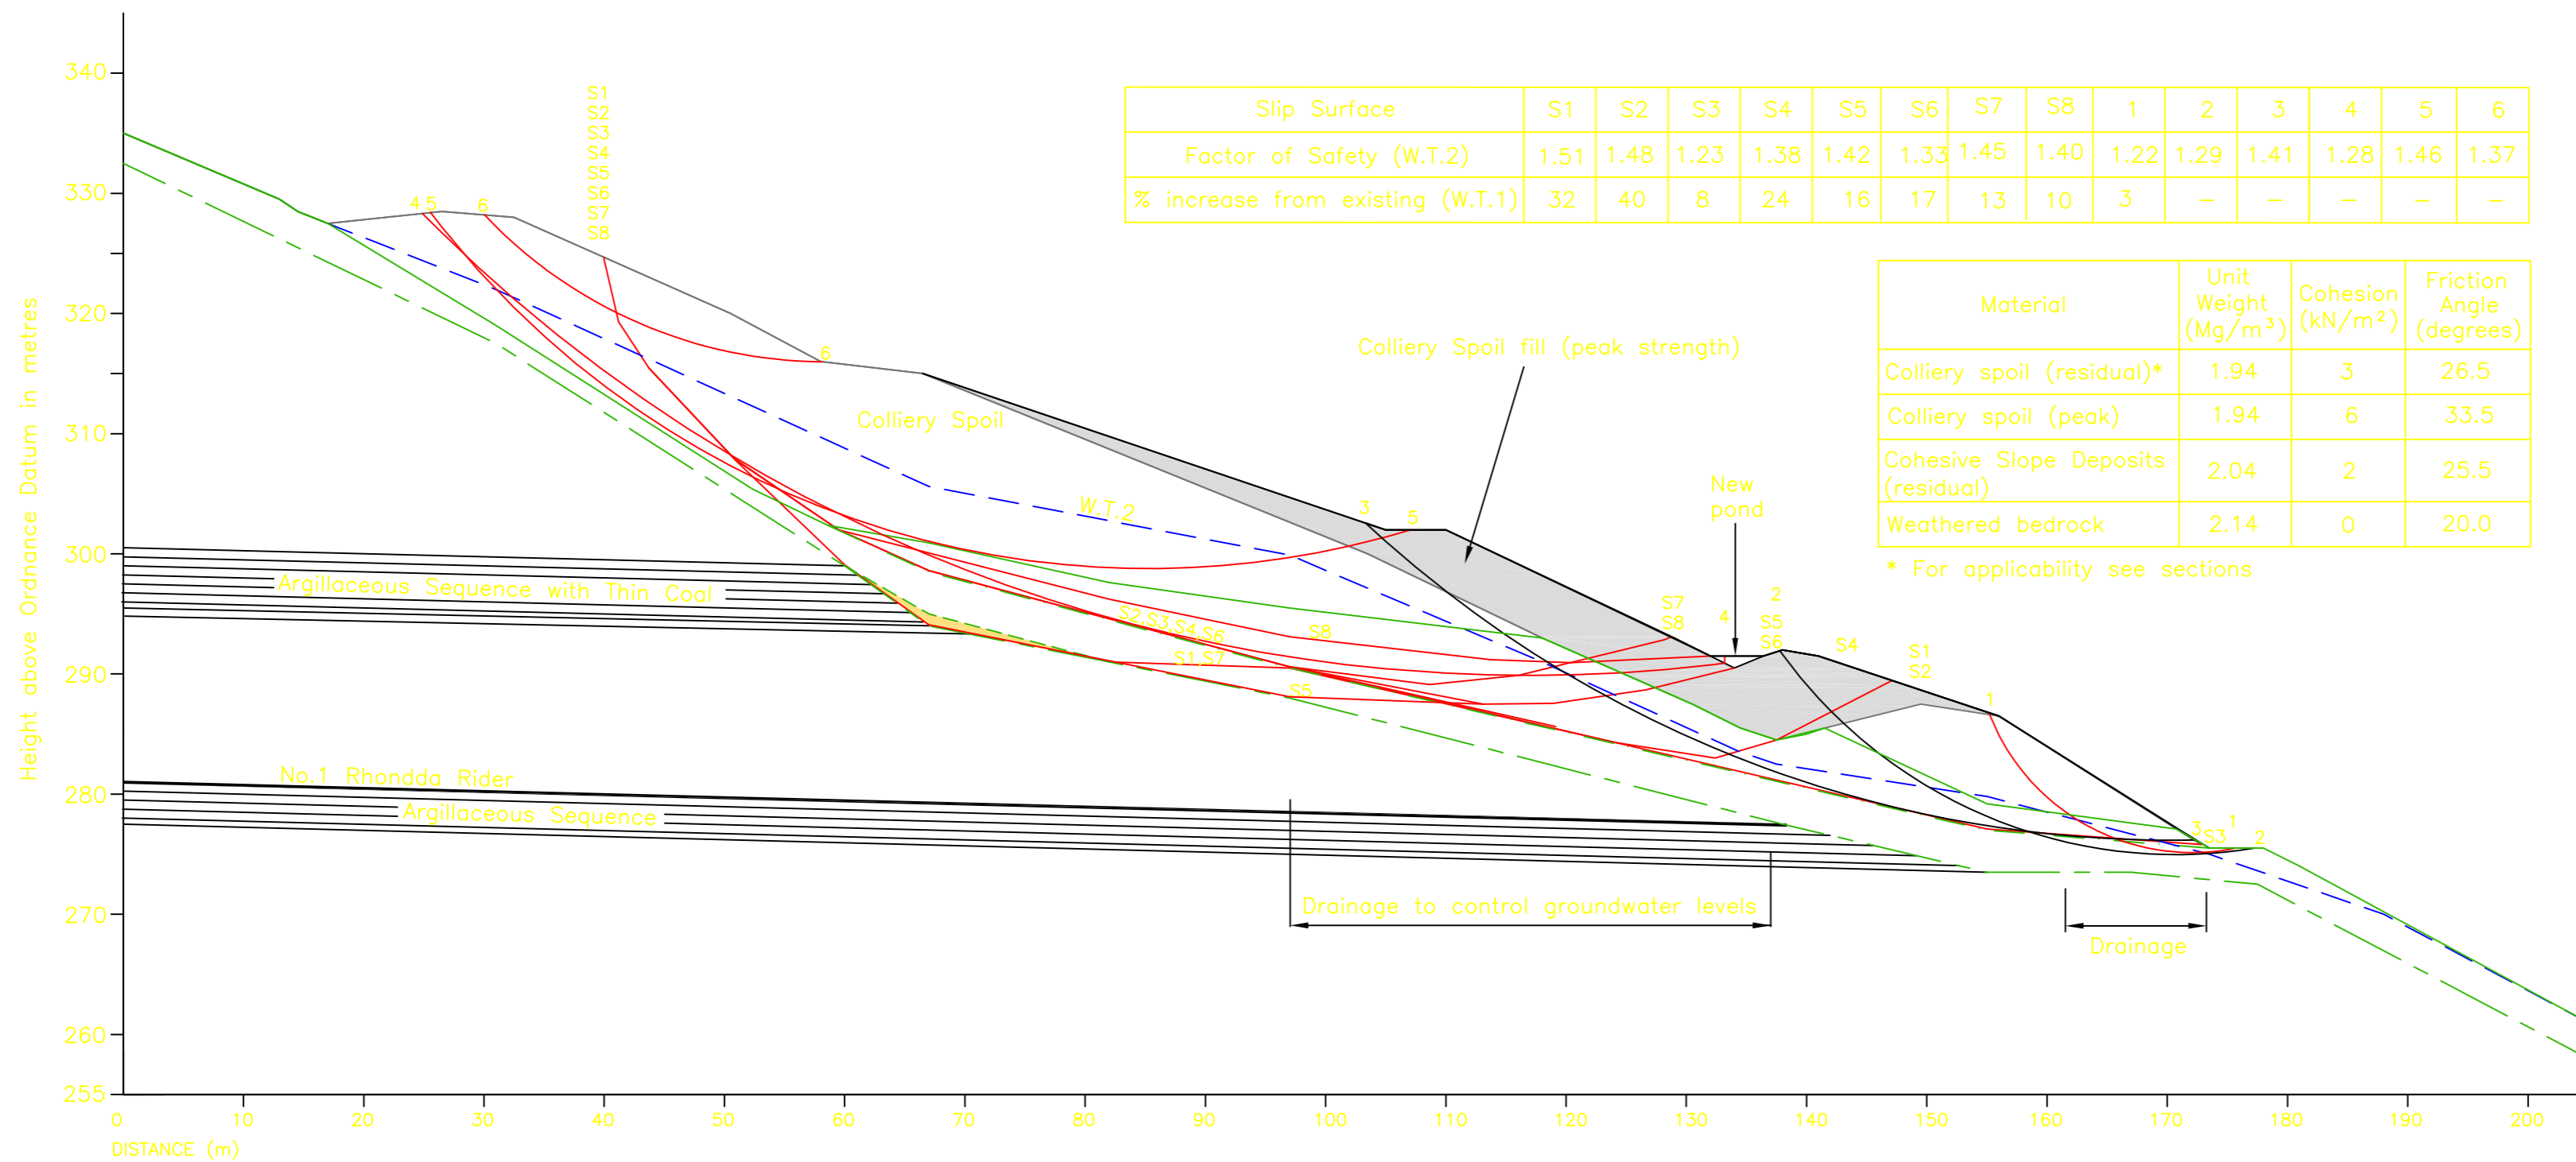
Figure No.
LWTR/R2/3

Slip Surface	S1	S2	S3	S4	S5	S6	S7	S8	1	2	3	4	5	6
Factor of Safety (W.T.2)	1.51	1.48	1.23	1.38	1.42	1.33	1.45	1.40	1.22	1.29	1.41	1.28	1.46	1.37
% increase from existing (W.T.1)	32	40	8	24	16	17	13	10	3	-	-	-	-	-
