Flood and Water Management Act 2010

Section 19 Flood Investigation Report

Unnamed Storm – 04/10/2021

Rhydyfelin

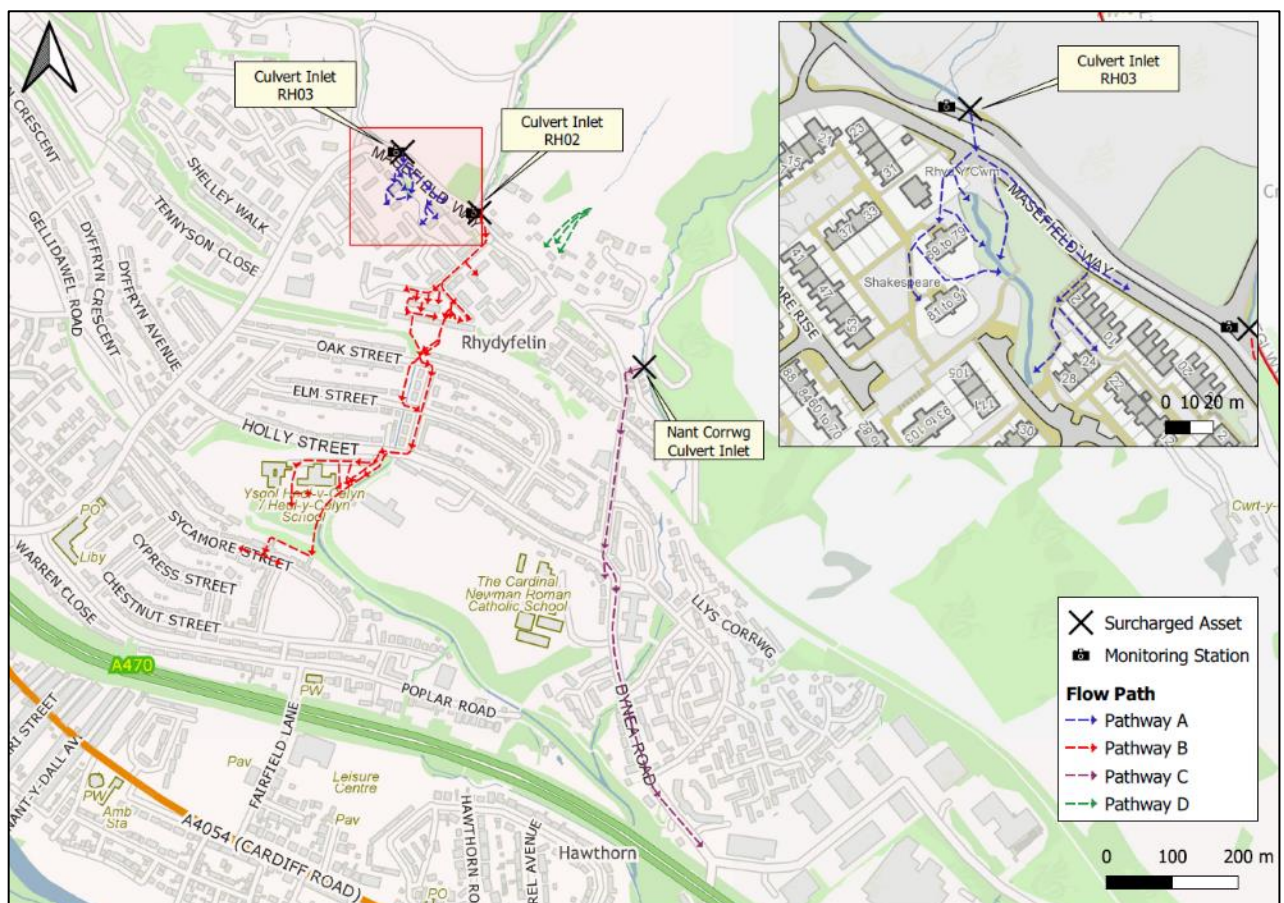
Pathway A shows where water enters the northwest of Rhydyfelin via an unnamed ordinary watercourse flowing from the hillside above. The watercourse is culverted beneath Rhydyfelin's residential development at 'Culvert Inlet RH03' which is located above Masefield Way. The inlet location and associated flow paths are illustrated in Figure 6.

Figure 6: Map illustrating the principal sources and flow paths of flooding during the storm event at Rhydyfelin. 'Pathway A', associated to 'Culvert Inlet RH03' is represented by a blue flow path.

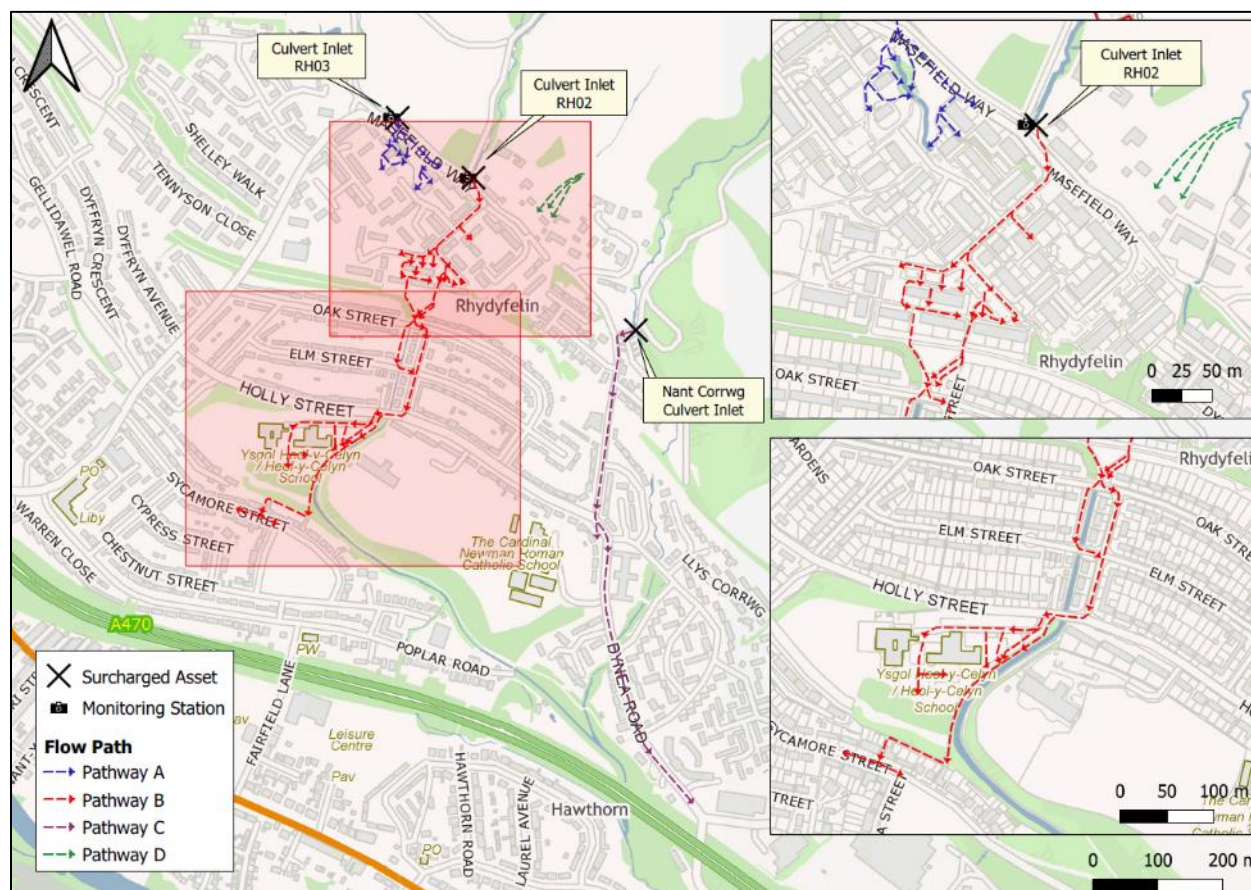
Figure 9: Map illustrating the principal sources and flow paths of flooding during the storm event at Rhydyfelin. 'Pathway B', associated to 'Culvert Inlet RH02' is represented by a red flow path.

Several calls were received from residents at Wordsworth Gardens on the night of the 4th of October 2021 to report water ingress into multiple residential properties. Upon a site inspection undertaken by RCT's Flood Risk Management team on 5th October, a culvert inlet located at Dynea Lane showed evidence of surcharge (labelled 'Culvert Inlet RH02' in Figure 9).

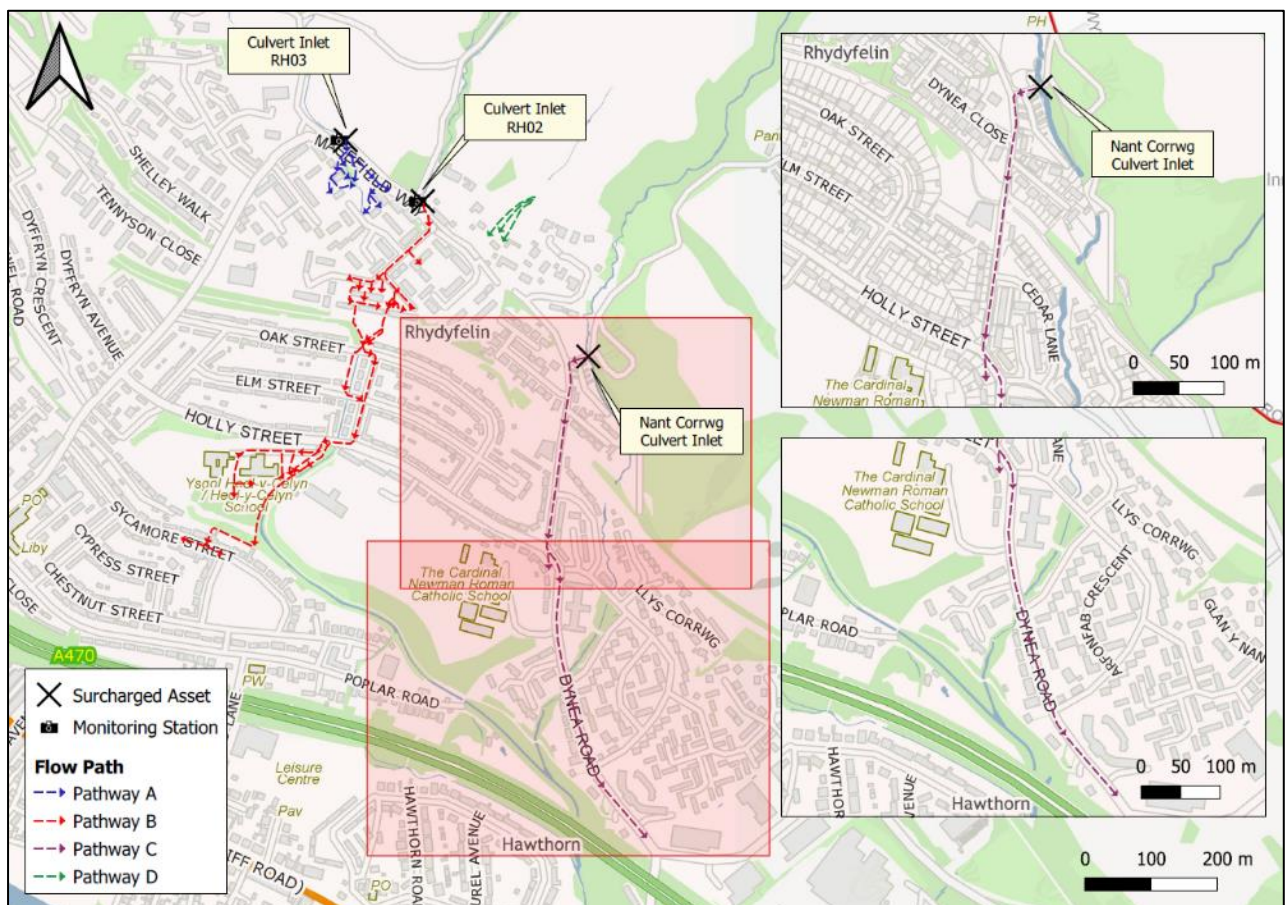
Pathway C shows where water enters the northeast of Rhydyfelin via the Nant Corrwg ordinary watercourse flowing from the hillside and farmland/pastures above. The watercourse is initially culverted beneath the highway adjacent to Dynea Caravan Site before continuing to flow downstream through various culverted sections. The inlet location (labelled 'Nant Corrwg Culvert Inlet') and associated flow paths are illustrated in Figure 15.

Figure 15: Map illustrating the principal sources and flow paths of flooding during the storm event at Rhydyfelin. 'Pathway C', associated to the 'Nant Corrwg Culvert Inlet' is represented by a purple flow path.

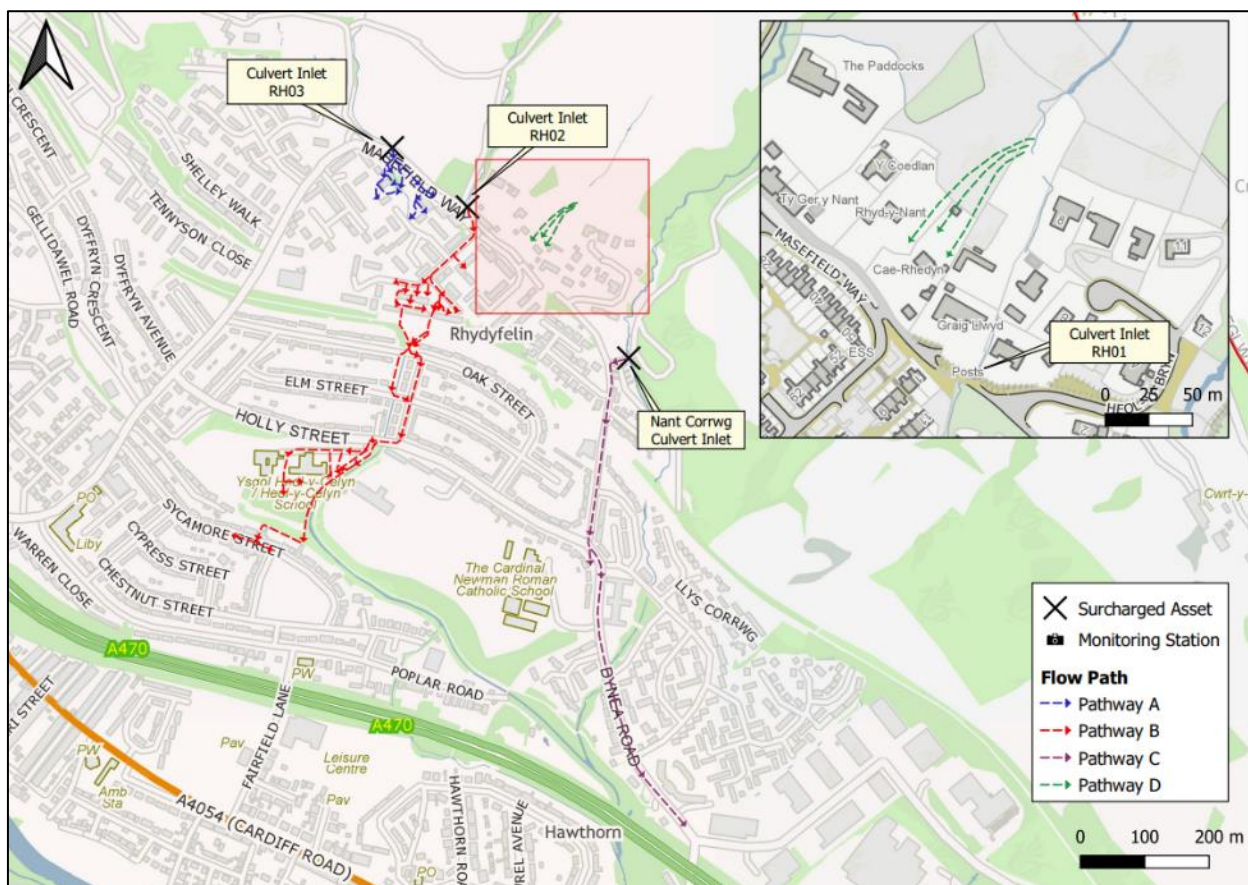
Pathway D shows where water enters the north of Rhydyfelin via an unnamed ordinary watercourse flowing from the hillside above. The watercourse is culverted beneath Rhydyfelin's residential development at 'Culvert Inlet RH01' which is located adjacent to Heol-y-Bryn. The watercourse, inlet location and associated flow paths are illustrated in Figure 17.

Figure 17: Map illustrating the principal sources and flow paths of flooding during the storm event at Rhydyfelin. 'Pathway D', associated to the overtopping of an unnamed ordinary watercourse is represented by a green flow path.

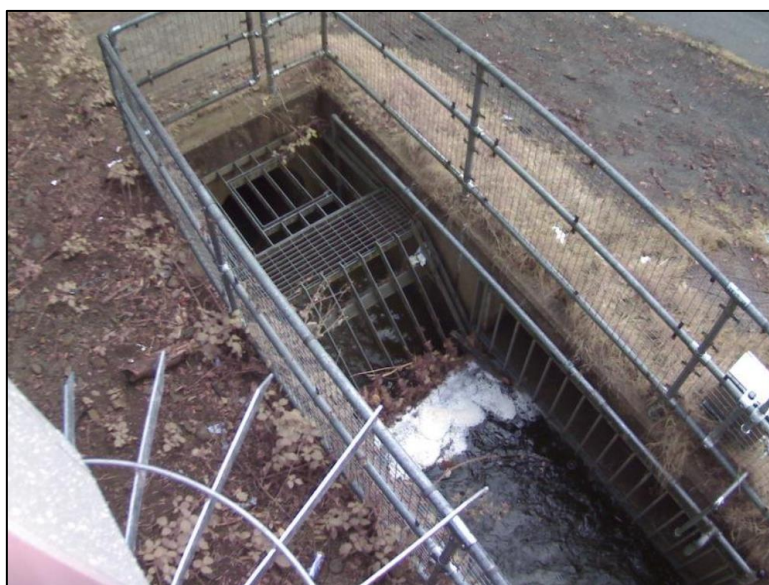
Figure 21: CCTV image of 'Culvert Inlet RH03' captured at 15:47 4th October 2021

The condition of 'Culvert Inlet RH03' throughout the duration of the storm event was captured by RCT's CCTV monitoring station. Prior to the storm event, on 4th October 2021, 'Culvert Inlet RH03' was assessed as being in acceptable condition with minor leafy debris identified at the screen. The condition of the culvert inlet captured pre storm event at 15:47 on 4th October is shown in Figure 21.

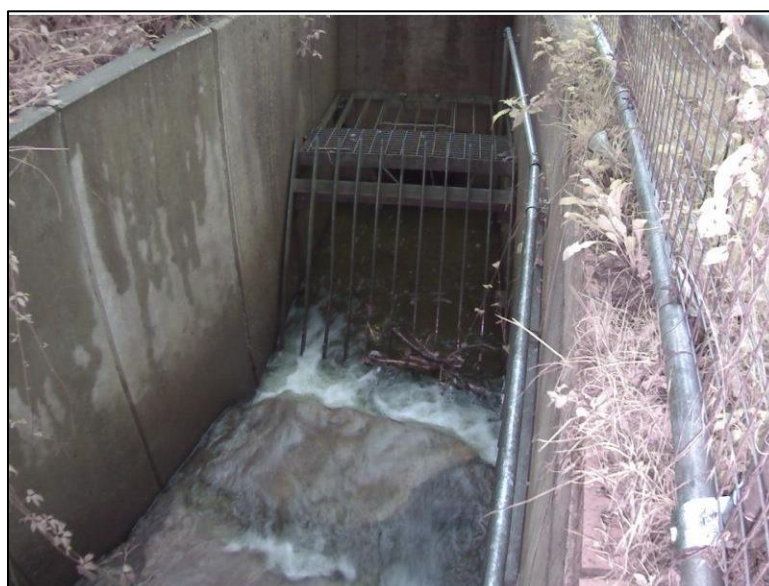
Figure 24: CCTV image of 'Culvert Inlet RH02' captured at 17:11 4th October 2021

The condition of 'Culvert Inlet RH02' throughout the duration of the storm event was captured by RCT's CCTV monitoring station. Prior to the storm event, on 4th October 2021, 'Culvert Inlet RH02' was assessed as being in acceptable condition with only some minor woody debris identified at the screen. The condition of the culvert inlet, captured pre storm event at 17:11 on 4th October, is shown in Figure 24.

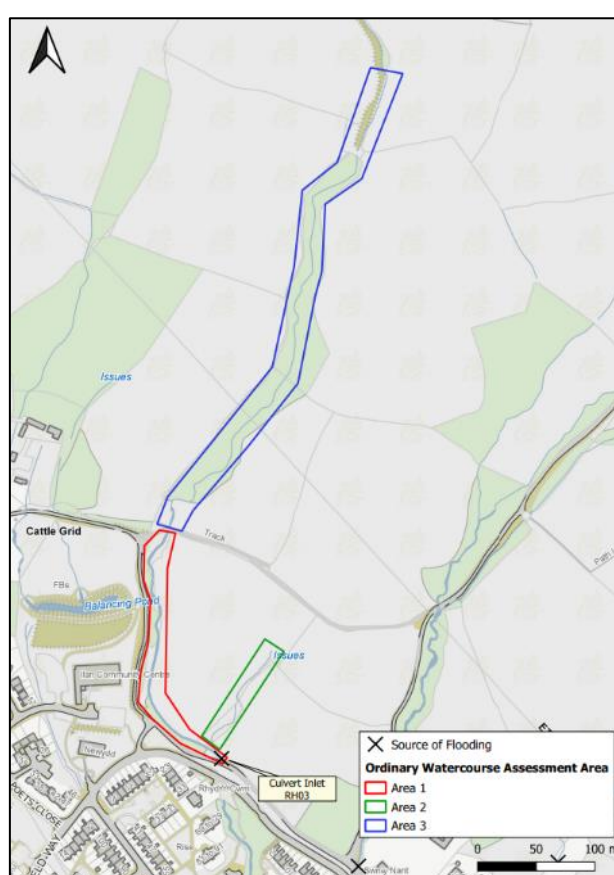
Figure 29: 'Unnamed Ordinary Watercourse RH03' inspection location plan

The catchment which feeds into 'Culvert Inlet RH03' is large and predominantly farmland. 'Unnamed Ordinary Watercourse RH03' was inspected at three areas, depicted in Figure 29 the results of which are described below.

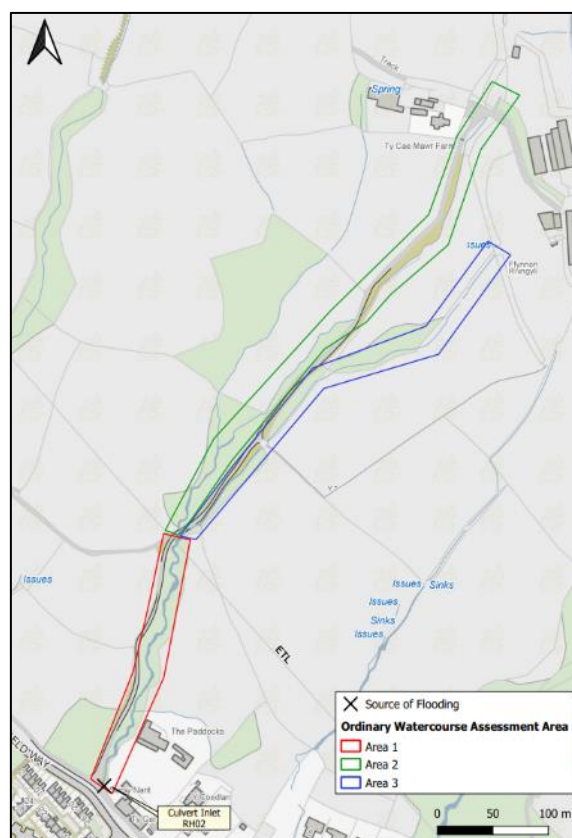
Figure 32: 'Unnamed Ordinary Watercourse RH02' inspection location plan

'Unnamed Ordinary Watercourse RH02' was inspected at three areas, depicted in Figure 32, the results of which are described below.

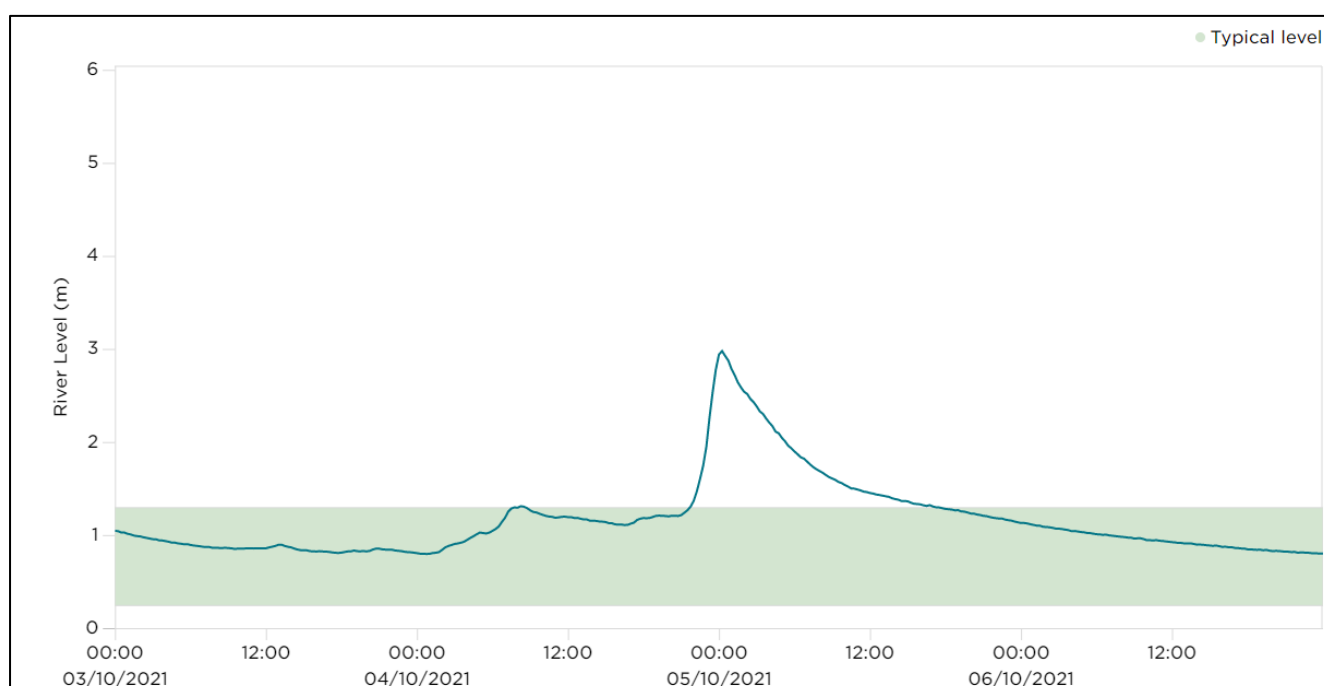
The hydrograph in Figure 36 illustrates a moderate rise in levels of the River Taf in response to rainfall, captured at NRW's Upper Boat station, located approximately 0.5 km downstream of the investigation area. The River Taf at Upper Boat reached a recorded peak of 2.978 metres at 00:15 on 5th October 2021.

Figure 36: The River Taf levels at Upper Boat station between the 3rd and 6th October 2021 (Natural Resources Wales)

The green bar displayed on the hydrograph shows the typical level of the River Taf at Upper Boat station, ranging between 0.1 and 0.5 metres. At its peak, the River Taf was approximately a metre higher than its average level. Within 12 hours of reaching its peak, levels within the River Taf fell rapidly to its typical level. The hydrograph illustrates the rapid response of RCT's catchments and river levels to rainfall.

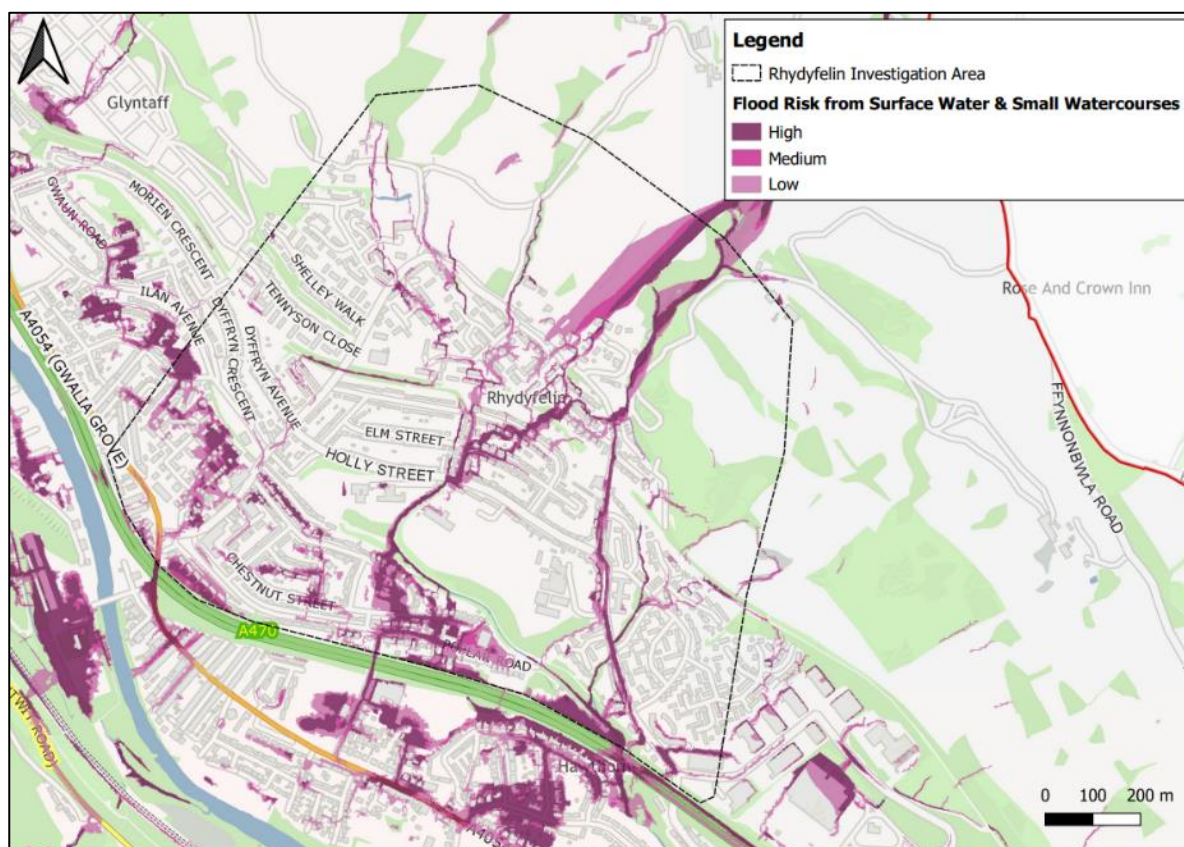
Figure 38 depicts the surface water and ordinary watercourse flood extents based on NRW's FRAW mapping exercise. A high to low risk of surface water and ordinary watercourse flooding is noted along several streets which were impacted by flooding across Rhydyfelin and is mostly consistent with the pathways of flooding observed along the highway network on the 4th of October 2021.

Figure 38: Natural Resources Wales' FRAW map for surface water and ordinary watercourse sources within Rhydyfelin investigation area. Contains Natural Resources Wales information © Natural Resources Wales and database right. All rights reserved.
