Section 19 Flood Investigation Report

Storm Dennis –

Flood Investigation Area RCT15
(Rhydyfelin & Hawthorn)

July 2022

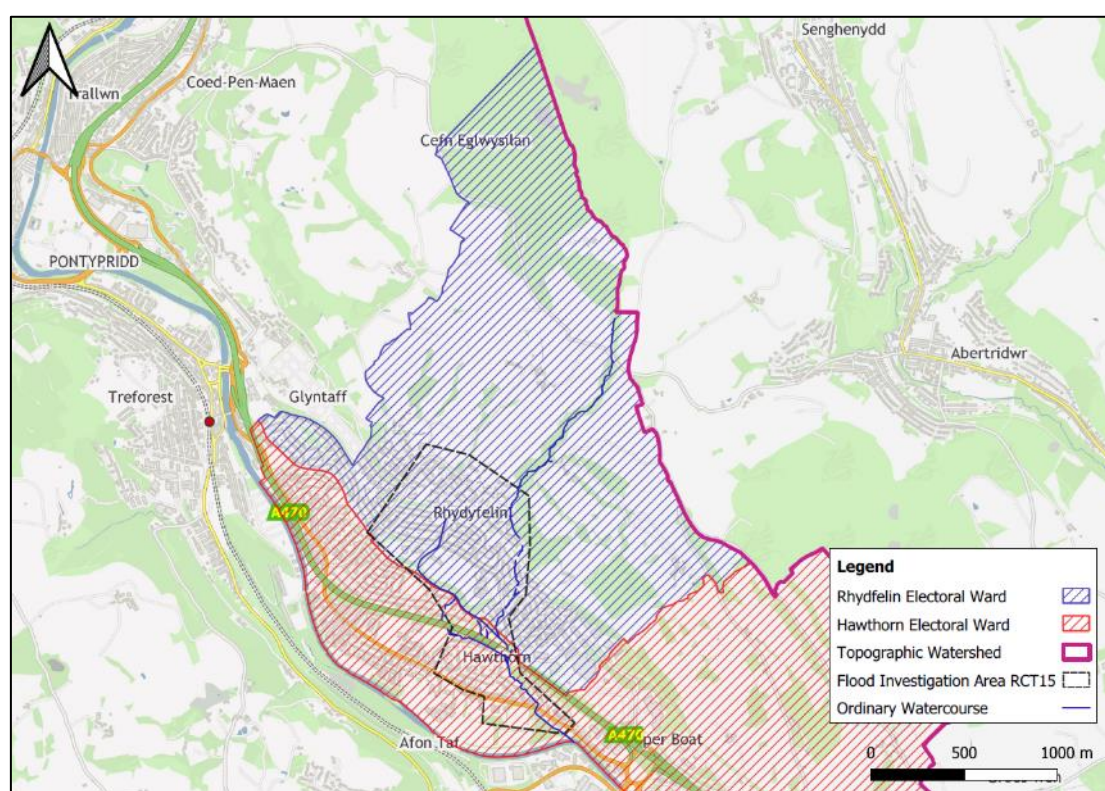
Figure 3: Rainfall Topographic Watershed above investigation area RCT15 and the electoral ward boundaries for Rhydyfelin and Hawthorn

Figure 3 depicts the topographic watershed of the River Taf and Nant yr Aber valleys (bold pink line), with rainfall to the southwest of the watershed draining to the River Taf catchment. On review of the area of land that would expect to drain towards the investigation area, LIDAR based assessment produced by Redstart's FIR (Figure 4) show the valley hillsides above Rhydyfelin's urban settlements to be steeply inclined and absent of any ridge-like features that may divert surface water flows. These steep slopes above the investigation area largely contributed to the rapid surface water and ordinary watercourse flows travelling down the hillside during heavy rainfall.

The flood incident at investigation area RCT15 will be further described in two parts: the incident in the Rhydyfelin electoral ward area, north of the A470 (red hatched area, Figure 3), and the incident south of the A470, in the Hawthorn electoral ward area (blue hatched area, Figure 3).

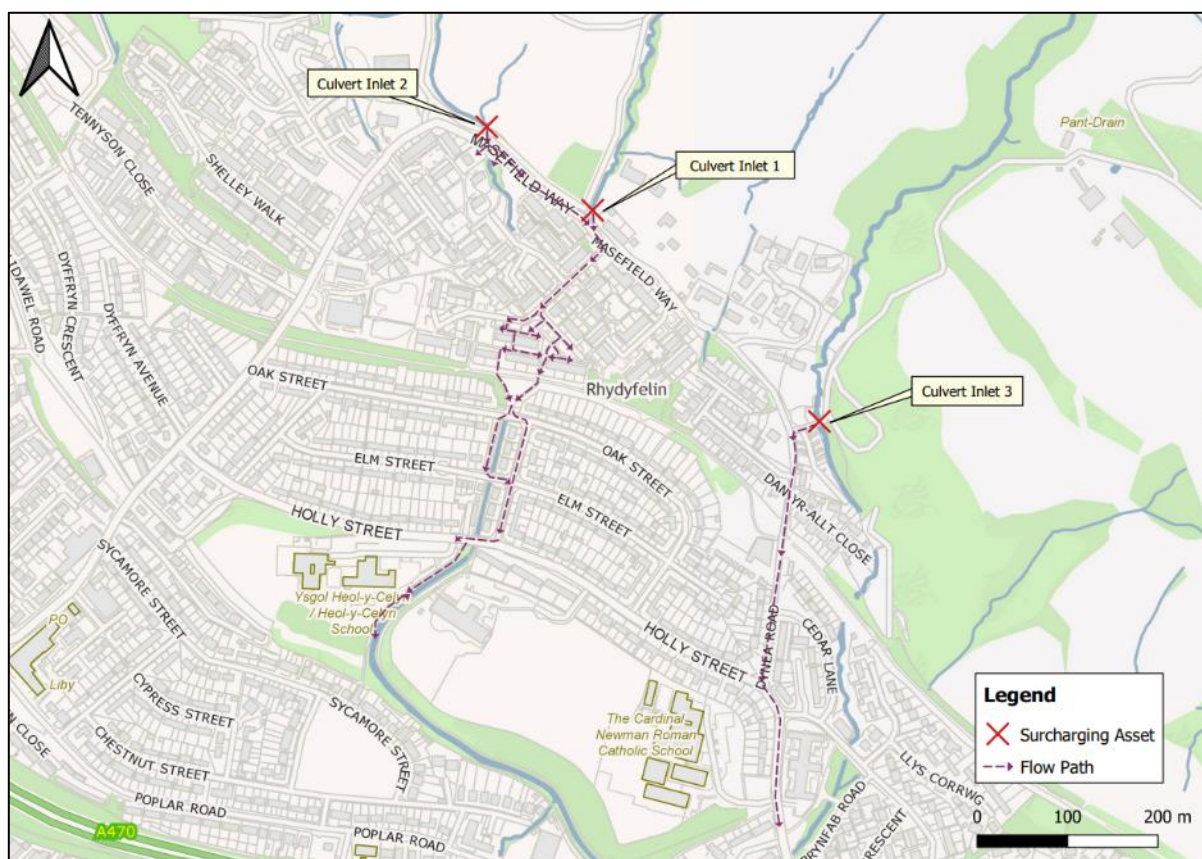
Figure 5: Observed flow paths within the Rhydyfelin area during Storm Dennis (16th February 2020)

Figure 5 depicts the observed pathways of flooding within the Rhydyfelin area during Storm Dennis. The infrastructure known to have surcharged and contribute to the flooding are also illustrated in Figure 5.

Several calls were received from residents at Wordsworth Gardens on 16th February 2020 to report water ingress into multiple residential properties. The residents' reports reference two culvert inlets, north of Rhydyfelin (labelled 'Culvert Inlet 1 and 2', Figure 5), as sources of flooding. Both inlets were inspected by RCT's Highway and Streetcare Depot during the storm events' emergency response, and both showed evidence of surcharge. Following the storm event, on 17th February 2020, a site inspection of both culvert inlets was also undertaken by RCT's Flood Risk Management team in order to gain further investigative evidence of the flooding impacts.

A culvert inlet located above Masefield Way (labelled 'Culvert Inlet 1' in Figure 5). showed evidence of surcharge. Evidence of mobilised silt and debris, indicative of the surcharging flows, suggest that the exceedance flows from 'Culvert Inlet 1' conveyed over the embankment, onto Masefield Way, and onwards towards properties within the lower reaches of Wordsworth Gardens. 14 residential properties at Wordsworth Gardens were confirmed as internally flooded as a result of the ordinary watercourse flows.

A second culvert inlet, located west of 'Culvert Inlet 1', was also observed as surcharging during the storm event (labelled 'Culvert Inlet 2' in Figure 5). Post event

Residents at Dynea Road also reported flooding during Storm Dennis. RCT's Flood Risk Management team identified the flooding to have originated from a surcharged culvert inlet adjacent to Dynea Caravan Park (labelled 'Culvert Inlet 3' in Figure 5). This culvert inlet is associated to the primary Nant Corrwg ordinary watercourse.

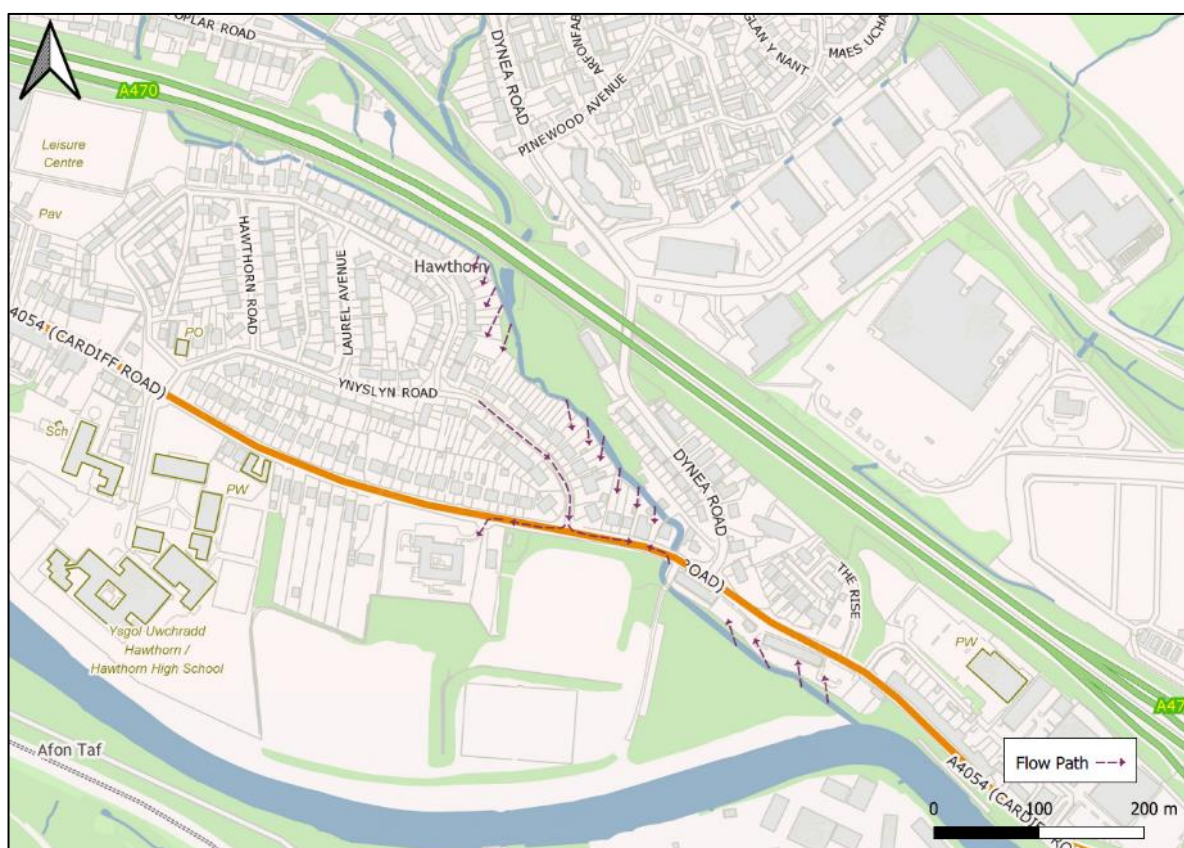
Figure 9: Observed flow paths within the Hawthorn area during Storm Dennis (16th February 2020)

Figure 9 depicts the observed pathways of flooding within the Hawthorn area during Storm Dennis.

Several calls were received from residents at Hawthorn Crescent on the 16th February 2020 to report water ingress into multiple residential properties. Reports of flooding reference the Nant Lonydd ordinary watercourse which flows to the rear of Hawthorn Crescent and Ynyslun Road before being culverted beneath the A4054 (Cardiff Road) and discharging into the River Taf.

along its length, impacting properties at Hawthorn Crescent, Ynyslyn Road and the A4054 (Cardiff Road). A section of the privately owned retaining wall to the rear of Hawthorn Crescent was identified as damaged following the overtopping of the Nant Lonydd watercourse. This led to partial compartmentalisation of flooding within the rear extents of several properties along the channel length.

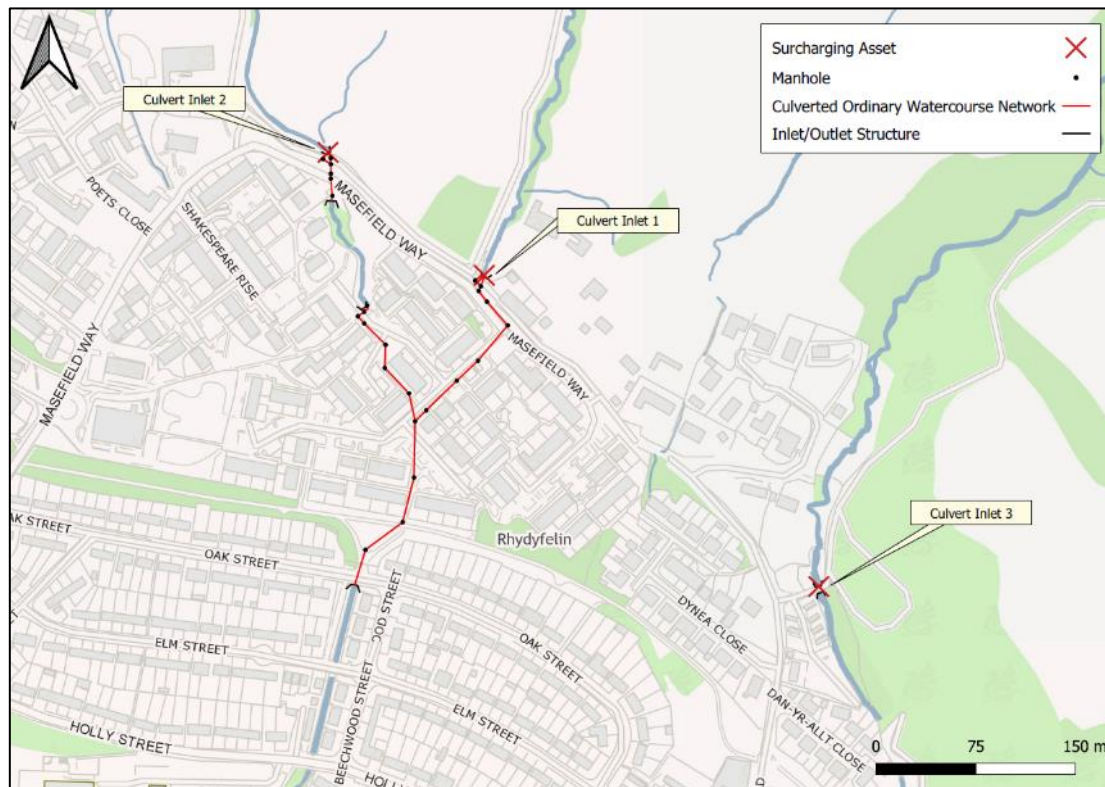
Figure 15: Surveyed culverted ordinary watercourse networks within RCT15

Figure 15 outlines the culvert inlet structures identified as sources of flooding during Storm Dennis and highlights the two associated culvert networks which were surveyed post event.

The culvert inlet structure and networks associated to 'Culvert Inlet 1 and 2' were both assessed as being in acceptable condition with no significant defects identified nor significant deposits or silt identified within the networks. Flooding was observed only at the inlet and not elsewhere along the culvert network during the storm event. It is thereby inferred that the primary cause of surcharge at both 'Culvert Inlet 1 and 2' was due to blockages caused by debris mobilised from the upper catchments which reduced the hydraulic capacities of both inlets, and associated overflow systems, to manage the flow of water, leading to surcharge.

The source of flooding along Dynea Road was identified as originating from a blocked culvert inlet adjacent to Dynea Caravan Park on the eastern edge of the investigation area, labelled 'Culvert Inlet 3' in Figure 15 (Figure 18). According to the investigating officer, the debris screens upstream of the culvert inlet became blocked with significant scour material mobilised from the upper reaches of the Nant Corrwg watercourse. The blockage at the debris screens restricted the flow of water entering the culvert and overflow system, resulting in the overtopping of flows over the western headwall. The condition of the culvert inlet structure is not considered to have impacted the surcharge.

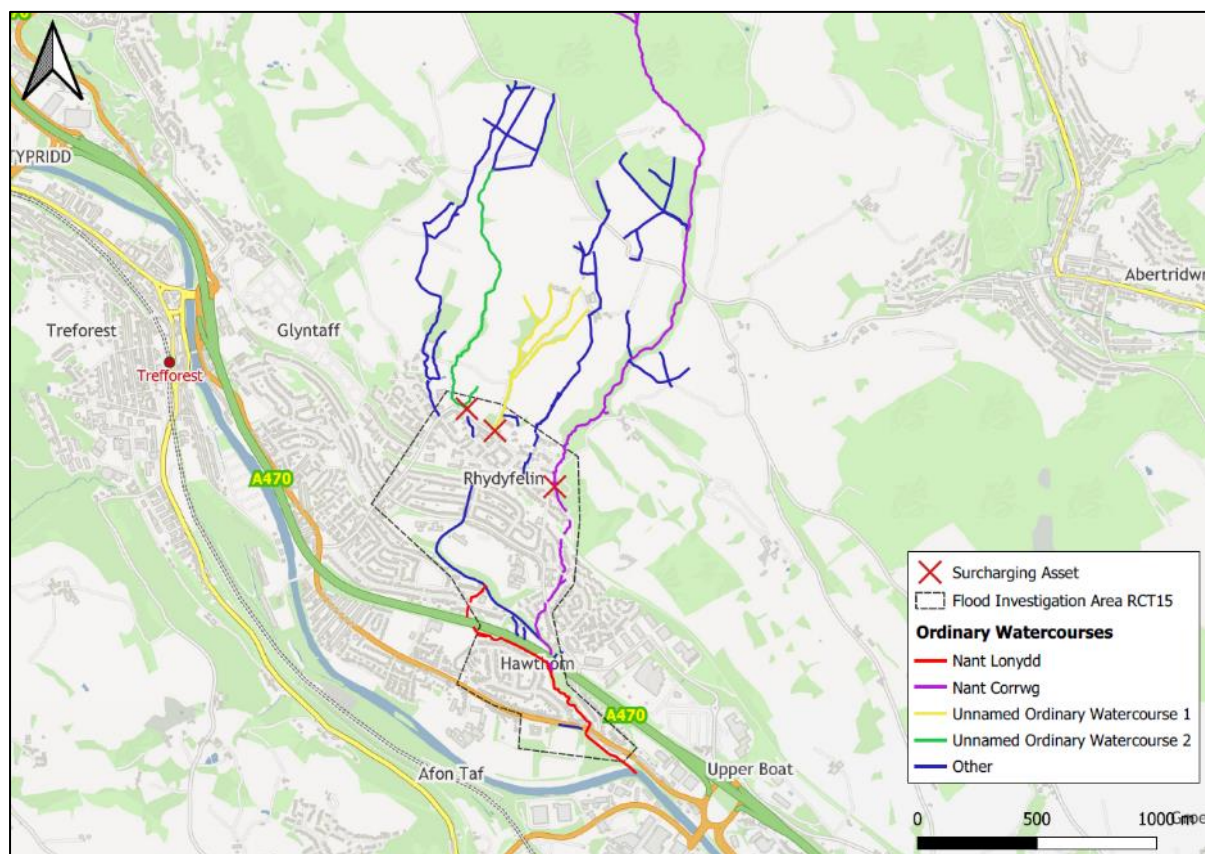
Figure 19: Map of Ordinary Watercourses which feed into and flow through investigation area RCT15

Several sections of natural ditches and open watercourses which drain the steep hillsides above RCT15 are identified to flow through the investigation area and discharge into the River Taf to the south of the investigation area (Figure 19). The most notable watercourses include the Nant Corrwg and the Nant Lonydd.

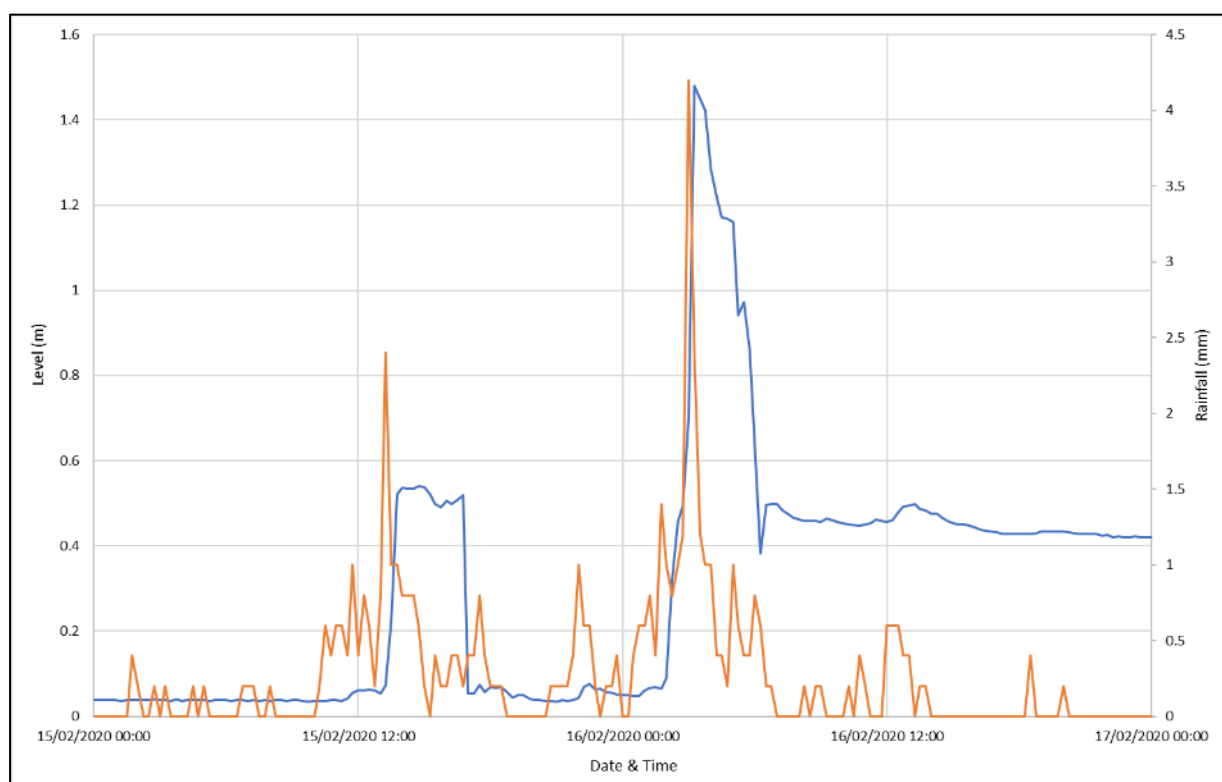
Figure 20: Water level (m) within the unnamed ordinary watercourse upstream of 'Culvert Inlet 1' and rainfall amounts (mm) during Storm Dennis (15 – 16th February 2020) captured at RCT's Rhydyfelin monitoring stations

Based on data captured by RCT's Rhydyfelin monitoring station, the storm resulted in two peaks in the level of flow within 'Unnamed Ordinary Watercourse 1'. Both peaks are illustrated in Figure 20 and align with the peak recorded rainfall.

The initial peak occurred at 14:45 on 15th February and rose to a depth of half a metre, approximately only one hour after the initial peak in rainfall. Levels within the channel fell sharply during the evening of 15th February, before spiking significantly at 03:15 on 16th February, resulting in a peak level of 1.48 metres. The second, more significant peak, in levels occurred only 15 minutes after peak rainfall was recorded at 03:00 (4.2mm/00:15). Water levels fell dramatically very shortly after the peak.

Figure 20 highlights the exceptionally short lag time between peak rainfall and peak discharge within the watercourse. This is primarily attributed to the catchment conditions of Rhydyfelin, which are characterised by steep valley sides, susceptible to intense rainfall and associated flash flooding. The rapid response to rainfall is considered to have overwhelmed the ordinary watercourse, resulting in some out-of-bank flows, whilst also highlighting the exceptional flows which would have been conveying towards the inlet carrying significant debris.

Although the monitoring stations provide an indication of the ordinary watercourse response during the storm event, the debris mobilised by the fast flows towards both culvert inlets are considered to have impacted the monitoring equipment and associated sensor readings. The results provided in Figures 20 and 22 should be considered an indication of the rapid response of Rhydyfelin's catchments to rainfall.

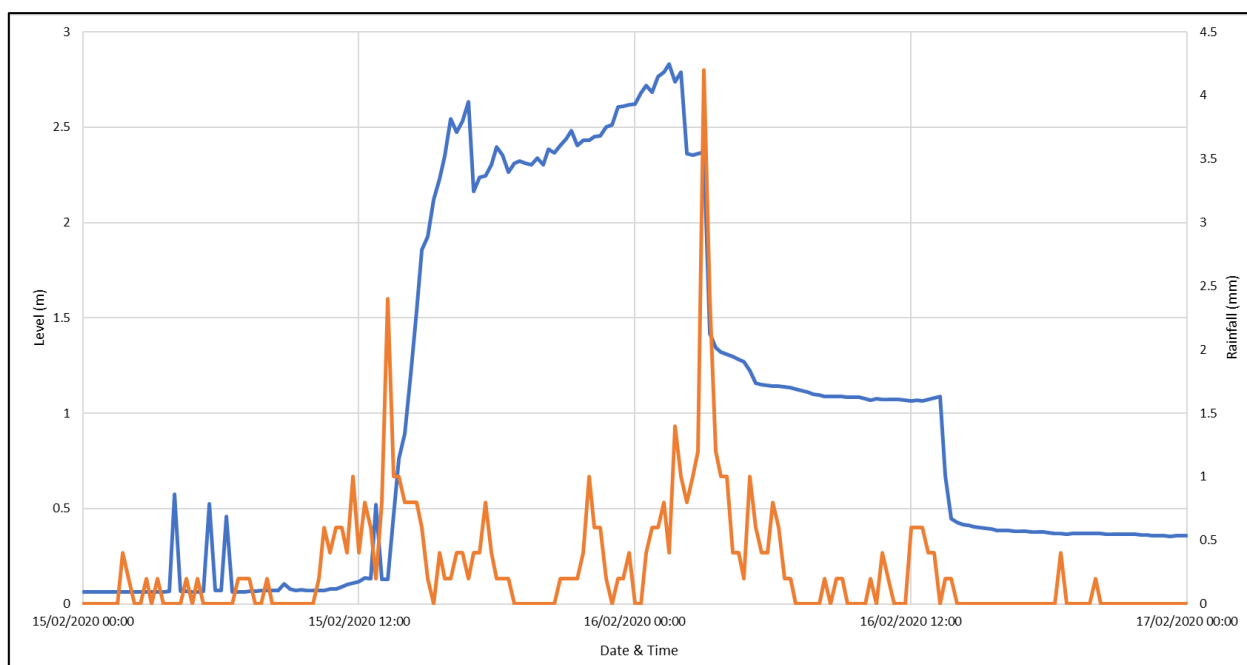
Figure 22: Water level (m) within the unnamed ordinary watercourse upstream of 'Culvert Inlet 2' and rainfall amounts (mm) during Storm Dennis (15 – 16th February 2020) captured at RCT's Rhydyfelin monitoring stations

2'. The water level and recorded rainfall during the storm event is illustrated in Figure 22.

Following the initial peak in rainfall at 13:15 on 15th February 2020, the watercourse rose sharply to reach a peak level of 2.6 metres at 16:45 on 15th February, approximately two hours after the peak rainfall. Based on the available telemetry data, levels within the watercourse at 'Culvert Inlet 2' remained high despite the receding rainfall. It is considered that debris became deposited at the sensor during the initial peak which caused a sustained rise in water levels, reaching a second peak of 2.8 metres at 01:30 16th February. Levels reduced sharply shortly after due to the initial operational clearance of debris from 'Culvert Inlet 2'. This was followed by a second cleansing operation during the afternoon of Sunday 16th February 2020, which would explain the observed staged and sharp falls in water level.

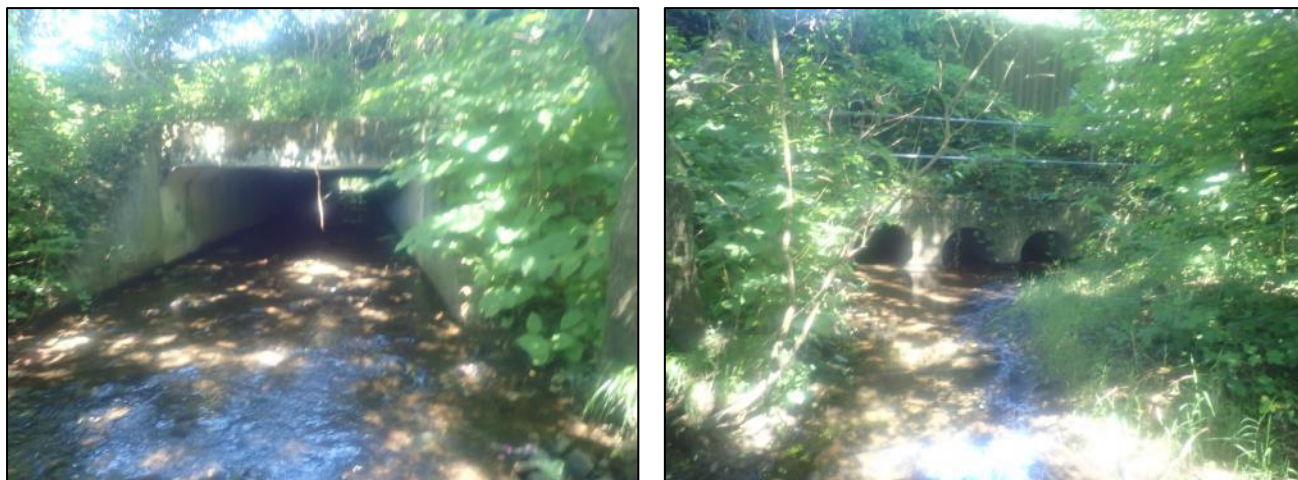
Figure 24: Nant Corrwg culvert outfall (left) and an unnamed ordinary watercourse culvert outfall (right) below the A470 (captured by RCT's Flood Risk Management team post event)

The Nant Corrwg watercourse is culverted beneath the A470 and outfalls below the highway, adjacent to Hawthorn Crescent (Figure 24, left). An unnamed ordinary watercourse to the east of the Nant Corrwg is also culverted beneath the A470 and discharges into the Nant Corrwg below the highway (Figure 24, right), before merging into the Nant Lonydd watercourse.

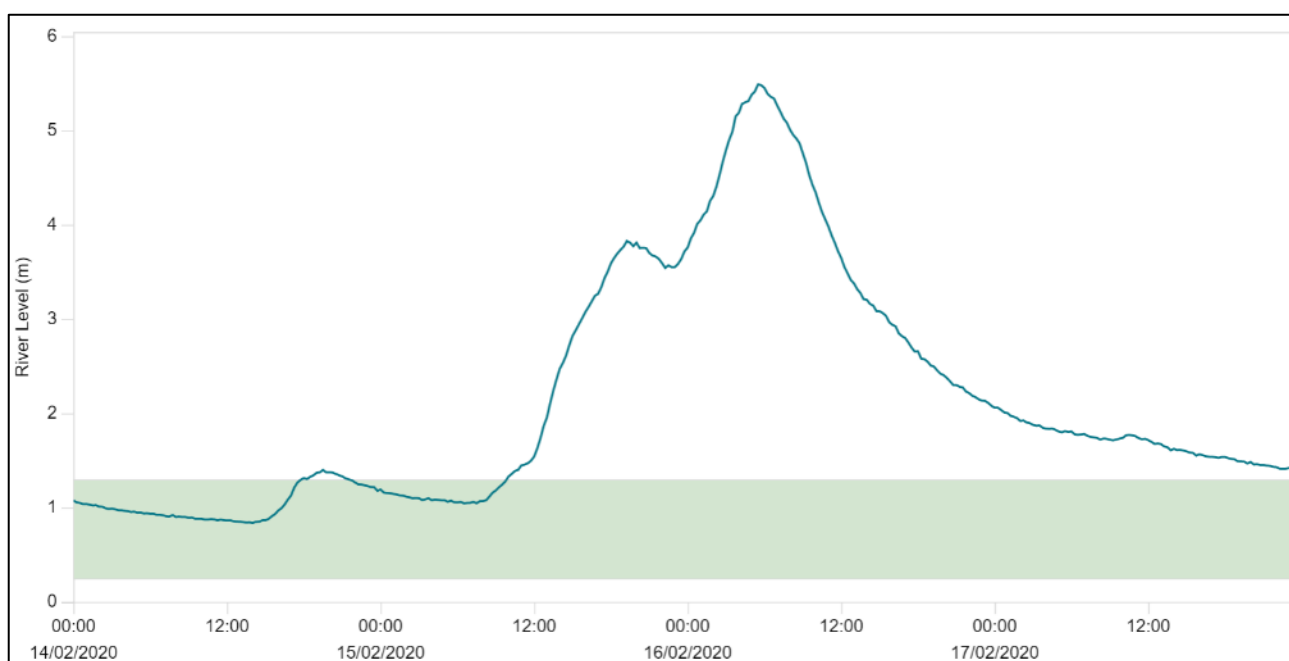
Figure 29: The River Taf levels at Upper Boat station between the 14th and 17th February 2020 (Natural Resources Wales)

The hydrograph in Figure 29 illustrates the significant rise in the River Taf's levels in response to rainfall between the 14 – 17th February 2020. River level data was captured at NRW's Upper Boat station, located approximately 0.5 km downstream of RCT15.

NRW issued a 'Flood Alert' (indicating possible flooding) for the entirety of the River Taf at approximately 13:30 on the 15th of February; at which point the main river was over 2 metres in depth and continuing to rise at Upper Boat station. At approximately midnight on the 16th of February the River Taf began to rise again, reaching a peak level of 5.49 metres at 06:00 on 16th February; the highest level recorded for the River Taf at Upper Boat since 2001.

The green bar displayed on the hydrograph shows the typical level of the River Taf at the Upper Boat station, ranging between 0.2 and 1.2 metres. The river level was above this green line for over 48 hours, highlighting the severity of the storm event and its unprecedented nature. At its peak, the River Taf at Upper Boat was over four metres higher than its average level.

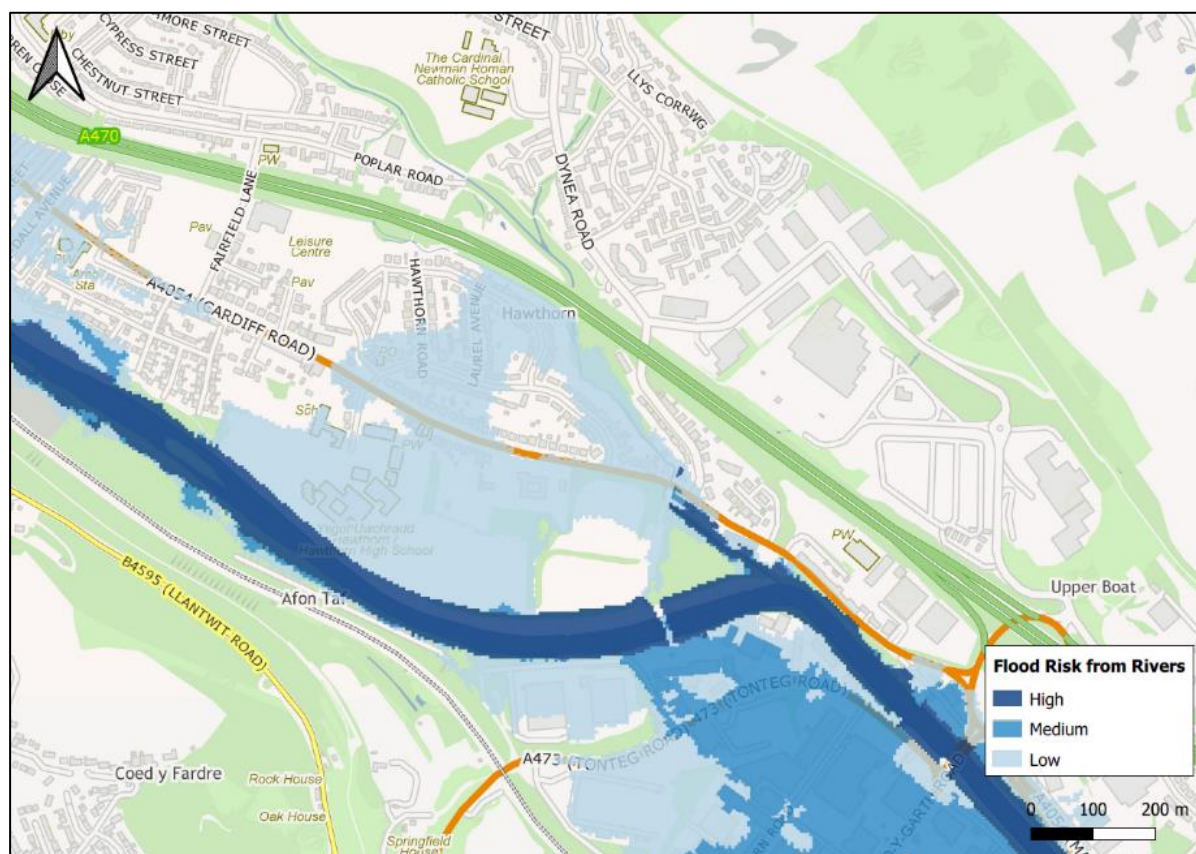
Figure 30: Natural Resources Wales' Flood Risk Assessment Wales (FRAW) map for River sources at RCT15. Contains Natural Resources Wales information © Natural Resources Wales and database right. All rights reserved.

The flood risk presented by the River Taf at RCT15 is illustrated within Figure 30; an excerpt from NRW's Flood Risk Assessment Wales (FRAW) mapping exercise which depicts the main river flood risk extents for the 'Defended' scenario, i.e., with the presence of flood defence assets. The darker shading identifies areas at higher risk of flooding (more frequent/less extreme rainfall events) and lighter shading showing the lower risk areas (less frequent/more extreme rainfall events).

The FRAW map (Figure 30) depicts a high to low main river flood risk within the Nant Lonydd ordinary watercourse. The flooding that occurred within the Hawthorn area of RCT15 during Storm Dennis is largely consistent with the modelled outputs of NRW's FRAW map (Figure 30), with the affected commercial properties at Melin Corrwg Business Park falling within an area of high main river flood risk, associated to its close proximity to the confluence between the Nant Lonydd ordinary watercourse and the River Taf. The impacted residential properties situated upstream of the A4054 fall within an area of low main river flood risk.

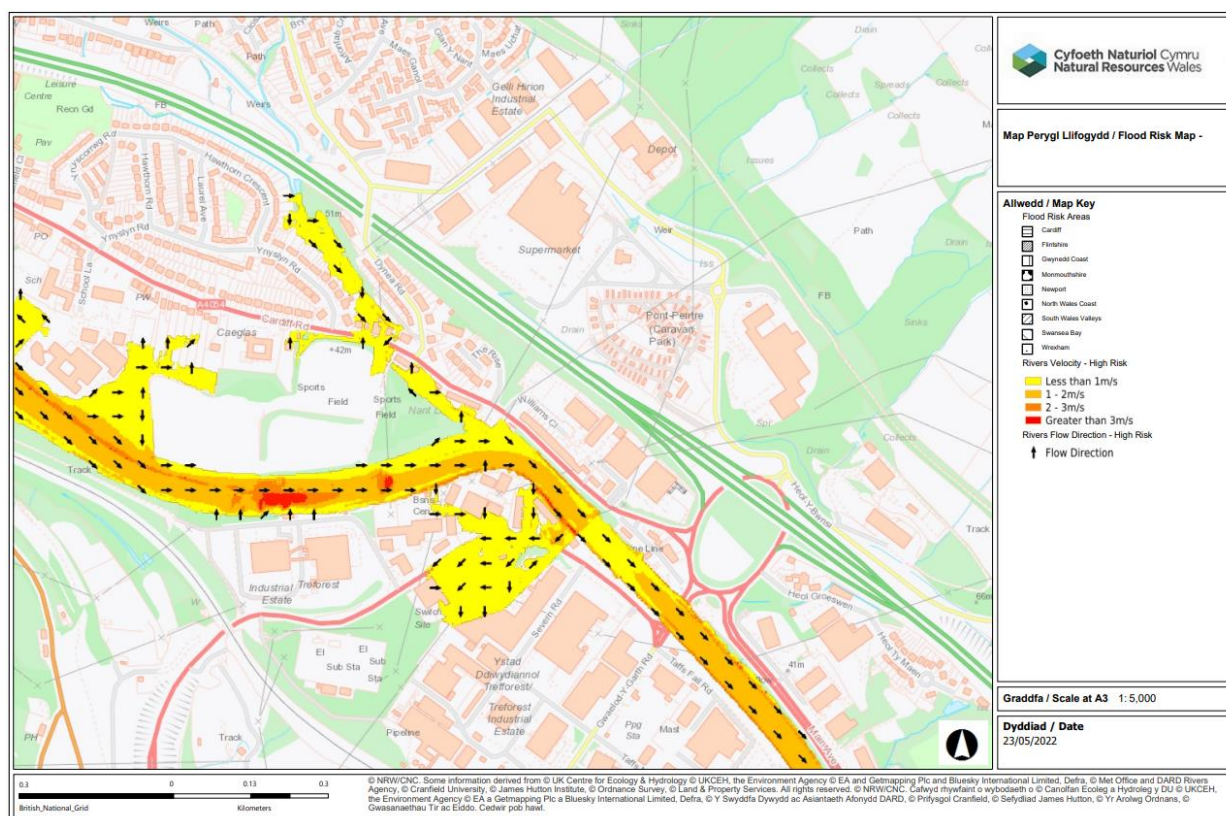
Figure 31: NRW's Flood Hazard map for High Risk River Flood Velocity and flow direction in the Hawthorn area. Contains Natural Resources Wales information © Natural Resources Wales and database right. All rights reserved.

On review of the FRAW maps for main river flooding, it is considered that the high river levels on the River Taf influenced the overtopping of the Nant Lonydd ordinary watercourse by causing a backing up of flow upstream. NRW's Flood Hazard map does in fact indicate that in a high-risk flood event, main river flow is identified to flow upstream of the Nant Lonydd watercourse. The indicative flow direction is illustrated in NRW's Flood Hazard Map for velocity in Figure 31.

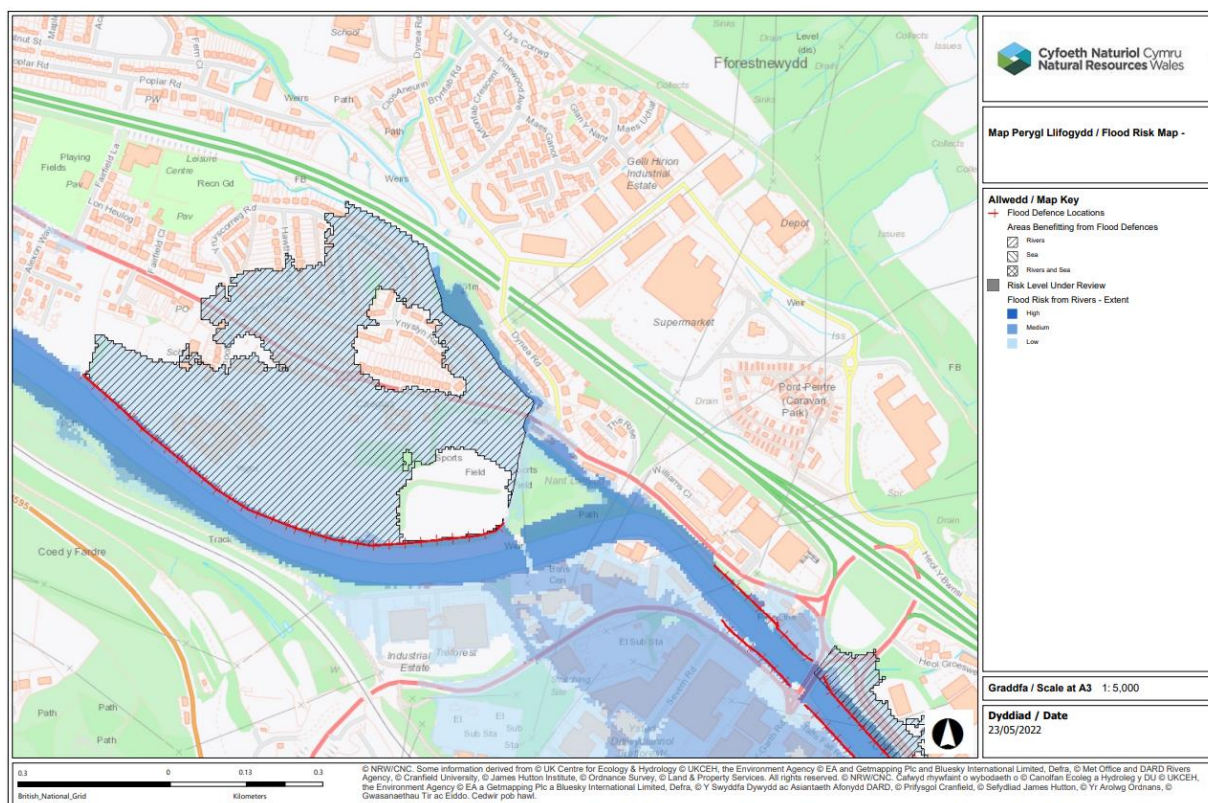
Figure 32: Natural Resources Wales' map for Main River flood defences and areas benefiting at RCT15. Contains Natural Resources Wales information © Natural Resources Wales and database right. All rights reserved.

As illustrated in Figure 32 (demarcated by a bold red line), there are approximately 800 metres of formally designated flood defence infrastructure along the northern banks of the River Taf, located upstream of the confluence with the Nant Lonydd ordinary watercourse. This infrastructure is operated and maintained by NRW.

There are no formal flood defences under the operation and maintenance of NRW in the area near the confluence of the Nant Lonydd watercourse and the River Taf, and the properties identified at high risk of main river flooding within Melin Corrwg Business Park do not fall within an area benefitting from flood defences, as depicted in Figure 32.

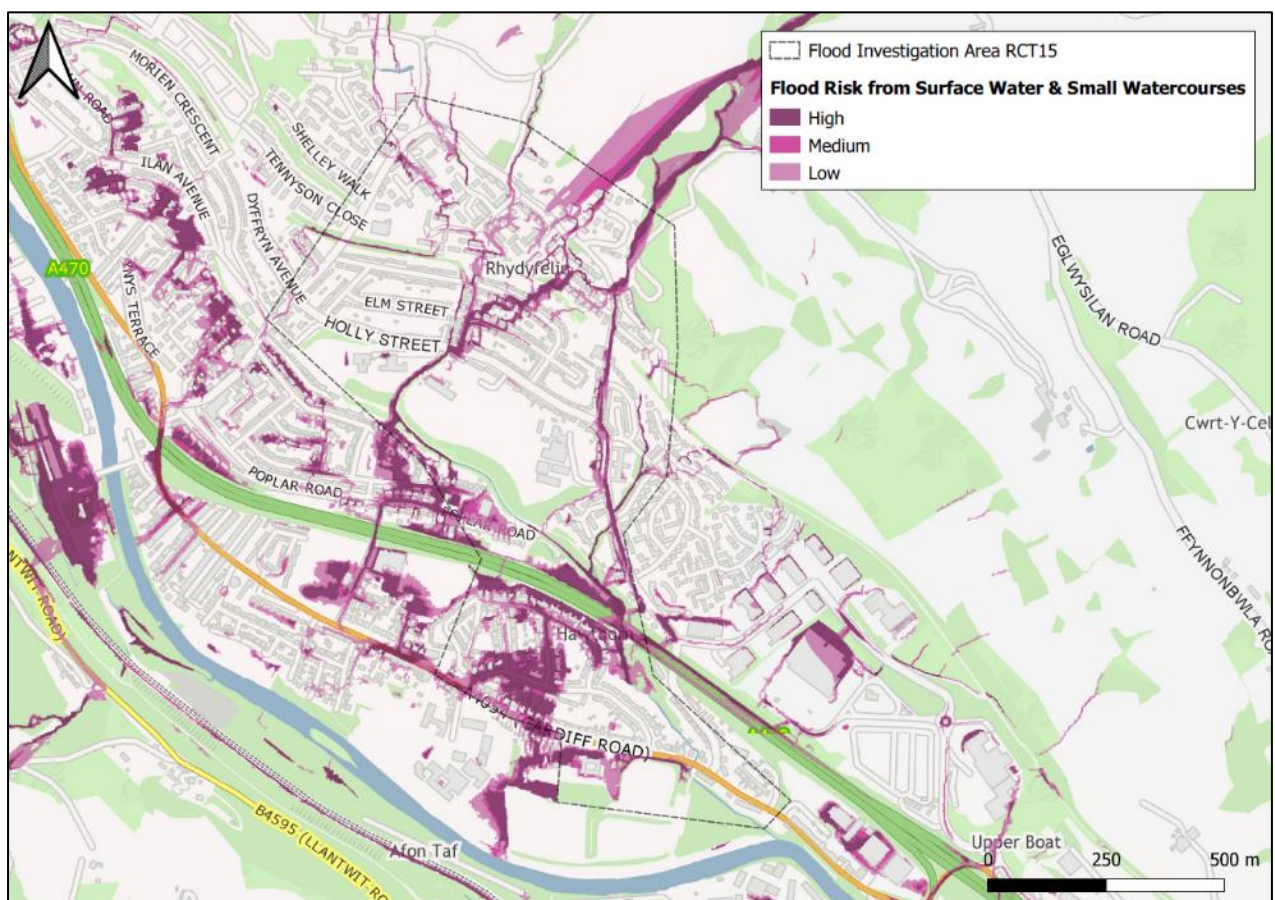
Figure 33: Natural Resources Wales' FRAW map for surface water and ordinary watercourse sources within investigation area RCT15. Contains Natural Resources Wales information © Natural Resources Wales and database right. All rights reserved.

Surface water flooding as a result of ordinary watercourse flooding associated to blocked, damaged and overwhelmed culvert infrastructure, in addition to overland flows originating from areas of hillside, has been determined as a contributing source of flooding to several residential and non-residential properties within the lower reaches of RCT15, particularly along Wordsworth Gardens, Dynea Road and Cardiff Road, where water naturally accumulates. This is highlighted in Figure 33 which depicts the surface water and ordinary watercourse flood extents based on NRW's FRAW mapping exercise.

Figure 33 also notes no flood risk from surface water and ordinary watercourse sources along the lower extent of the Nant Lonydd ordinary watercourse, further reinforcing that the impacted properties at Cardiff Road and Melin Corrwg Business Park were influenced by flooding associated with high river levels on the River Taf backing up flow upstream of the Nant Lonydd.
