# Flood and Water Management Act 2010

## Section 19 Flood Investigation Report

Storm Dennis –  
Flood Investigation Area RCT01  
(Hirwaun)

January 2022

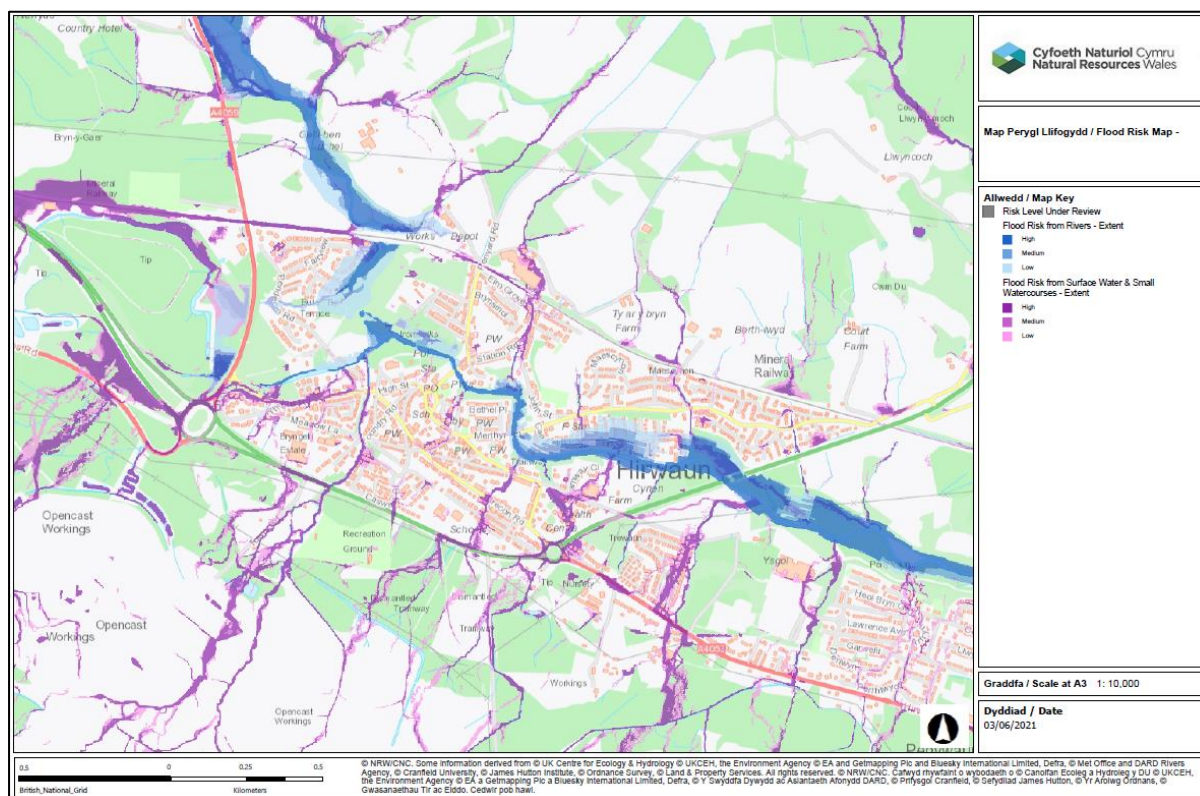
**Figure 2:** Natural Resources Wales' Flood Risk Assessment Wales (FRAW) map for rivers and ordinary watercourse and surface water flood risk at investigation area RCT01. Contains Natural Resources Wales information © Natural Resources Wales and database right. All rights reserved.

The highest risk posed to people and properties is broadly associated with the River Cynon across the length of the watercourse, with significant risk along sections of Cae Felin Parc and Llys Cynon. A risk of flooding is also noted in the north of the site, sourced from the River Cynon culvert inlet<sup>3</sup>. Natural Resources Wales' Flood Risk Assessment Wales (FRAW) map also notes a low to high risk of surface water and ordinary watercourse flooding sources from various culvert inlets (Figure 2).

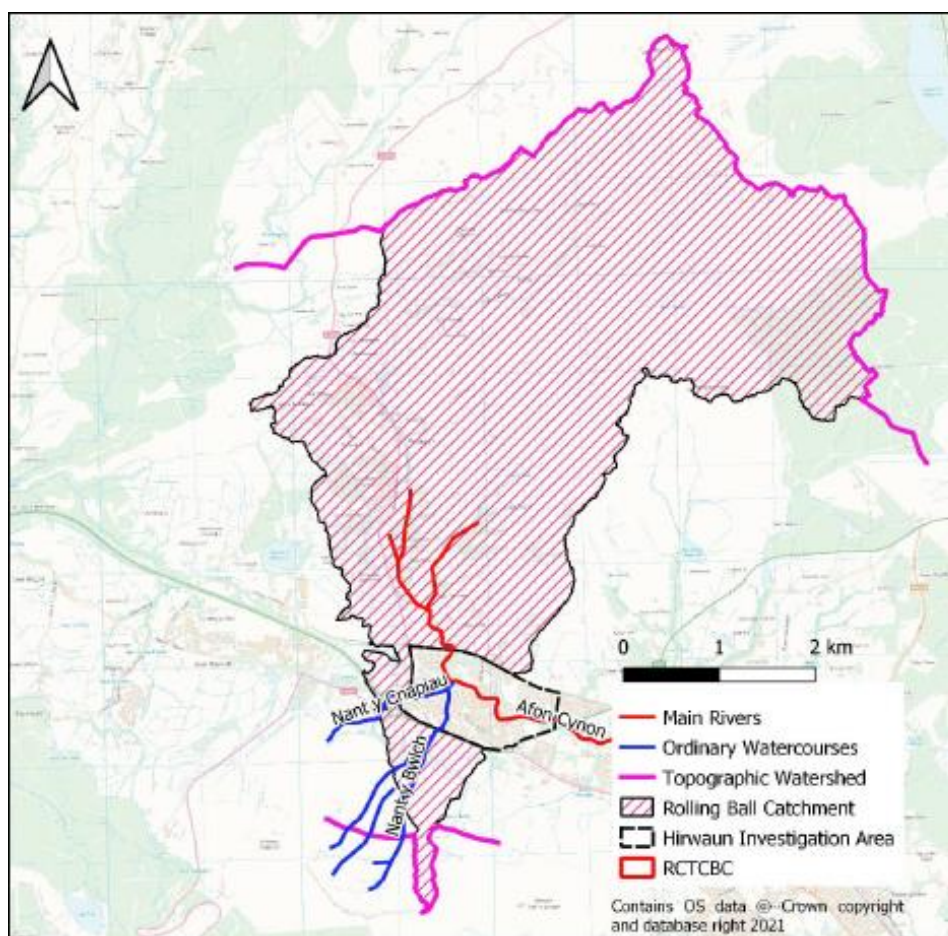
**Figure 9:** Rainfall Topographic Catchment area and named ordinary watercourses draining into the River Cynon at investigation area RCT01

There are several named and unnamed ordinary watercourses which flow through investigation area RCT01. Notable watercourses include the Nant y Cnapiau and Nant y Bwlch which both drain the catchment area to the south and southwest of Hirwaun before discharging into the River Cynon (Figure 9).

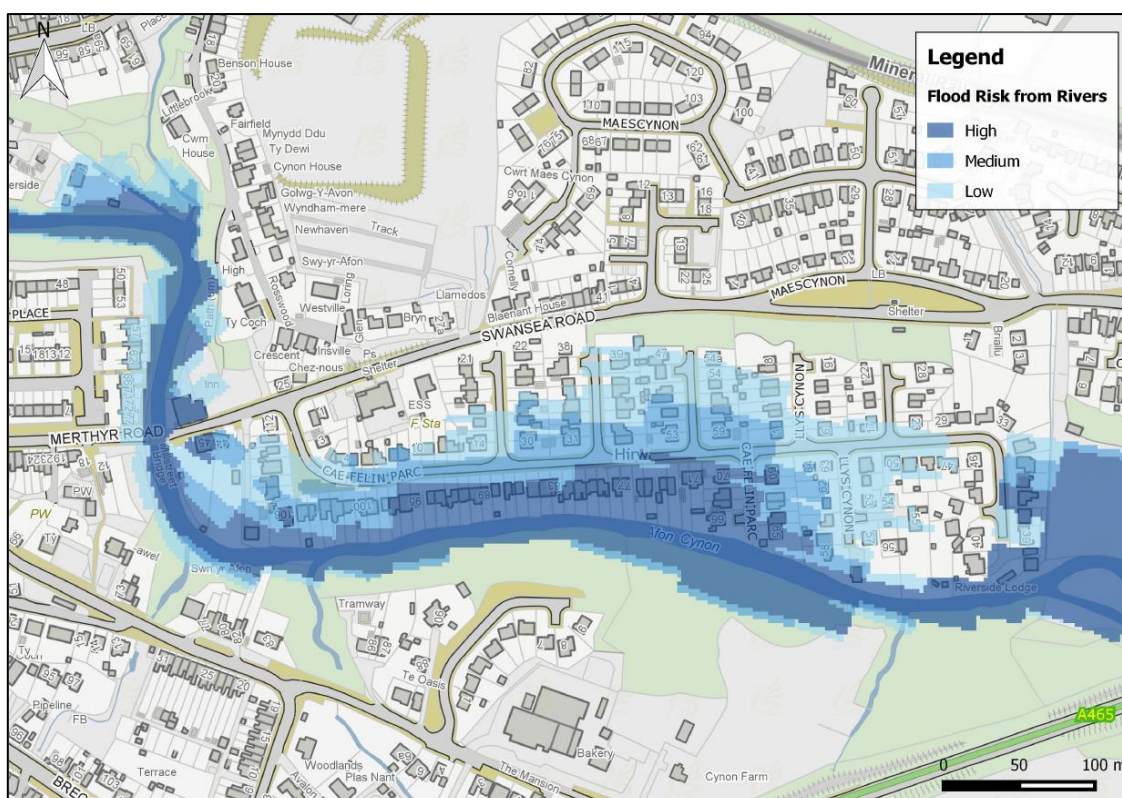
**Figure 13:** Natural Resources Wales' Flood Risk Assessment Wales (FRAW) map for River sources at RCT01. Contains Natural Resources Wales information © Natural Resources Wales and database right. All rights reserved.

Properties impacted by flooding at Cae Felin Parc are identified at high risk of fluvial flooding, as depicted within Figure 13, which is an extract from NRW's FRAW mapping exercise and depicts the main river flood extents for the 'Defended' scenario, i.e., with the presence of flood defence infrastructure. The darker shading identifies areas at higher risk of flooding (more frequent/less extreme rainfall events) and lighter shading showing the lower risk areas (less frequent/more extreme rainfall events).

Those properties directly adjacent to the River Cynon suffered the most severe impacts, with reported flood depths up to 1 metre in height observed at those properties falling in the high flood risk zone.

Based on evidence provided by the FRAW map and the lack of formal flood defences, properties at Cae Felin Parc are identified at high risk of flooding from the main river (Figure 13).

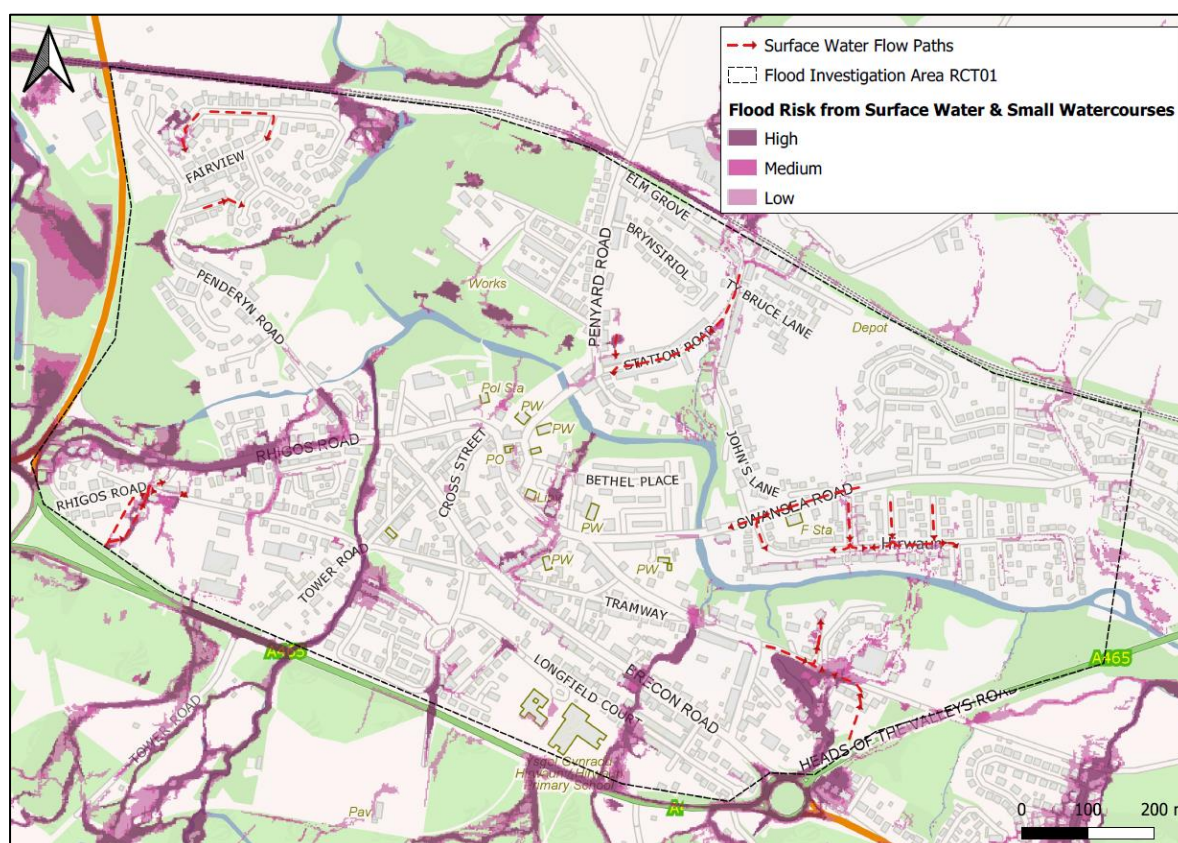
**Figure 15:** Natural Resources Wales' FRAW map for surface water and ordinary watercourse sources and indicative surface water flow paths within investigation area RCT01. Contains Natural Resources Wales information © Natural Resources Wales and database right. All rights reserved.

The pathways for surface water runoff during the storm event was observed primarily along the highway network, but also as overland flows originating from areas of hillside within the investigation area. It should be noted that the exact flow routes have not been confirmed due to limited anecdotal evidence, however, NRW's national surface water and ordinary watercourse flood maps provide a reasonable indication of the pathways that would have occurred during the storm event. These indicative surface water flow paths are illustrated in Figure 15 and correlate well with NRW's surface water flood map.

Runoff was channeled via several roads, towards properties at Cae Felin Parc, Tramway, Penmark Row, Fairview and Station Road. The gradient of the roads, elevation of properties relative to the road, and the extent of impermeable surfaces surrounding the affected streets is considered to have; increased surface water flows along the highway and attributed to the pooling of water outside properties. In most cases, the surface water flooding at RCT01 was primarily caused by intense rainfall falling on already saturated catchments following Storm Ciara on 7-8<sup>th</sup> February 2020.
